Permit Fact Sheet

Permit Number:	WI-0065218-03-0
Permittee Name:	Fendryk Brothers Partnership
Address:	W9075 County Road P
City/State/Zip:	Crivitz WI 54114
Discharge Location:	Main Dairy : W9075 County P, Crivitz, WI 54114 , NW ¼ of NE ¼ Section 30 T31N R20E Rymer Farm: W10054 14 th Road, Pound, WI 54161, SW ¼ of SW ¼ Section 23 T31N R19E
Receiving Water:	Iron Springs Creek & unnamed tributaries within the Little Peshtigo River Watershed, and groundwaters of the state
Discharge Type:	Existing

On Thursday July 13, 2023 Hanson & Arnoldi met with Fendryk, Fendryk, Paulson & Hodkiewicz at 9:00 at Fendryk Brothers Partnership site to conduct a permit reissuance walkover inspection. Both the main production site & the Rymer Farm were inspected. A trace amount of liquid precipitation had fallen recently and the temperature was in the 70's and cloudy. No permit violations were observed, and no water samples were collected. Hanson & Arnoldi departed at approximately 10:50.

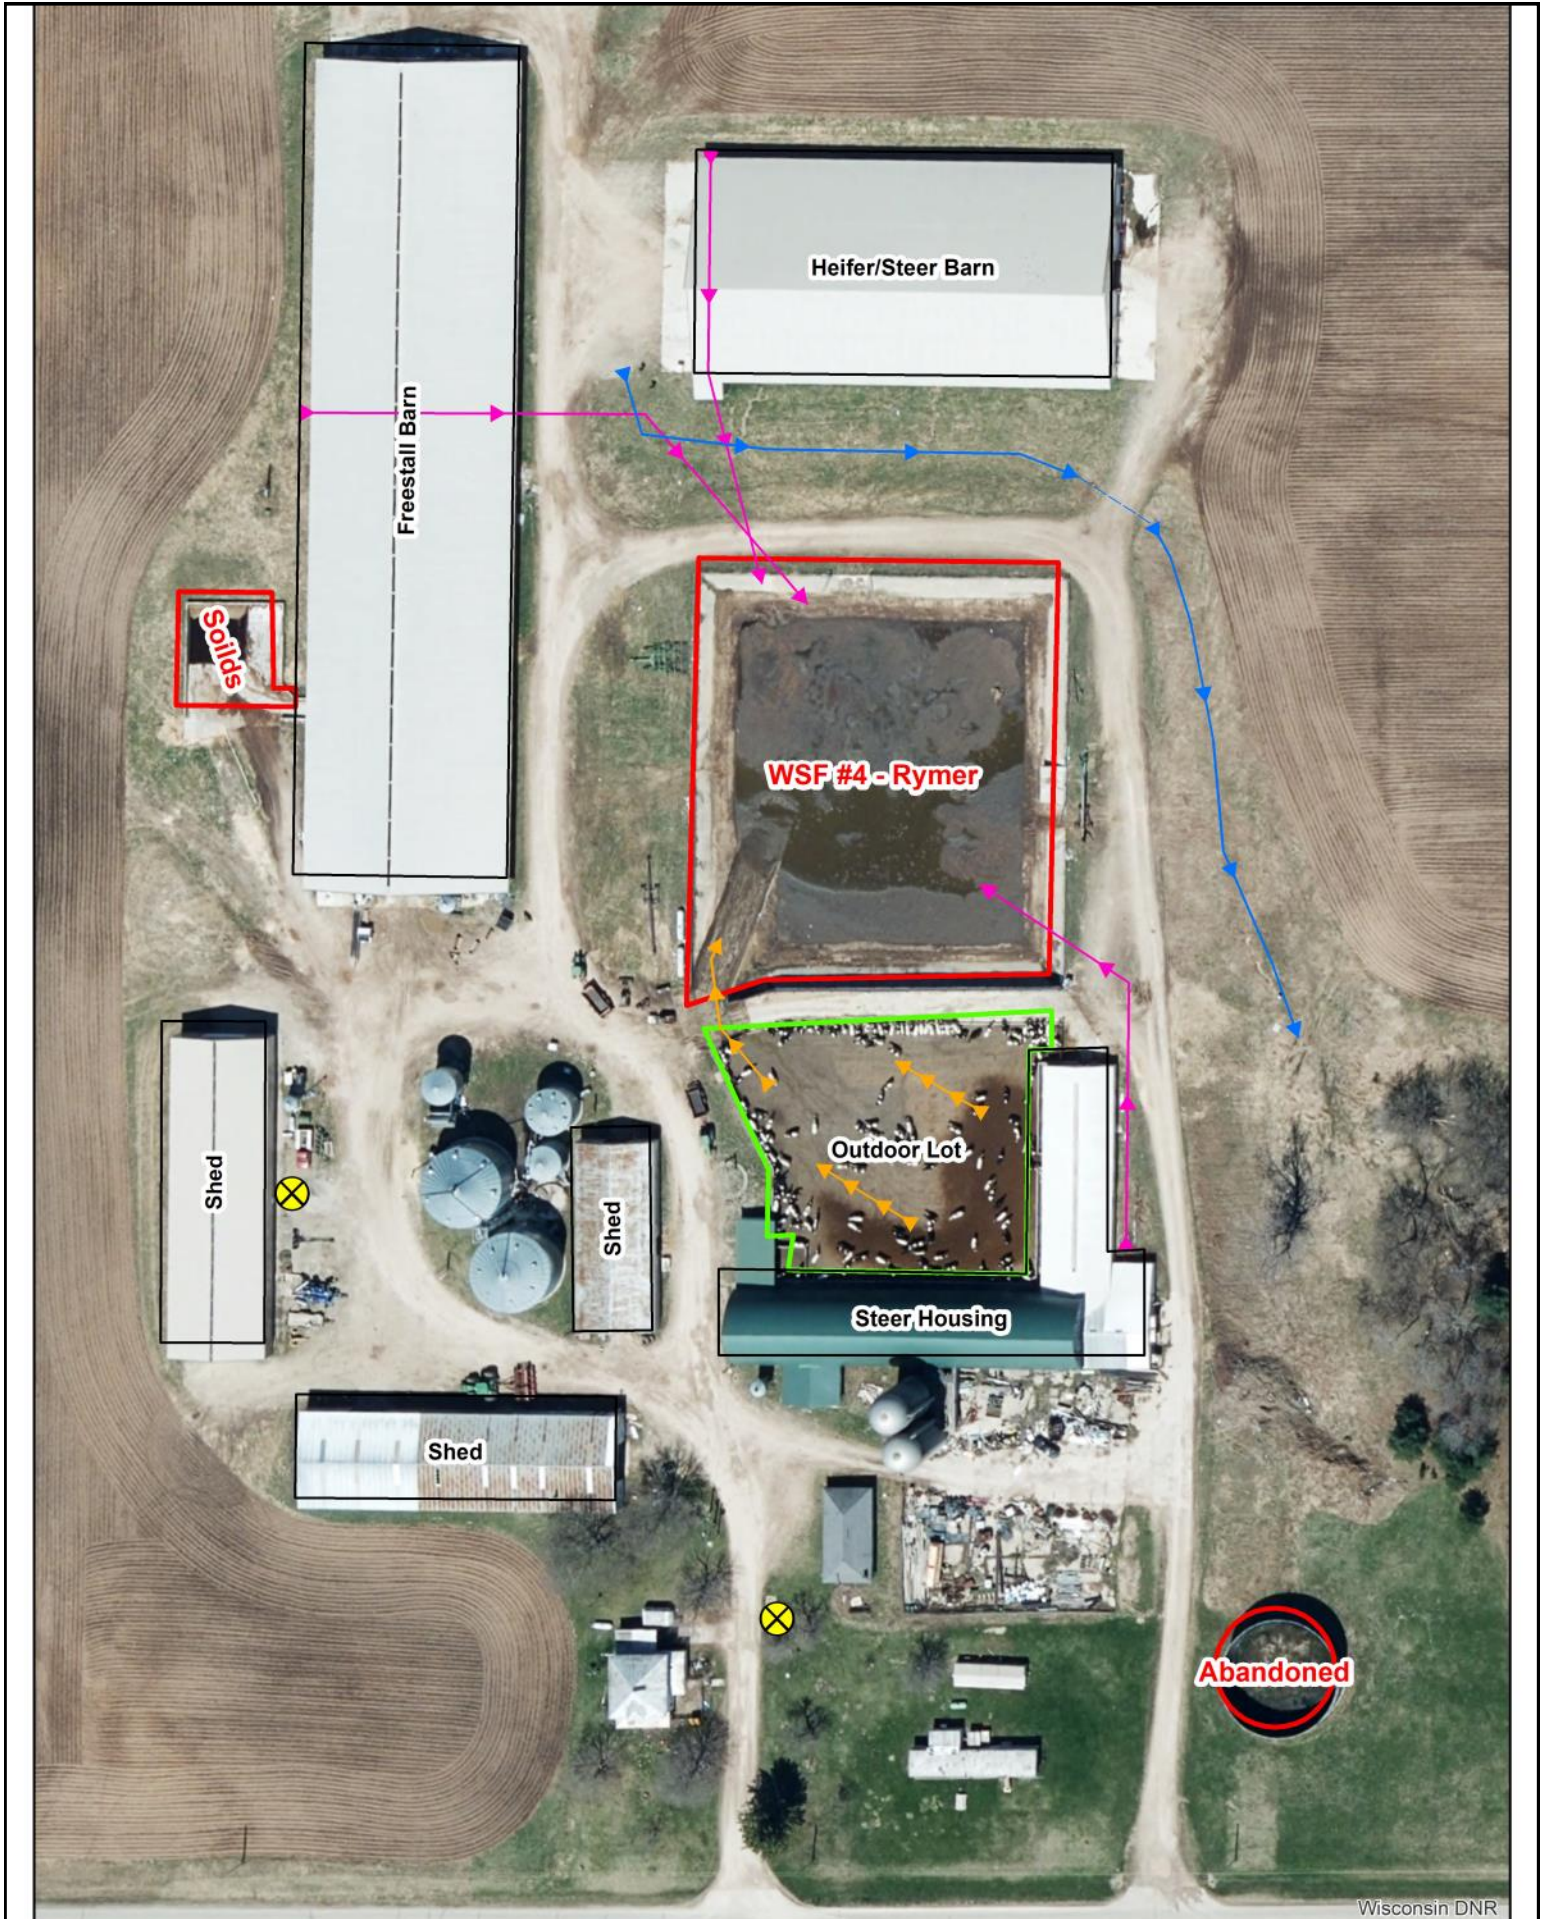
Site Overview Diagram (Rymer Farm: orange lines = potential runoff flow patterns, blue lines = stormwater flow, pink lines = waste transfer system, yellow circles indicate water supply well locations)

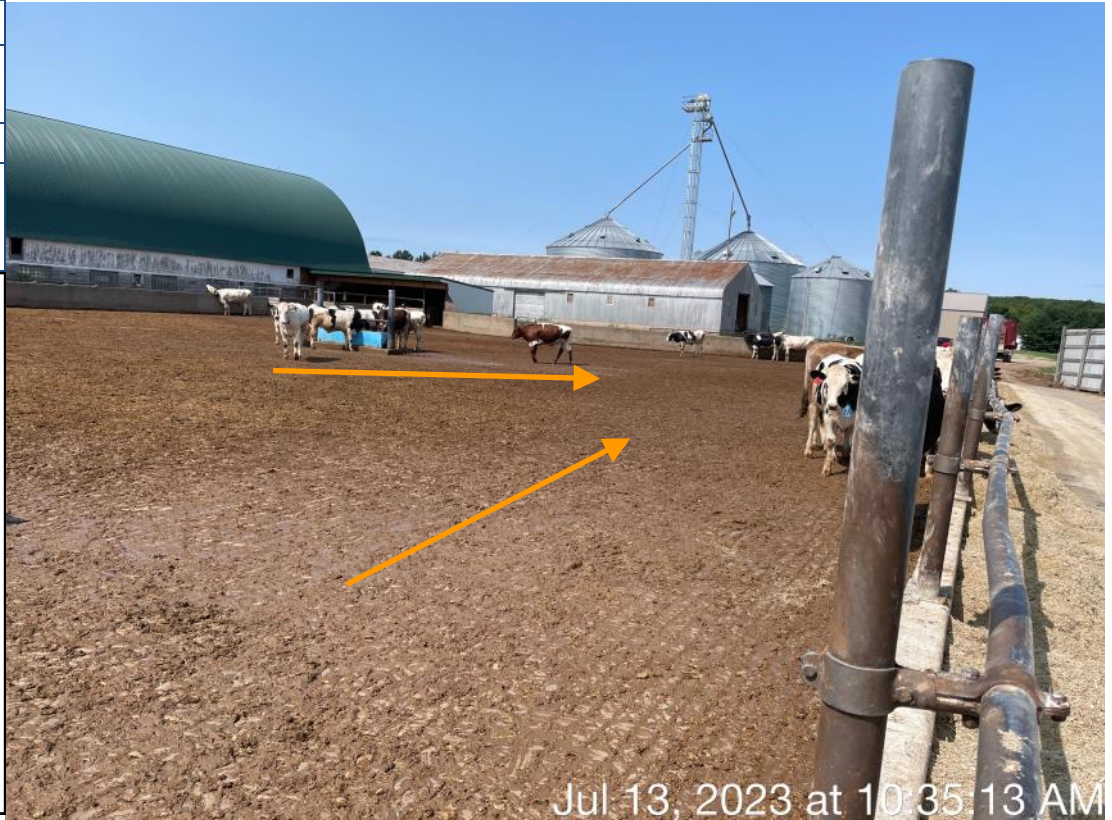
Photo #:	7158
Date/Time of Photo:	7/13/2023 10:35
Photo By:	Brian Hanson
Photo Location:	Rymer Farm Feedlot

Photo Description:
 Standing at the northeast corner of outdoor feedlot looking southwest: View of outdoor feedlot. Arrows indicate direction of runoff flow.

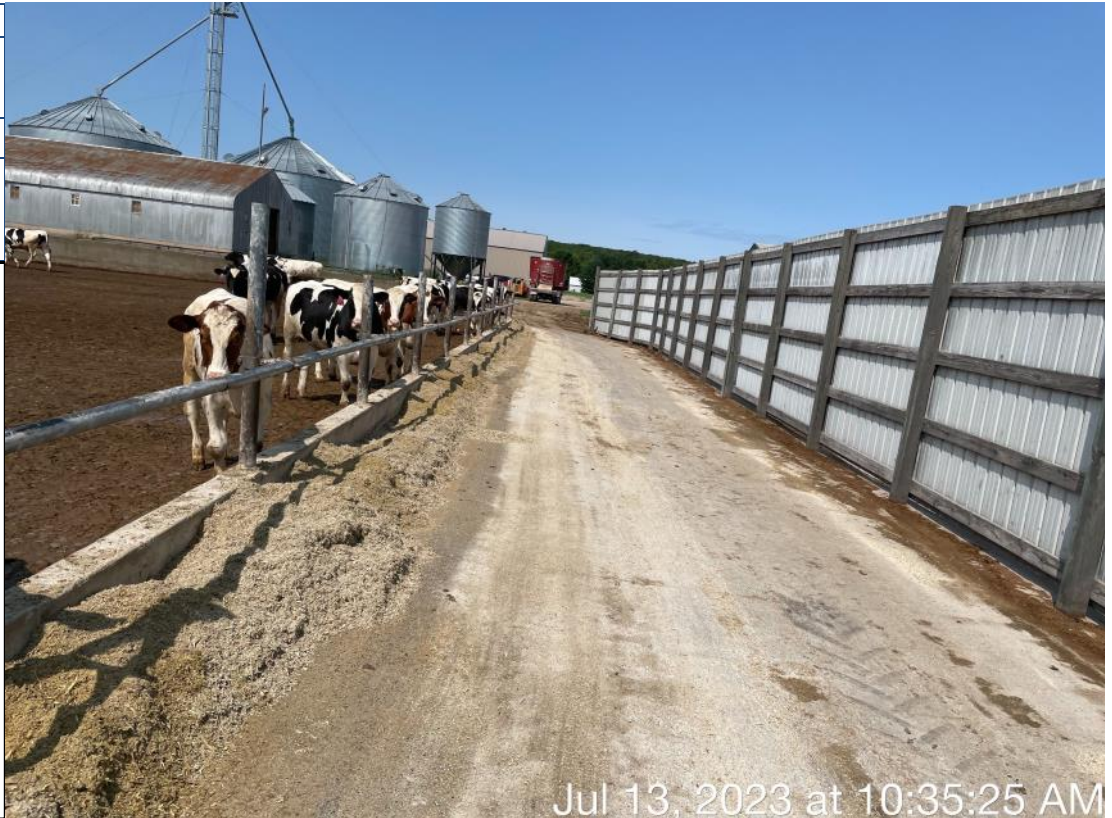
Photo #:	7160
Date/Time of Photo:	7/13/2023 10:35
Photo By:	Brian Hanson
Photo Location:	Rymer Farm Feedlot

Photo Description:
 Standing on north side of outdoor feedlot looking west: View of drive by feeding area for feedlot. Notice wall on right side of photo. This is the south edge of WSF #4. All runoff from lot and feeding area gravity flows directly into WSF #4

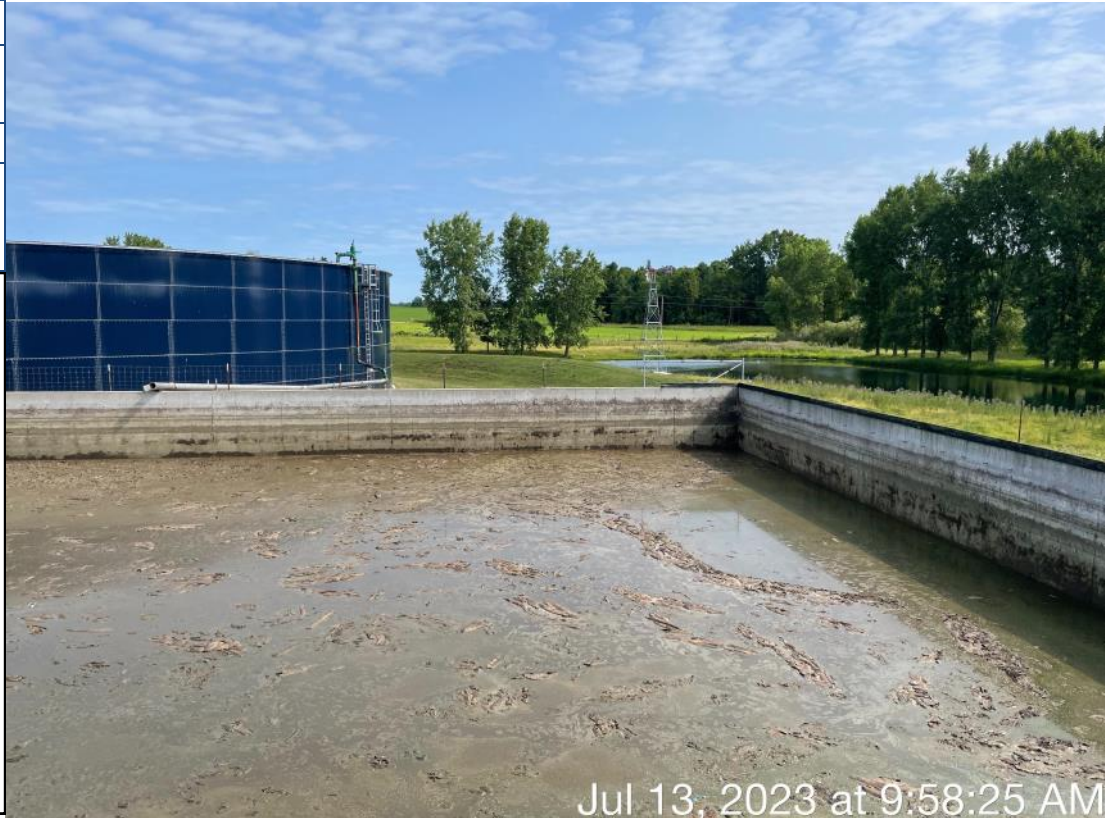
Photo #:	7098
Date/Time of Photo:	7/13/2023 9:58
Photo By:	Brian Hanson
Photo Location:	Main Dairy WSF #1
Photo Description:	Standing on south side of WSF #1 looking northeast: View of northeast corner of WSF #1.

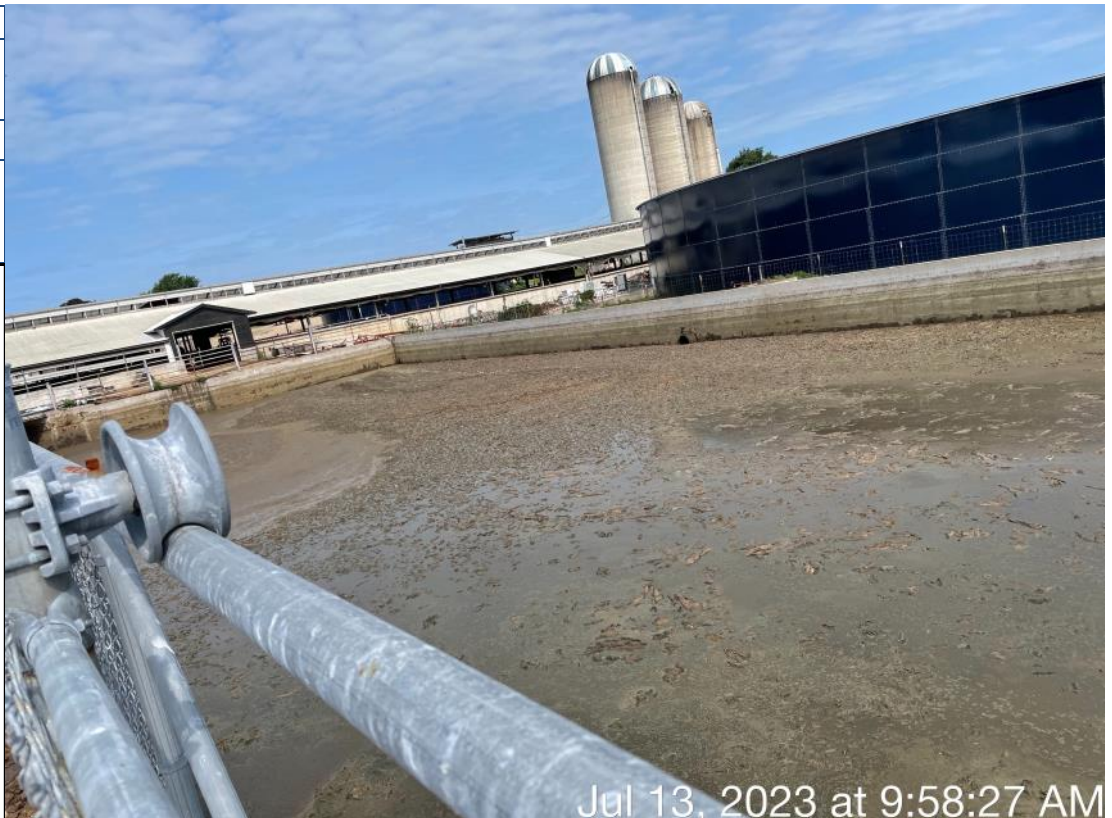
Photo #:	7100
Date/Time of Photo:	7/13/2023 9:58
Photo By:	Brian Hanson
Photo Location:	Main Dairy WSF #1
Photo Description:	Standing on the south side of WSF #1 looking northwest: View of center section of WSF #1.

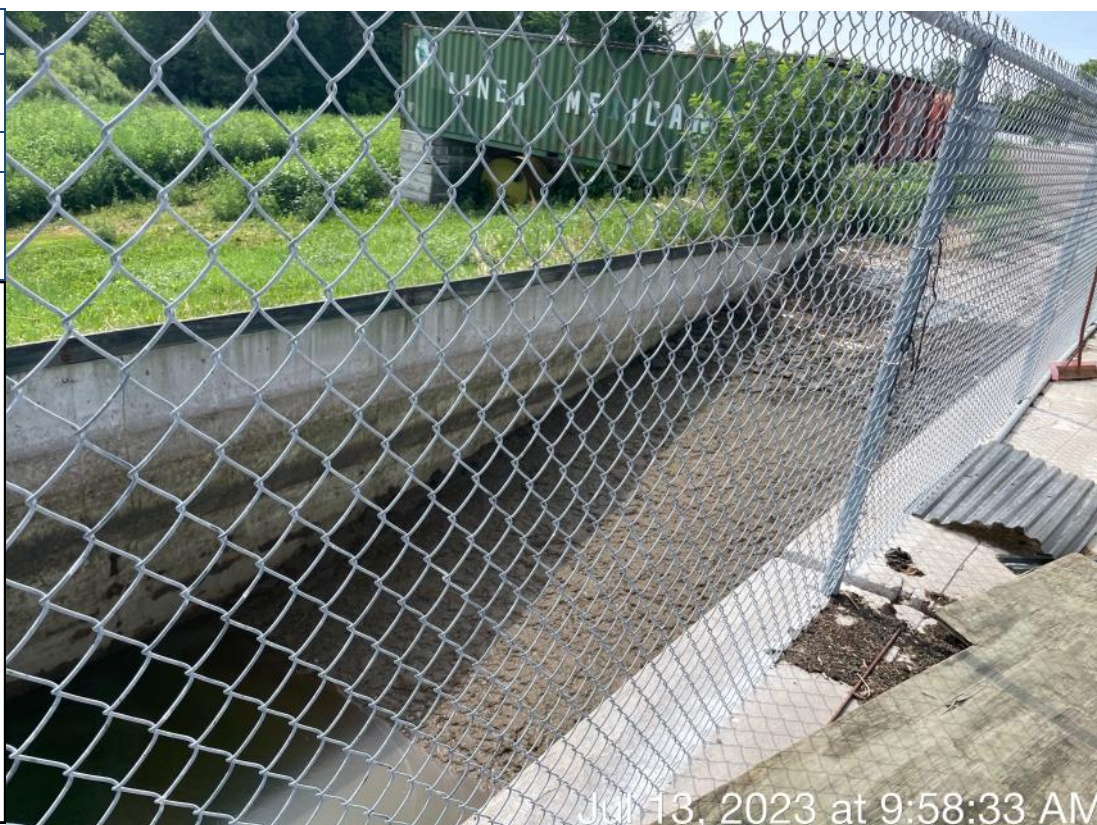
Photo #:	7101
Date/Time of Photo:	7/13/2023 9:58
Photo By:	Brian Hanson
Photo Location:	Main Dairy WSF #1

Standing at southeast corner of WSF #1 looking southwest:
View of concrete access ramp in southeast corner of WSF #1.

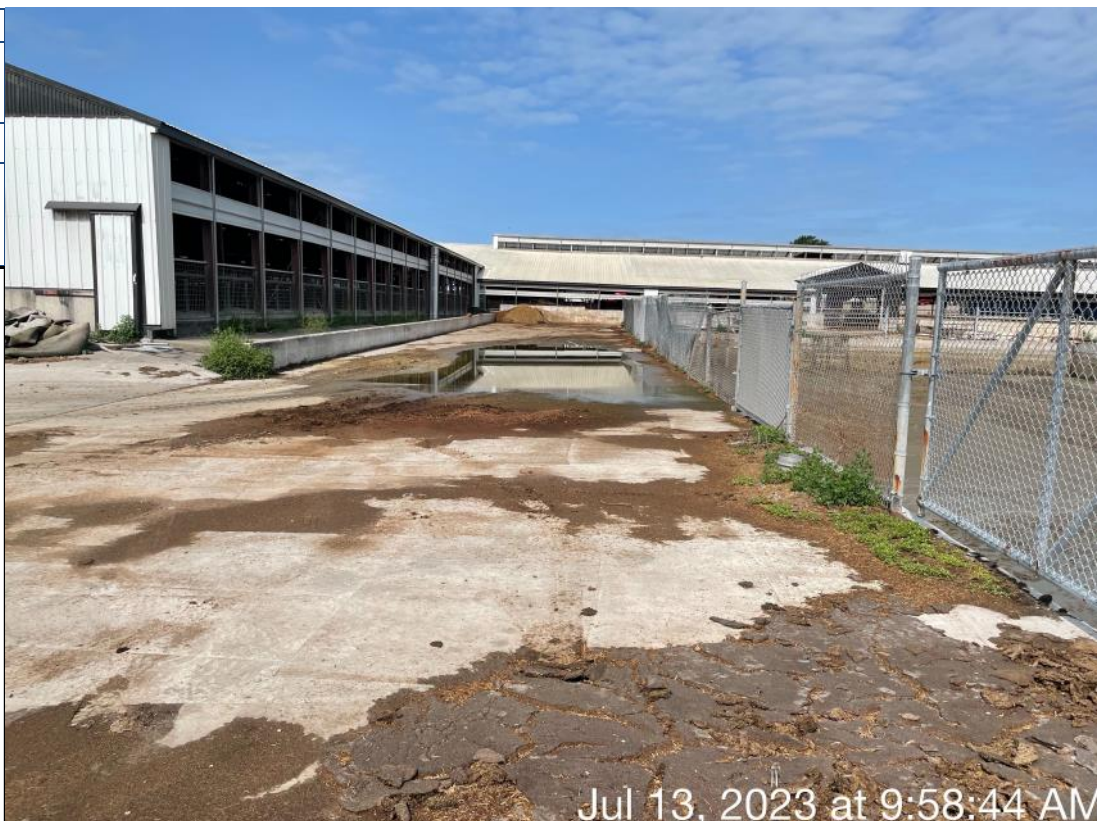
Photo #:	7105
Date/Time of Photo:	7/13/2023 9:58
Photo By:	Brian Hanson
Photo Location:	Main Dairy WSF #1

Standing on south side of WSF #1 looking west: View of concrete slab on south side of WSF #1. Part of this area used for solid manure stacking. Runoff flows directly into WSF #1.

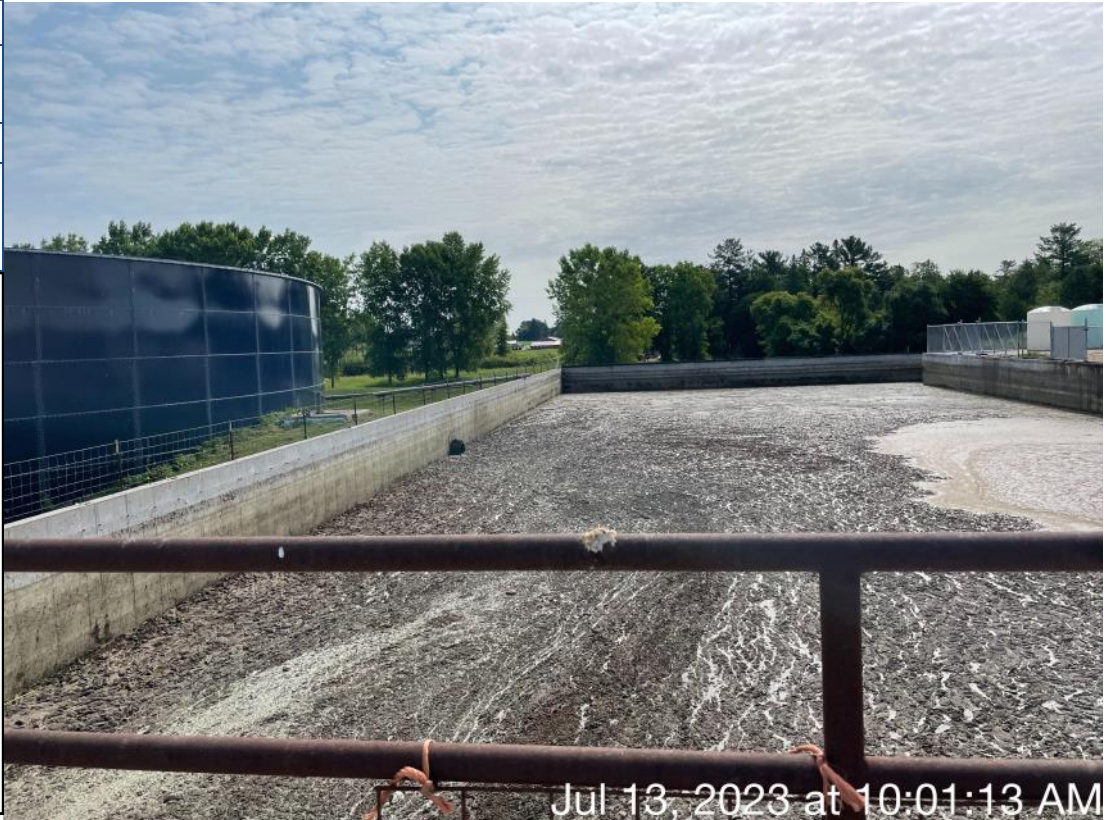
Photo #:	7118
Date/Time of Photo:	7/13/2023 10:01
Photo By:	Brian Hanson
Photo Location:	Main Dairy WSF #1

Photo Description:
Standing on west side of WSF #1 looking east: View of north wall of WSF #1.

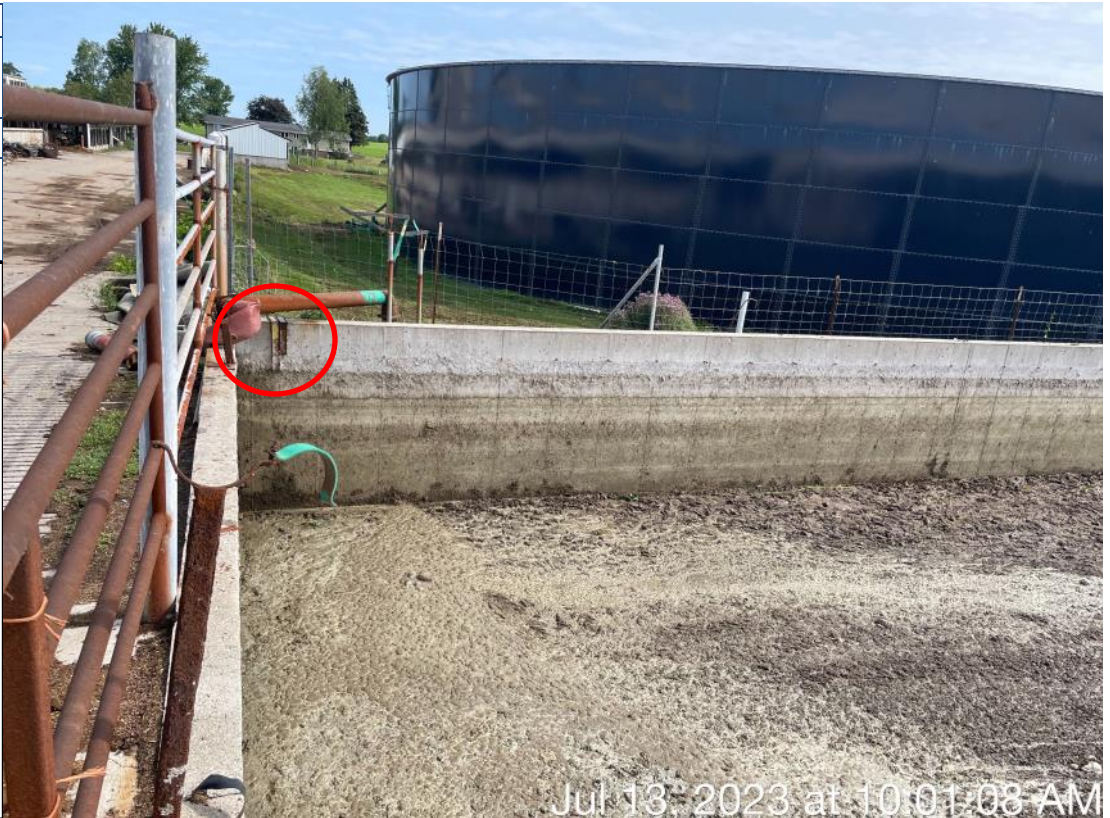
Photo #:	7117
Date/Time of Photo:	7/13/2023 10:01
Photo By:	Brian Hanson
Photo Location:	Main Dairy WSF #1

Photo Description:
Standing on the west side of WSF #1 looking north: View of northwest corner of WSF #1. Permanent markers highlighted.

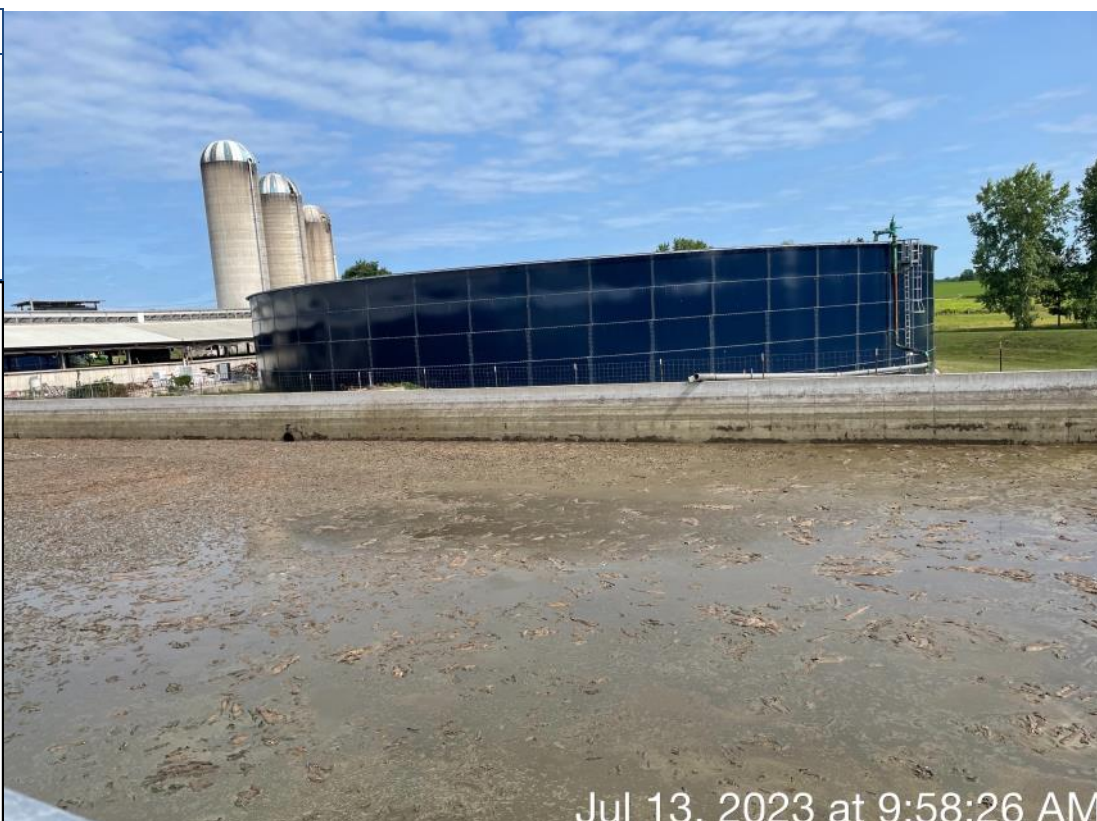
Photo #:	7099
Date/Time of Photo:	7/13/2023 9:58
Photo By:	Brian Hanson
Photo Location:	Main Dairy WSF #2
Photo Description:	Standing on south side of WSF #1 looking north: View of WSF #2 in relation to WSF #1. Notice transfer pump & pipe on east side of WSF #2. Pump used to transfer waste from WSF #2 to WSF #1 prior to land application.

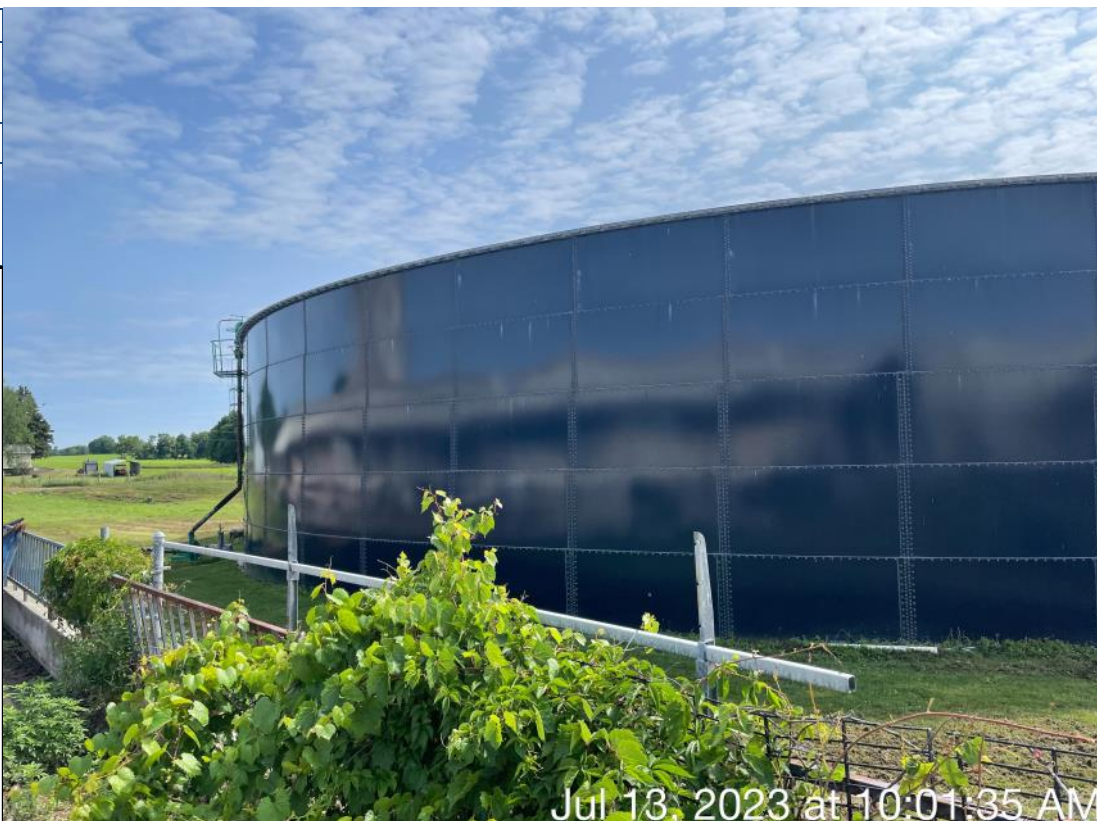
Photo #:	7121
Date/Time of Photo:	7/13/2023 10:01
Photo By:	Brian Hanson
Photo Location:	Main Dairy WSF #2
Photo Description:	Standing on west side of WSF #2 looking north: View of western side of WSF #2.

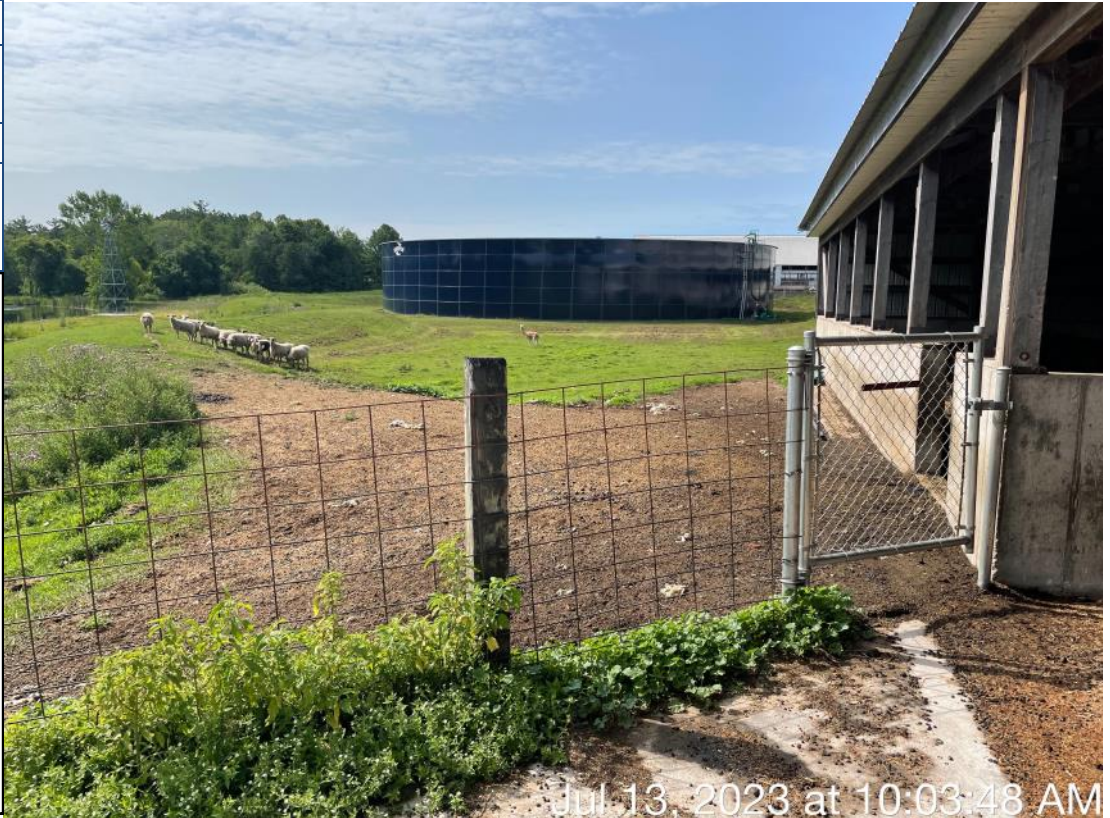
Photo #:	7131
Date/Time of Photo:	7/13/2023 10:03
Photo By:	Brian Hanson
Photo Location:	Main Dairy WSF #2

Photo Description:
Standing north & west of WSF #2: View of secondary containment area on north side of WSF #2. Culvert through containment berm (near sheep in picture) has gate valve that can be closed in case of WSF #2 failure.

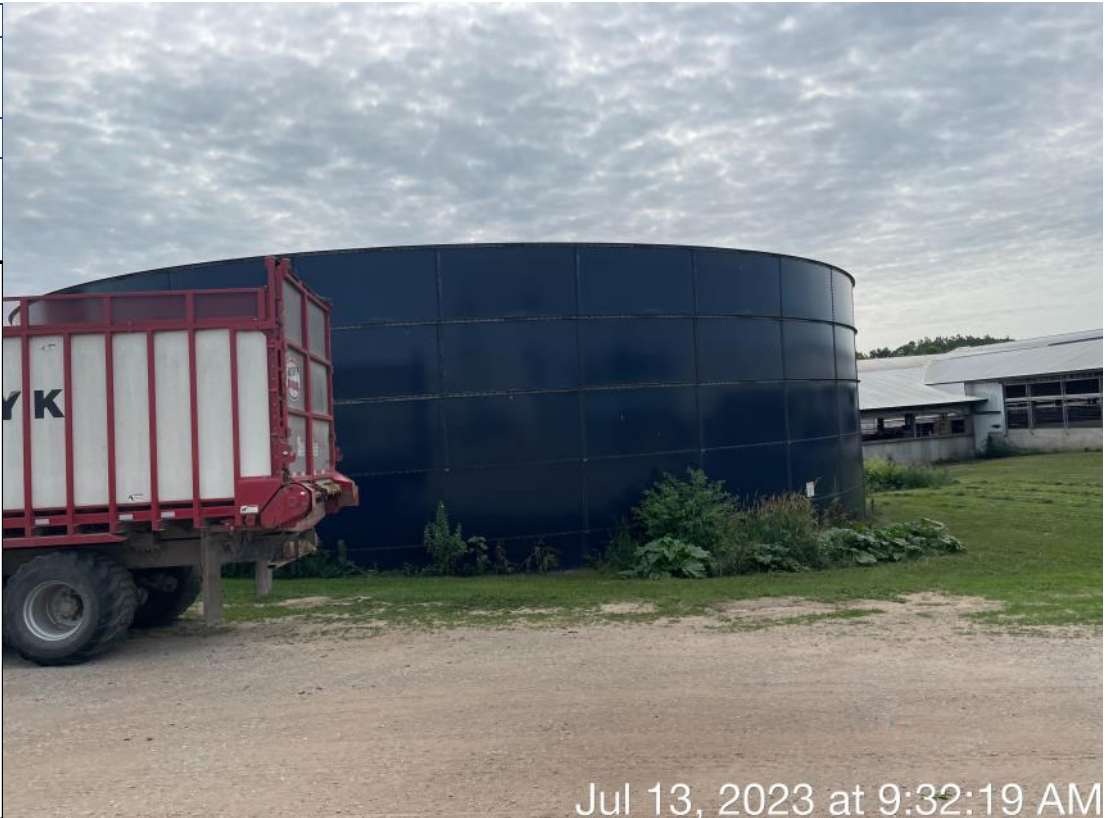
Photo #:	7029
Date/Time of Photo:	7/13/2023 9:32
Photo By:	Brian Hanson
Photo Location:	Main Dairy WSF #3

Photo Description:
Standing on west side of WSF #3 looking southeast: View of west side of WSF #3.

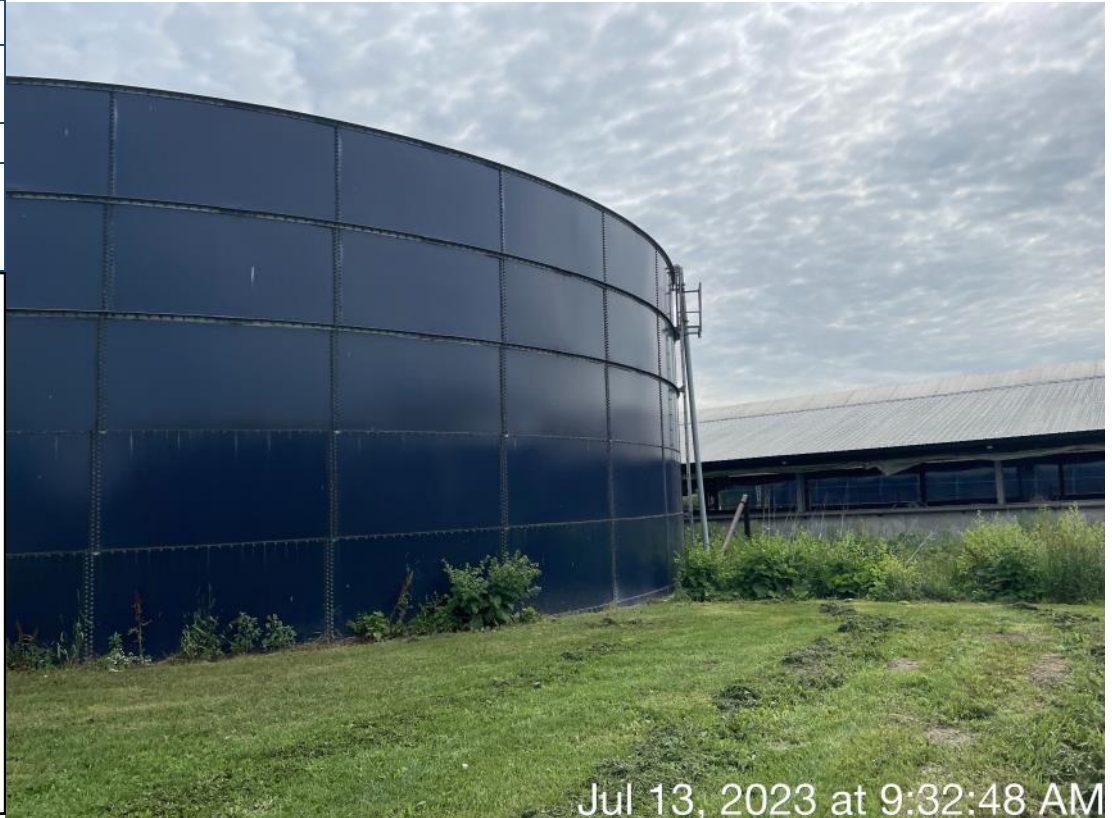
Photo #:	7032
Date/Time of Photo:	7/13/2023 09:32
Photo By:	Brian Hanson
Photo Location:	Main Dairy WSF #3

Photo Description:
Standing at southwest corner of WSF #3 looking east: View of south side of WSF #3.

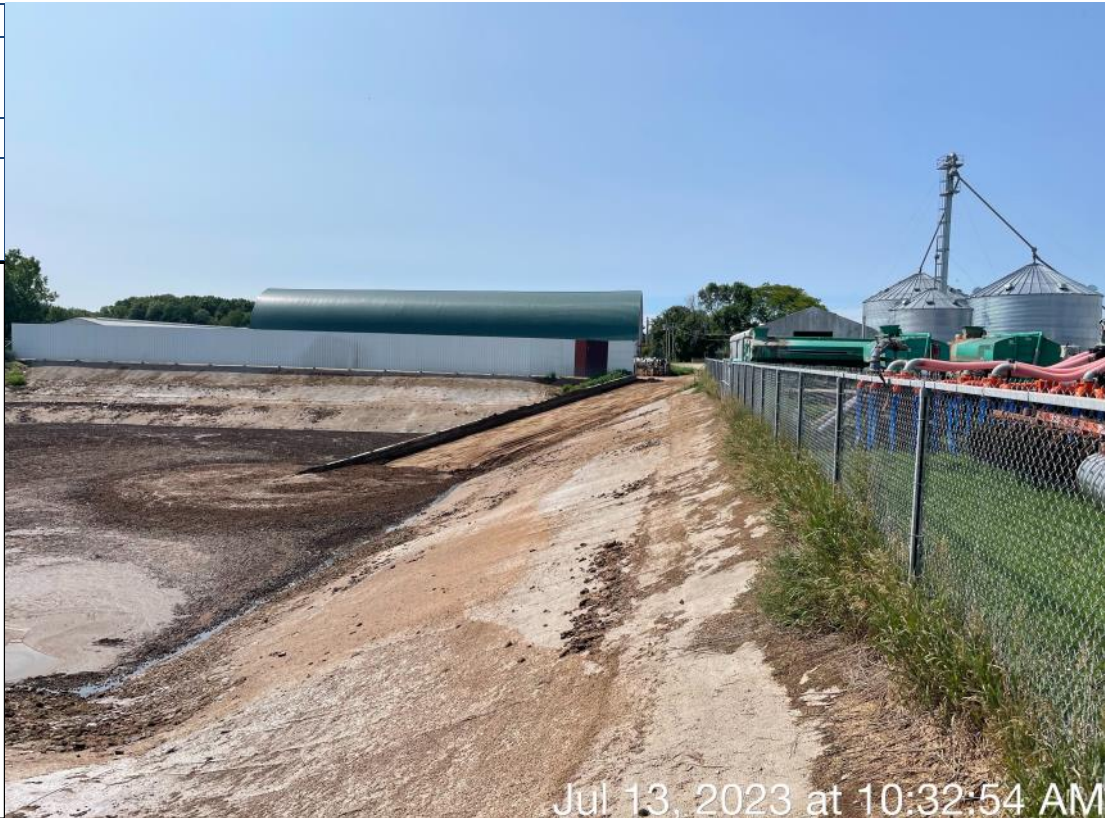
Photo #:	7147
Date/Time of Photo:	7/13/2023 10:32
Photo By:	Brian Hanson
Photo Location:	Rymer Farm WSF #4

Photo Description:
Standing at northwest corner of WSF #4 looking south: View of west edge of WSF #4. Notice access ramp in far corner.

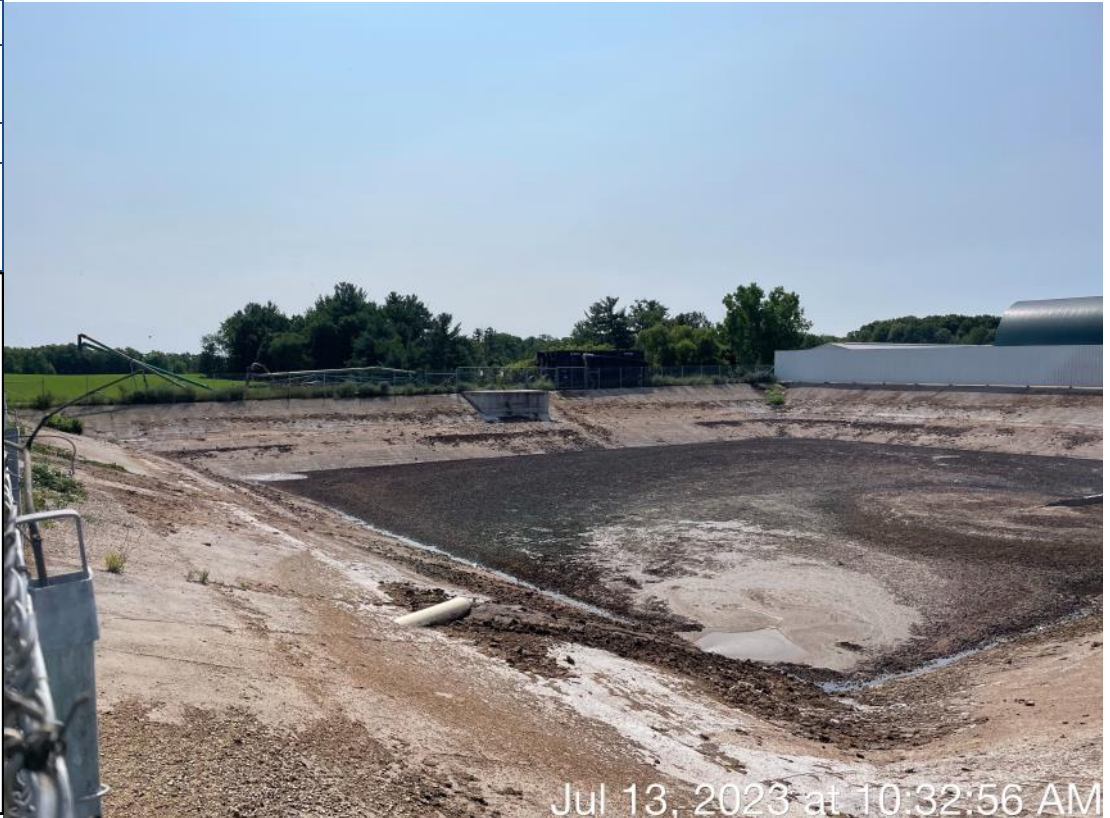
Photo Description:
Standing at northwest corner of WSF #4 looking southeast: View of northwest corner of WSF #4.

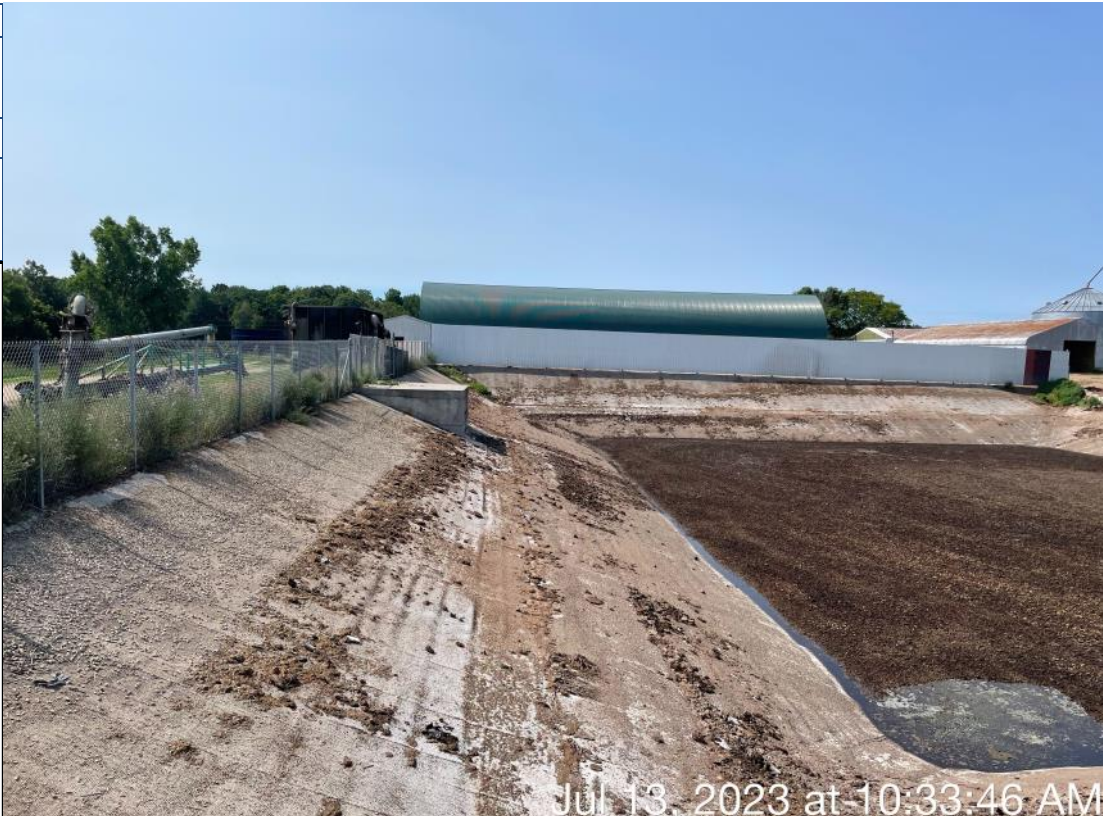
Photo #:	7150
Date/Time of Photo:	7/13/2023 10:33
Photo By:	Brian Hanson
Photo Location:	Rymer Farm WSF #4

Photo Description:
Standing at northeast corner of WSF #4 looking south: View of east edge of WSF #4.

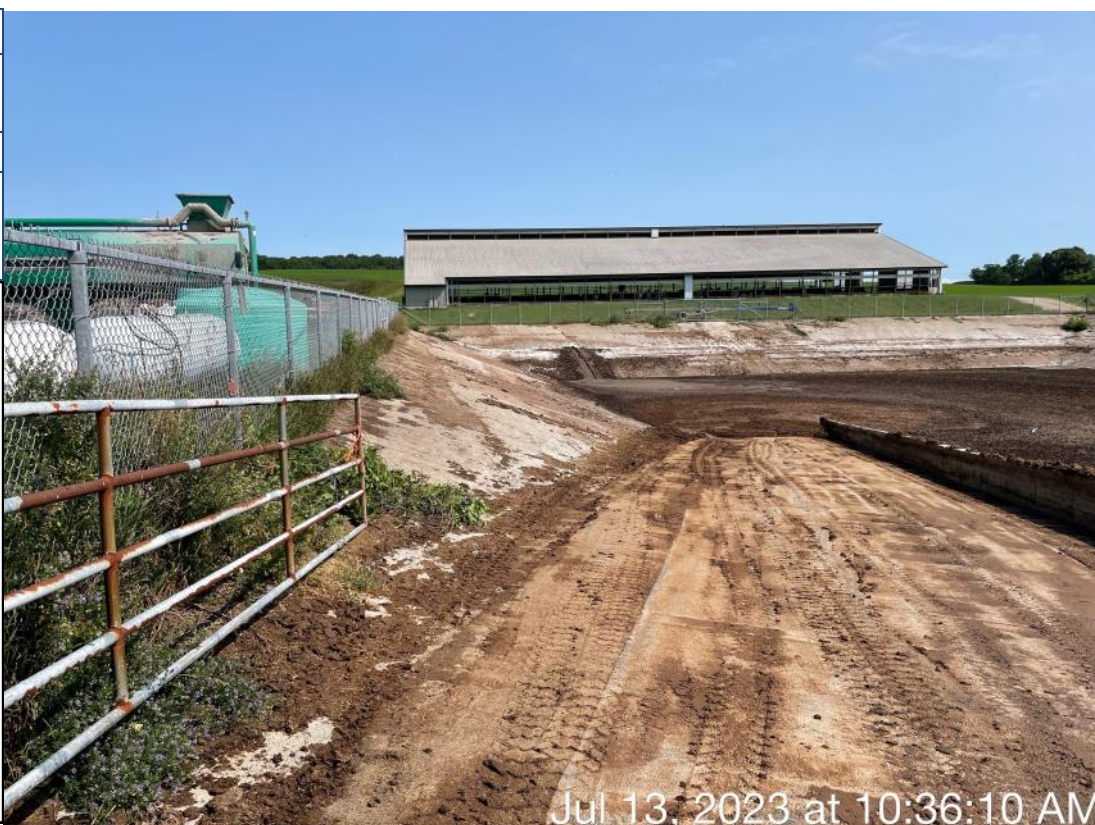
Photo #:	7164
Date/Time of Photo:	7/13/2023 10:36
Photo By:	Brian Hanson
Photo Location:	Rymer Farm WSF #4

Photo Description:
Standing at southwest corner of WSF #4: View of southwest corner of WSF #4 that is used as access ramp to remove solids from bottom of pit.

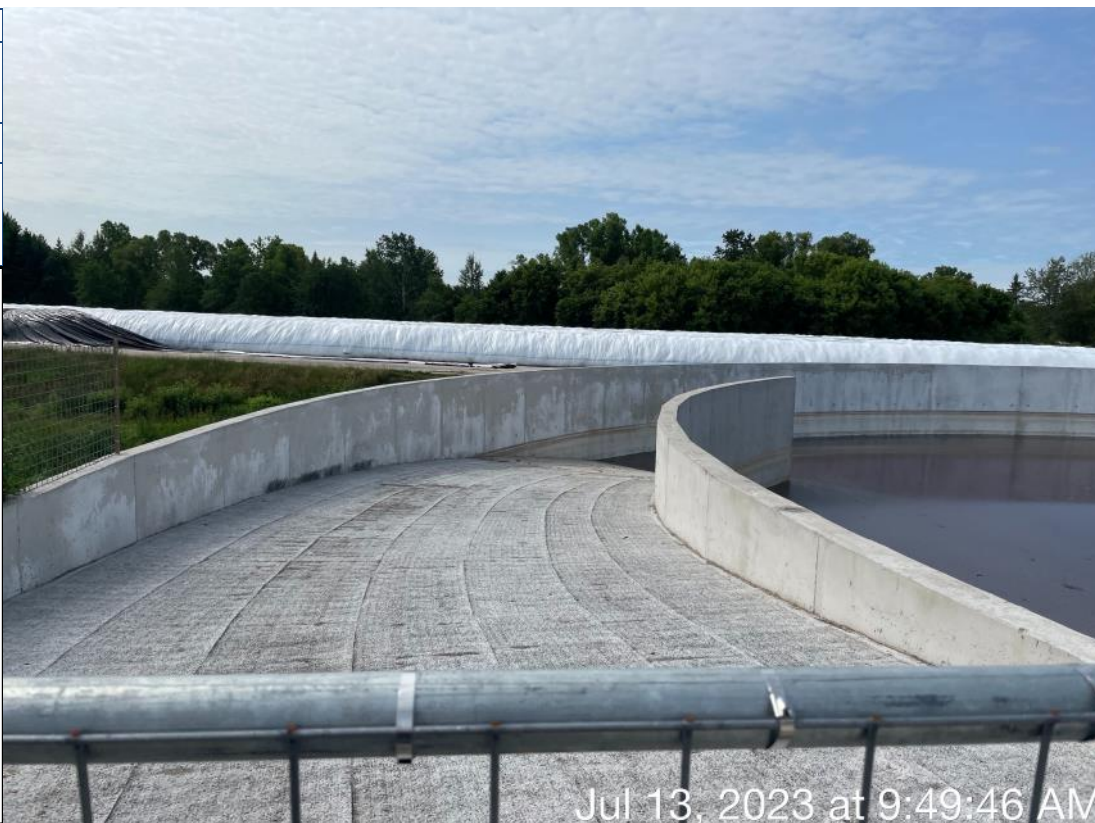
Photo #:	7085
Date/Time of Photo:	7/13/2023 09:49
Photo By:	Brian Hanson
Photo Location:	Main Dairy WSF #5

Photo Description:
Standing on the east side of WSF #5 looking south: View of concrete access ramp into WSF #5.

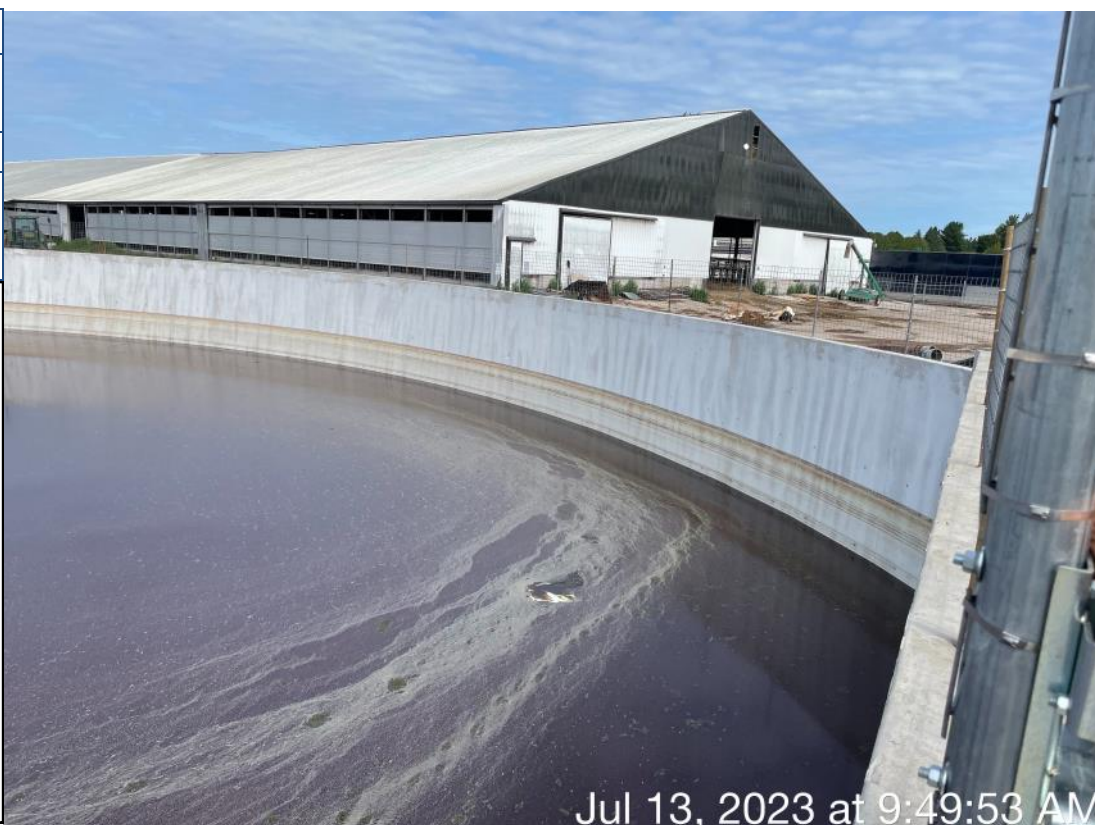
Photo #:	7086
Date/Time of Photo:	7/13/2023 09:49
Photo By:	Brian Hanson
Photo Location:	Main Dairy WSF #5

Photo Description:
Standing on the east side of WSF #5 looking northwest:
View of north edge of WSF #5.

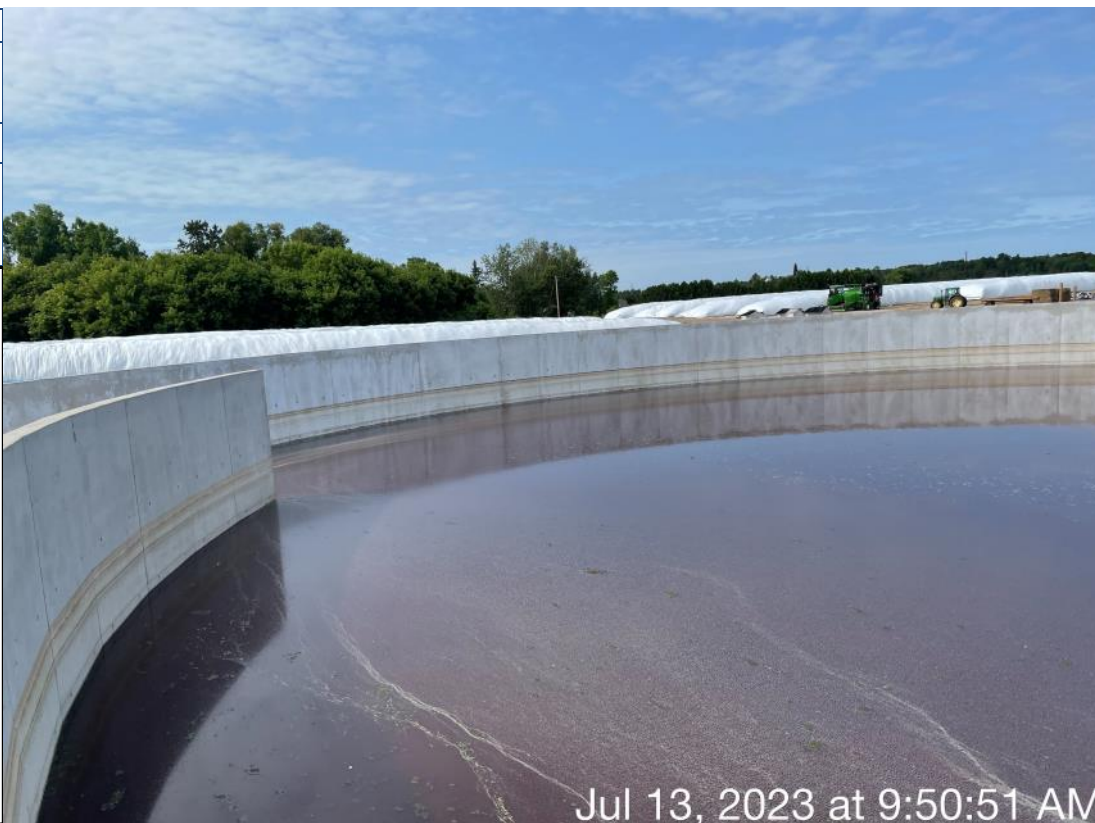
Photo #:	7093
Date/Time of Photo:	7/13/2023 09:50
Photo By:	Brian Hanson
Photo Location:	Main Dairy WSF #5

Photo Description:
Standing on the east side of WSF #5 looking southwest:
View of south edge of WSF #5 near bottom of access ramp.
