Permit Fact Sheet

Permit Number:	WI-0065218-03-0
Permittee Name:	Fendryk Brothers Partnership
Address:	W9075 County Road P
City/State/Zip:	Crivitz WI 54114
Discharge Location:	Main Dairy : W9075 County P, Crivitz, WI 54114 , NW ¼ of NE ¼ Section 30 T31N R20E Rymer Farm: W10054 14 th Road, Pound, WI 54161, SW ¼ of SW ¼ Section 23 T31N R19E
Receiving Water:	Iron Springs Creek & unnamed tributaries within the Little Peshtigo River Watershed, and groundwaters of the state
Discharge Type:	Existing

On Thursday July 13, 2023 Hanson & Arnoldi met with Fendryk, Fendryk, Paulson & Hodkiewicz at 9:00 at Fendryk Brothers Partnership site to conduct a permit reissuance walkover inspection. Both the main production site & the Rymer Farm were inspected. A trace amount of liquid precipitation had fallen recently and the temperature was in the 70's and cloudy. No permit violations were observed, and no water samples were collected. Hanson & Arnoldi departed at approximately 10:50.

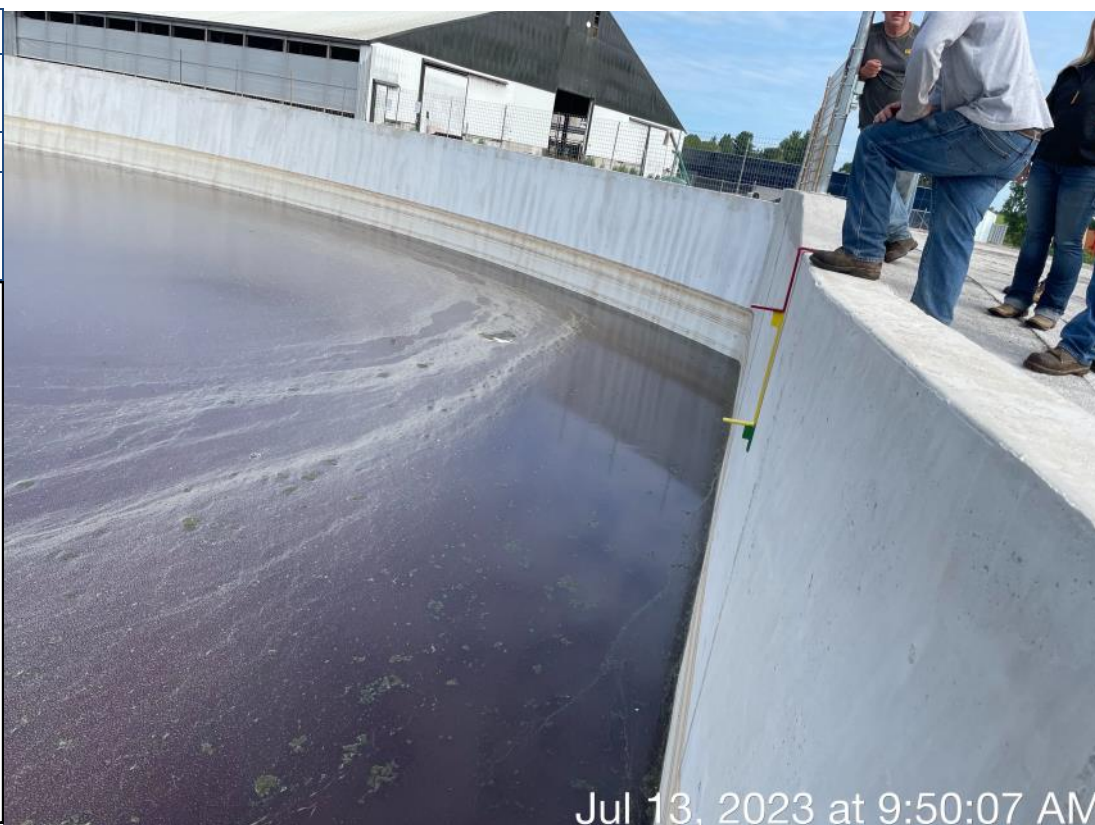
Photo #:	7089
Date/Time of Photo:	7/13/2023 09:50
Photo By:	Brian Hanson
Photo Location:	Main Dairy WSF #5

Photo Description:
Standing on access ramp on east side of WSF #5 looking north: View of interior ramp wall. Notice permanent depth markers hanging on edge of wall.

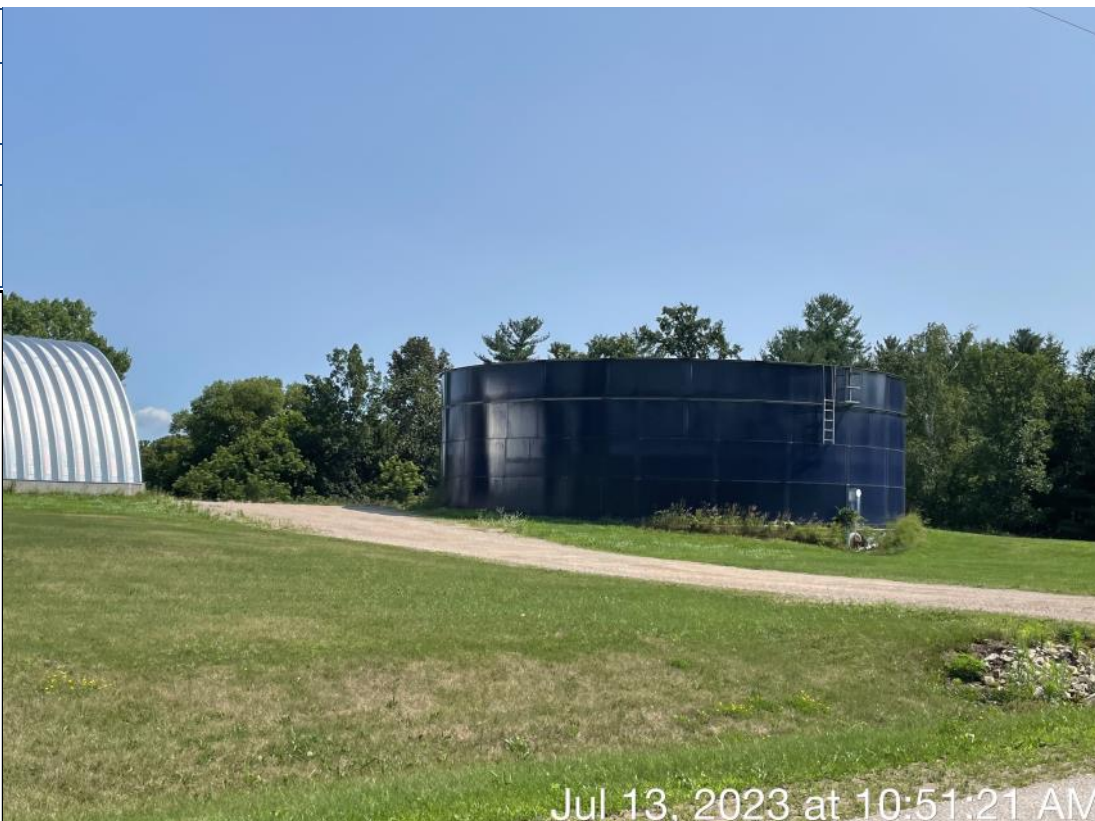
Photo #:	7169
Date/Time of Photo:	7/13/2023 10:51
Photo By:	Brian Hanson
Photo Location:	Rymer Farm Abandoned Pit

Photo Description:
Standing on road looking northeast: View of abandoned slurry store in southeast corner of Rymer Farm. Facility has been abandoned & no longer used by farm.

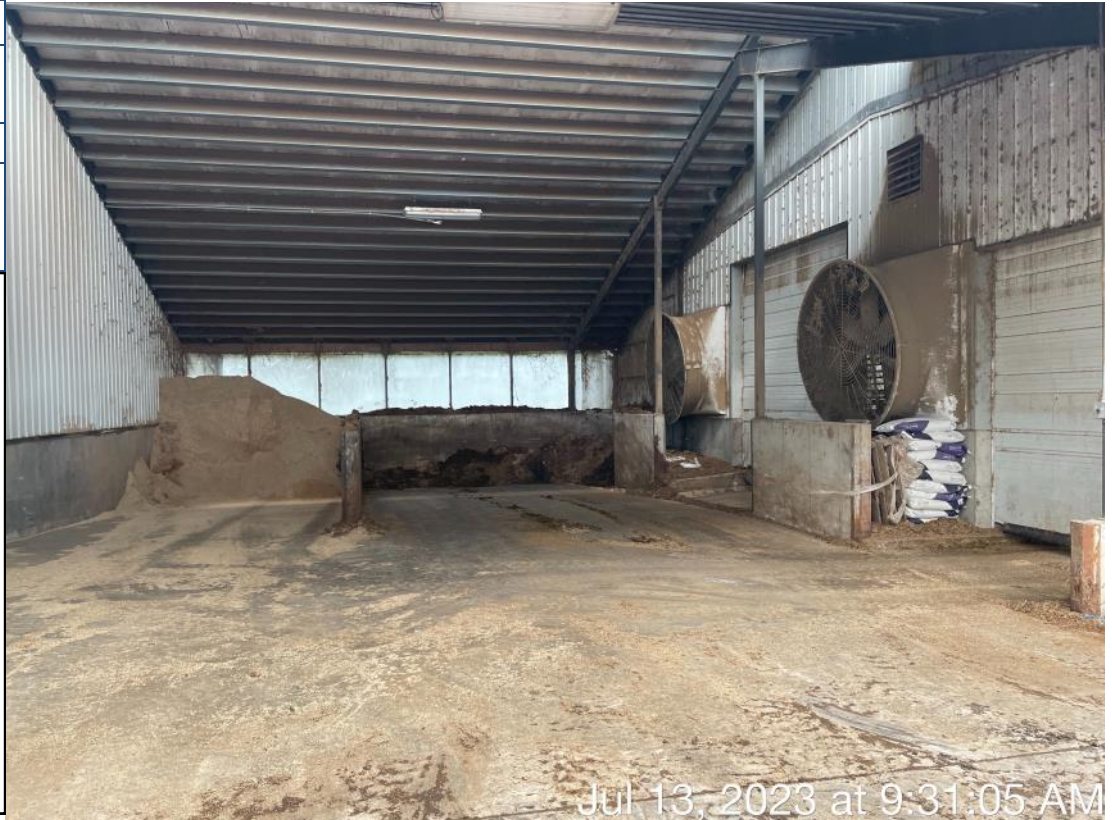
Photo #:	7027
Date/Time of Photo:	7/13/2023 09:31
Photo By:	Brian Hanson
Photo Location:	Main Dairy Calf Barn
Photo Description: Standing on the east side of calf barn looking west: View of solid stacking area in between the 2 calf barns. Area is completely roofed.

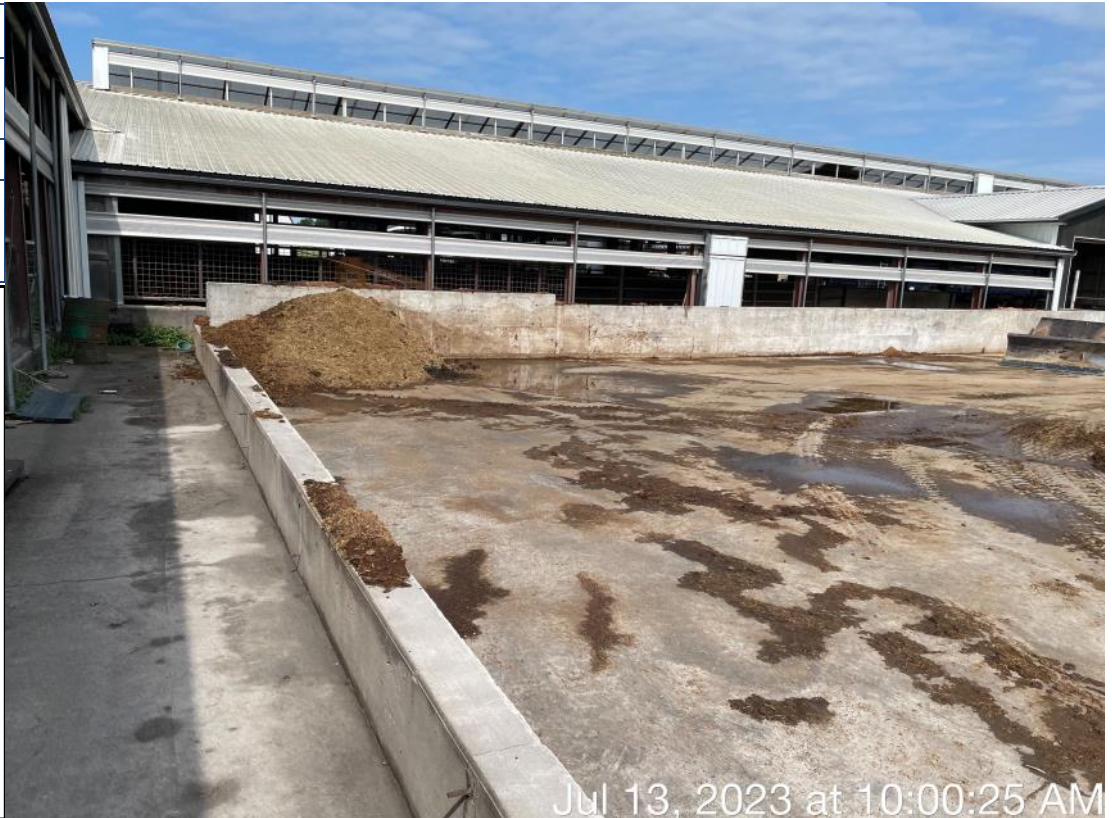
Photo #:	7111
Date/Time of Photo:	7/13/2023 10:00
Photo By:	Brian Hanson
Photo Location:	Main Dairy Solid Stacking
Photo Description: Standing on the south side of WSF #1 looking west: View of solid stacking area at southwest corner of WSF #1. Runoff flows directly into WSF #1.

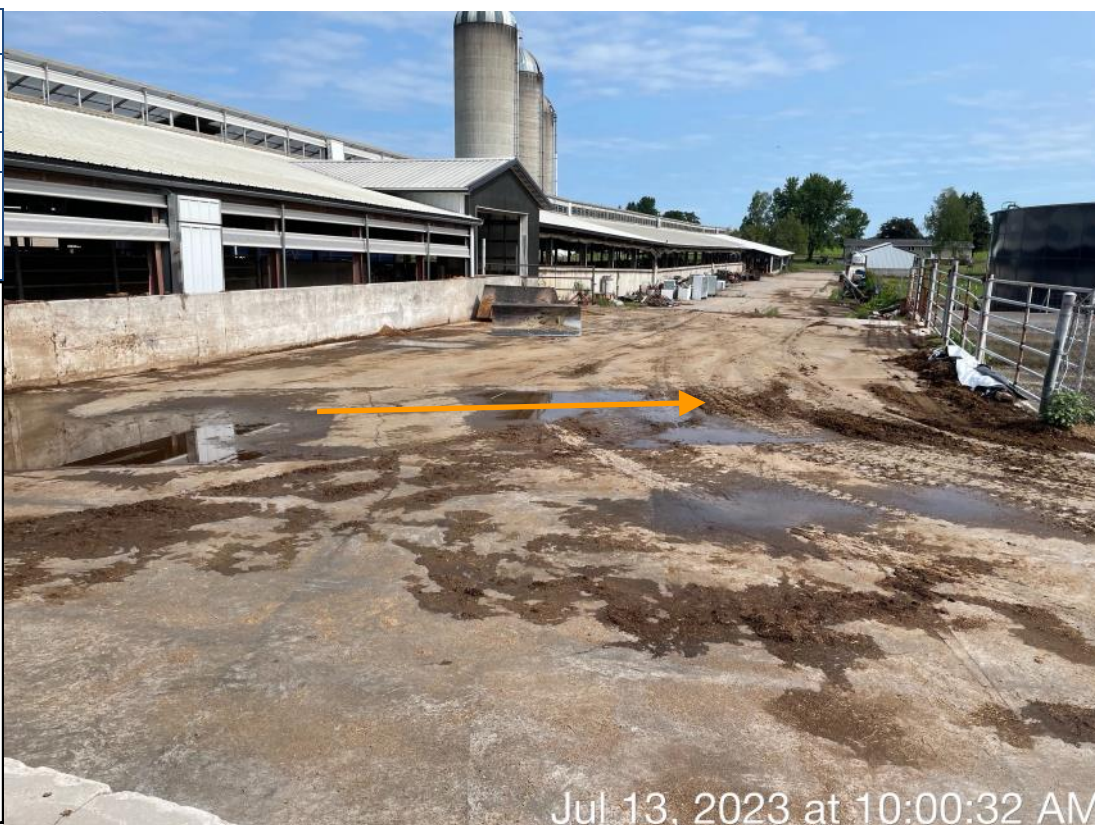
Photo #:	7113
Date/Time of Photo:	7/13/2023 10:00
Photo By:	Brian Hanson
Photo Location:	Main Dairy Solids Stacking

Standing at southwest corner of WSF #1 looking north: View of solids stacking area on west side of WSF #1. Runoff flows directly into WSF #1.

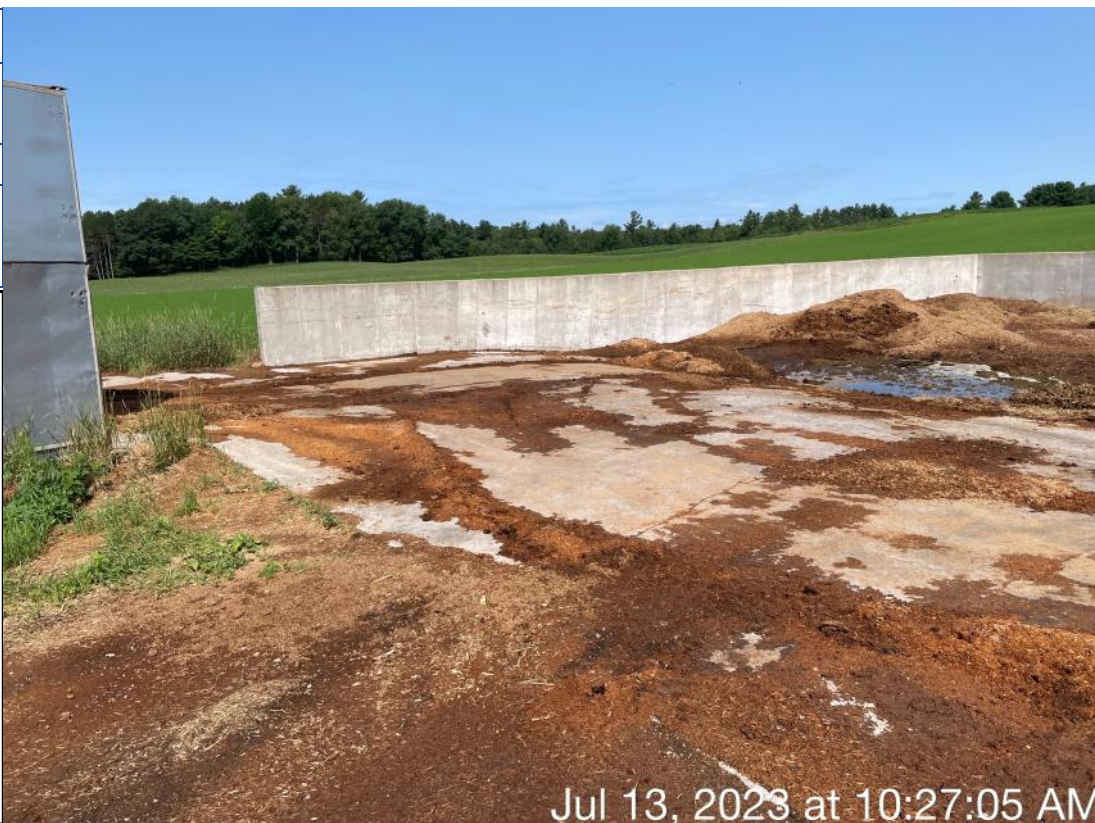
Photo #:	7135
Date/Time of Photo:	7/13/2023 10:27
Photo By:	Brian Hanson
Photo Location:	Rymer Farm Solids Stacking

Standing on the west side of the freestall barn looking northwest: View of west edge of solids stacking area. Are is internally drained.

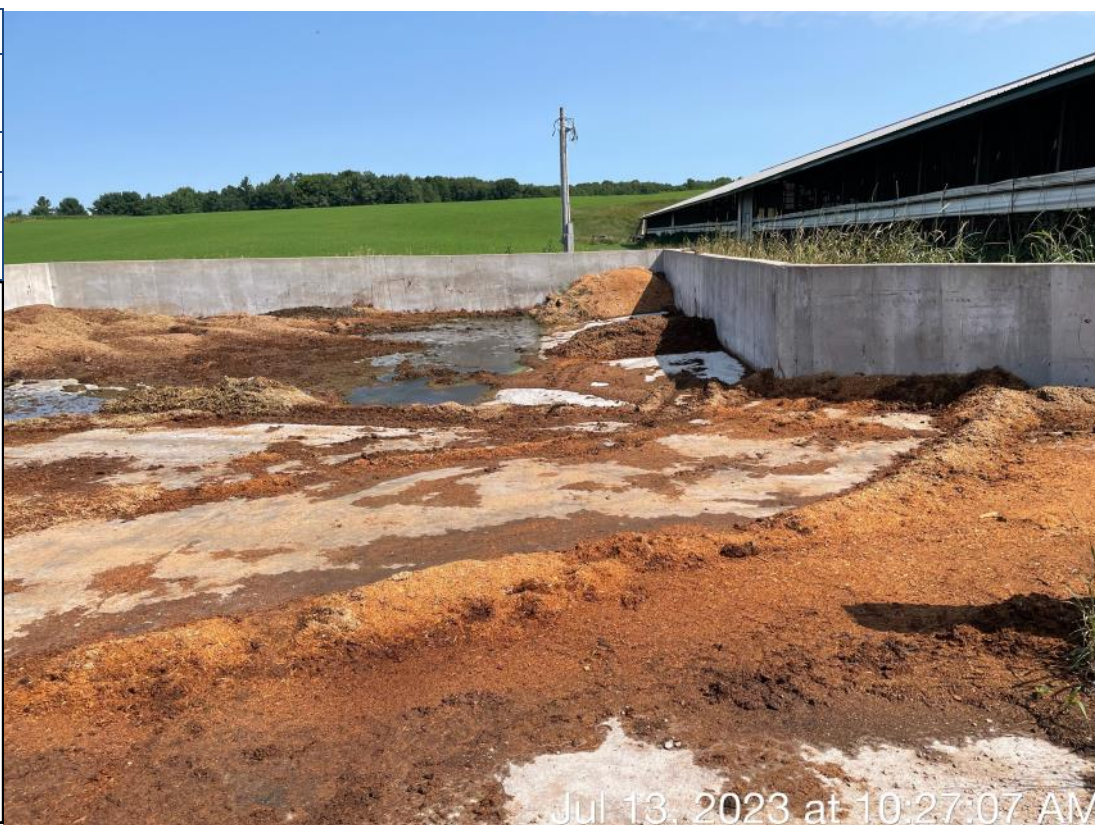
Photo #:	7137
Date/Time of Photo:	7/13/2023 10:27
Photo By:	Brian Hanson
Photo Location:	Rymer Farm Solids Stacking

Photo Description:
Standing on west side of freestall barn looking north: View of east side of solids stacking area.

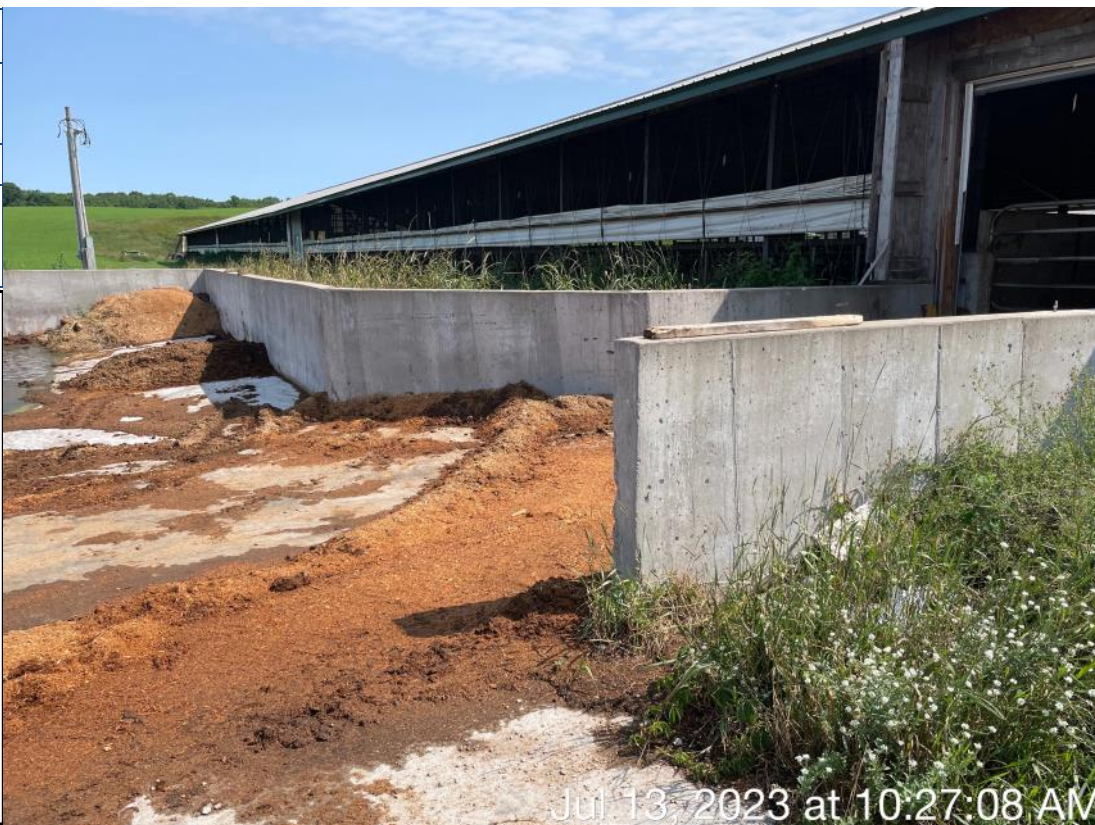
Photo #:	7138
Date/Time of Photo:	7/13/2023 10:27
Photo By:	Brian Hanson
Photo Location:	Rymer Farm Solids Stacking

Photo Description:
Standing on west side of freestall barn looking northeast: View of east side of stacking area where solids are pushed out of barn onto stacking area.

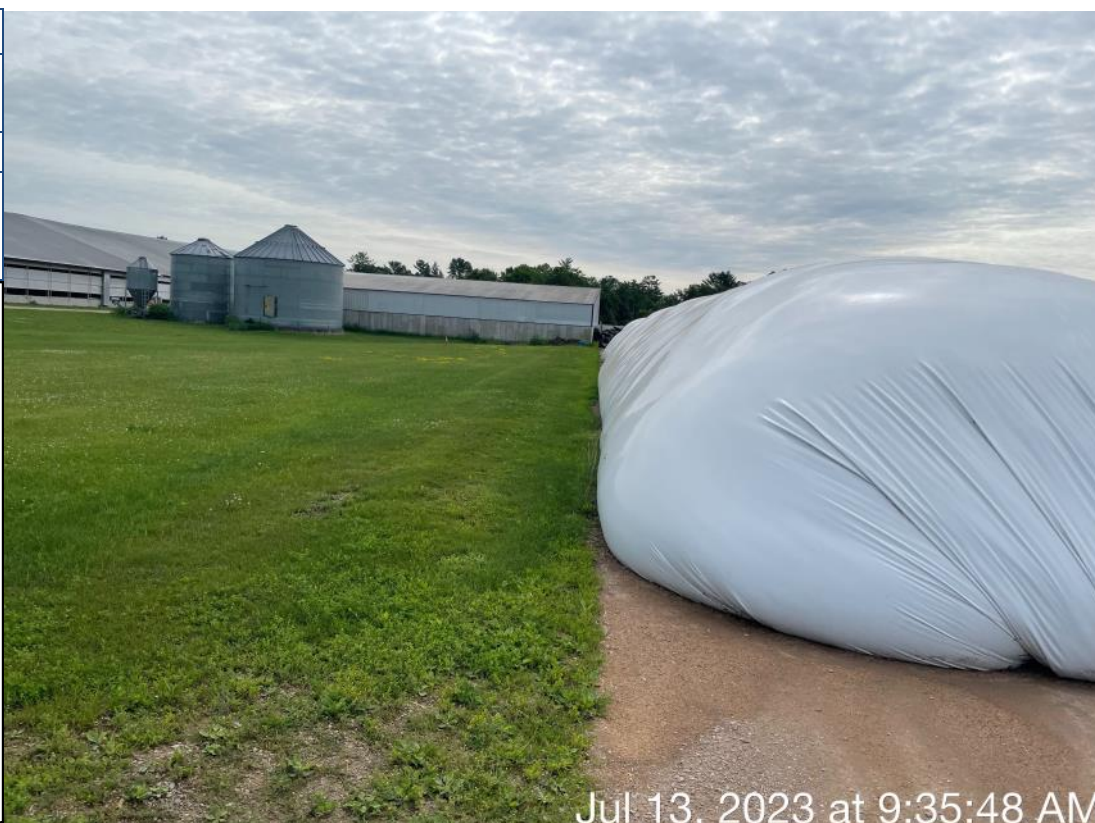
Photo #:	7038
Date/Time of Photo:	7/13/2023 09:35
Photo By:	Brian Hanson
Photo Location:	Main Dairy W. Feed Storage

Photo Description:
Standing on the northwest corner of silage pad looking east: View of the north edge of the silage pad.

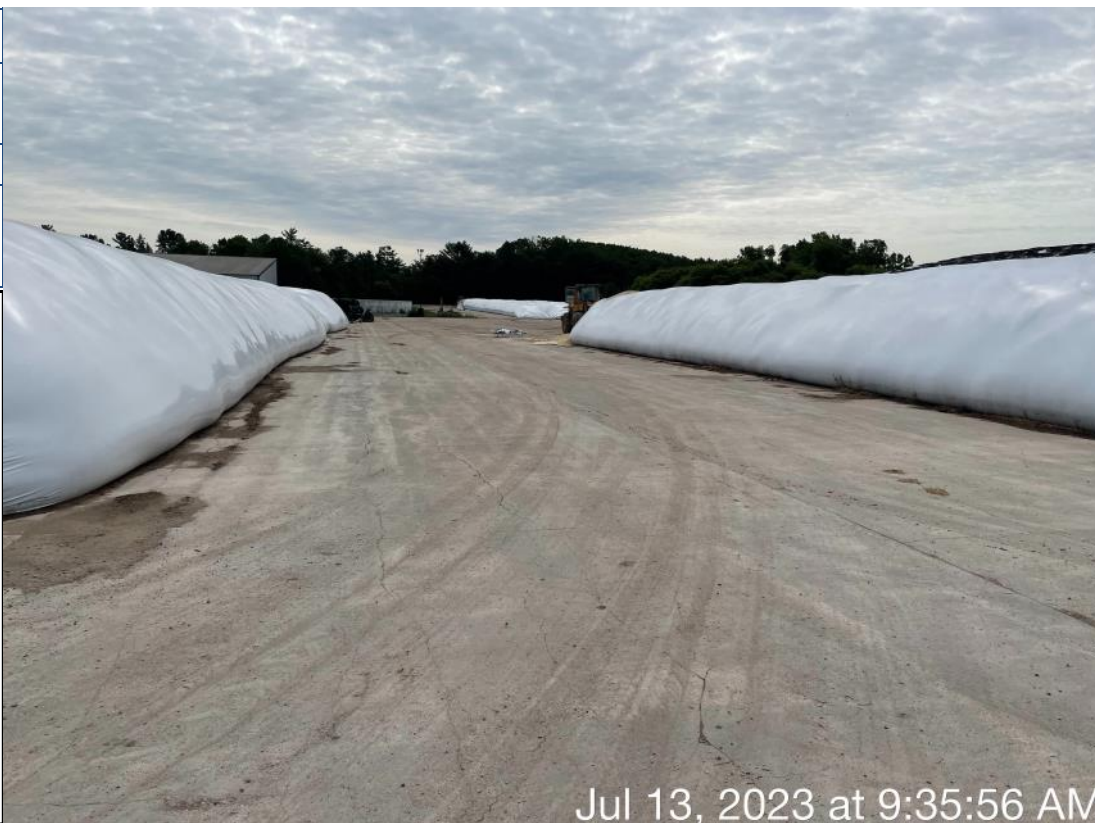
Photo #:	7039
Date/Time of Photo:	7/13/2023 09:35
Photo By:	Brian Hanson
Photo Location:	Main Dairy W. Feed Storage

Photo Description:
Standing on the west side of FSA looking east: View of silage bags on north side of main silage pile.

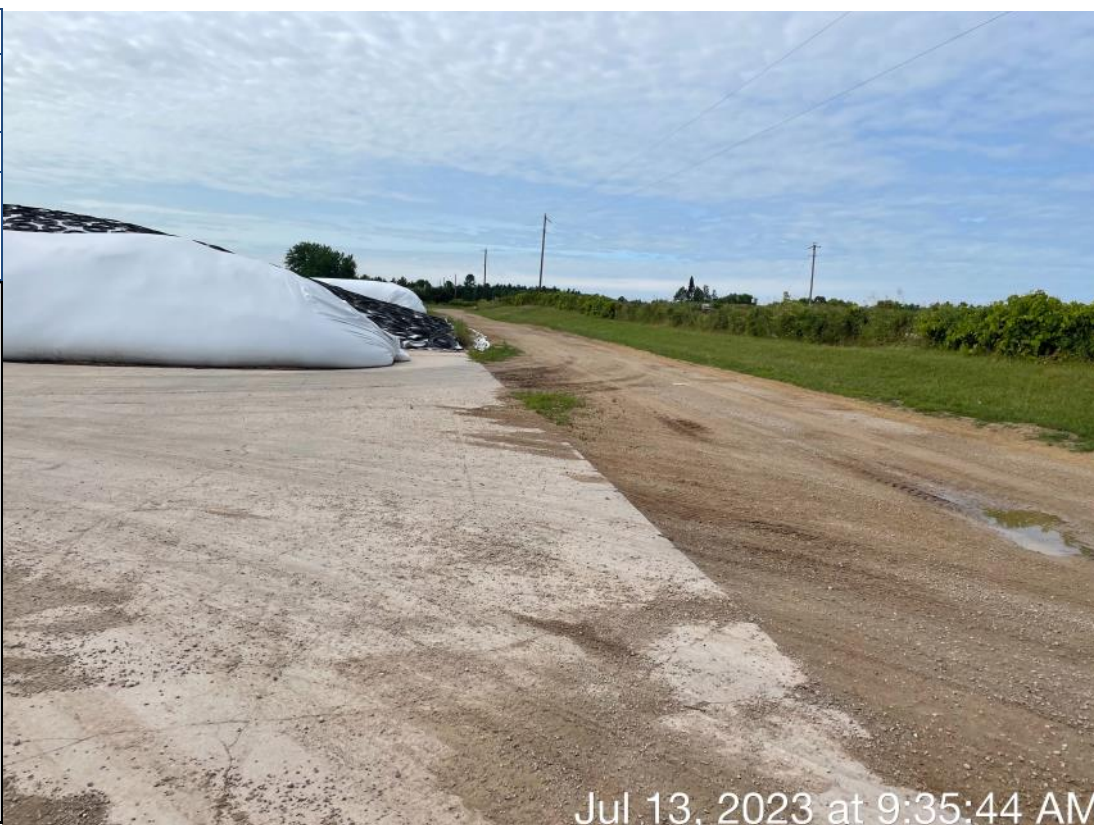
Photo #:	7037
Date/Time of Photo:	7/13/2023 09:35
Photo By:	Brian Hanson
Photo Location:	Main Dairy W. Feed Storage

Photo Description:
 Standing on the west side of FSA looking south: View of west edge of FSA. Notice silage pile extends right to edge of concrete slab. See further details in photo 3231 below.

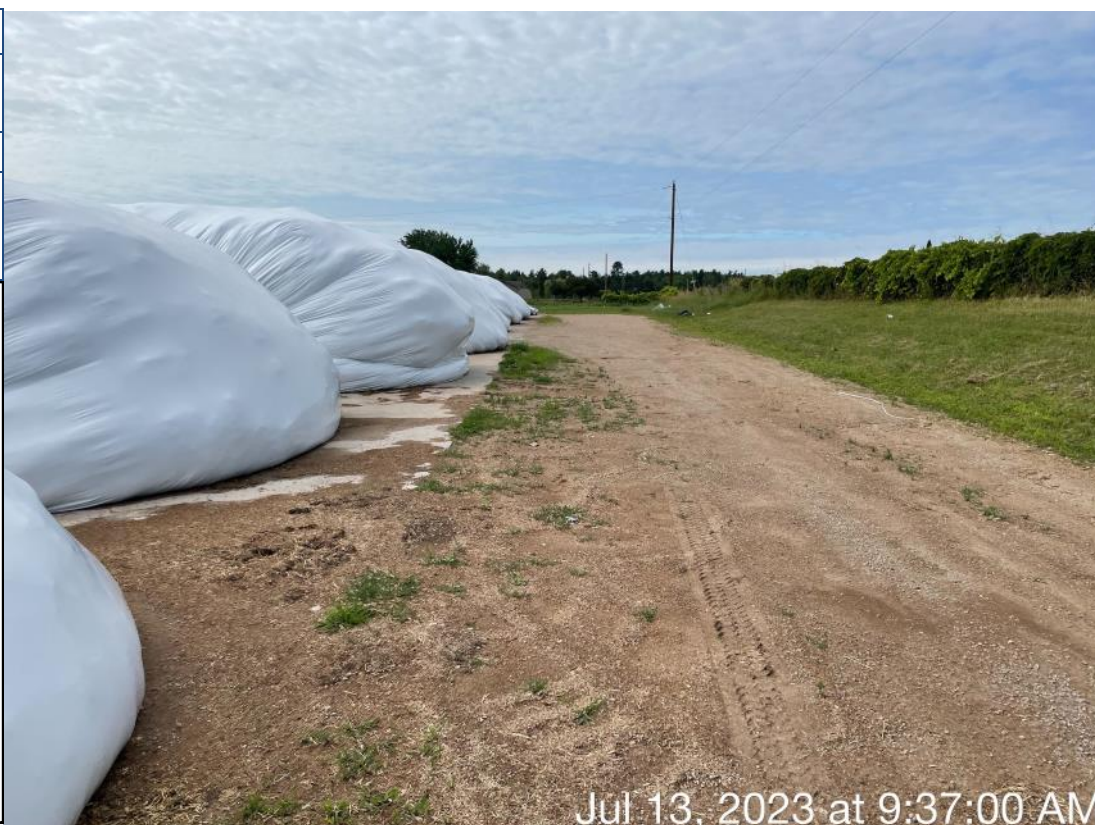
Photo #:	7043
Date/Time of Photo:	7/13/2023 09:37
Photo By:	Brian Hanson
Photo Location:	Main Dairy W. Feed Storage

Photo Description:
Standing on west side of FSA looking south: View of west edge of FSA adjacent to haylage bags on the south half of the pad.

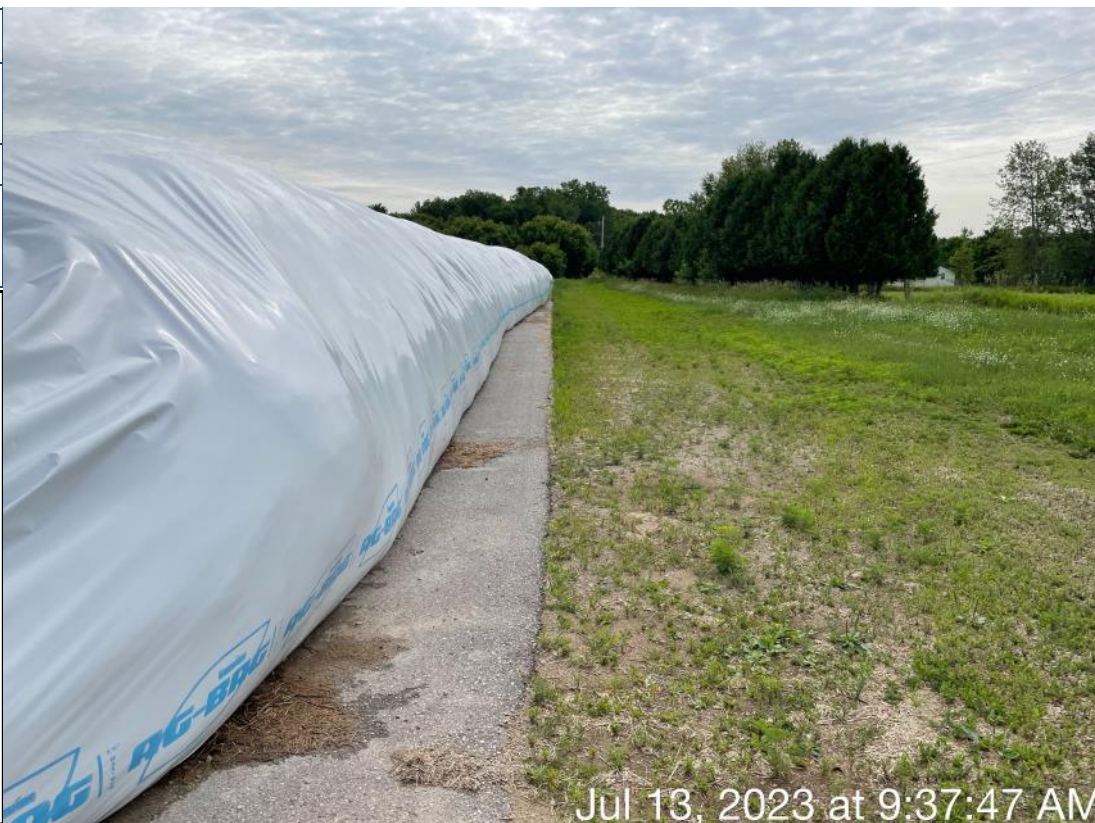
Photo #:	7044
Date/Time of Photo:	7/13/2023 09:37
Photo By:	Brian Hanson
Photo Location:	Main Dairy W. Feed Storage

Photo Description:
Standing on south side of FSA looking east: View of south edge of FSA.

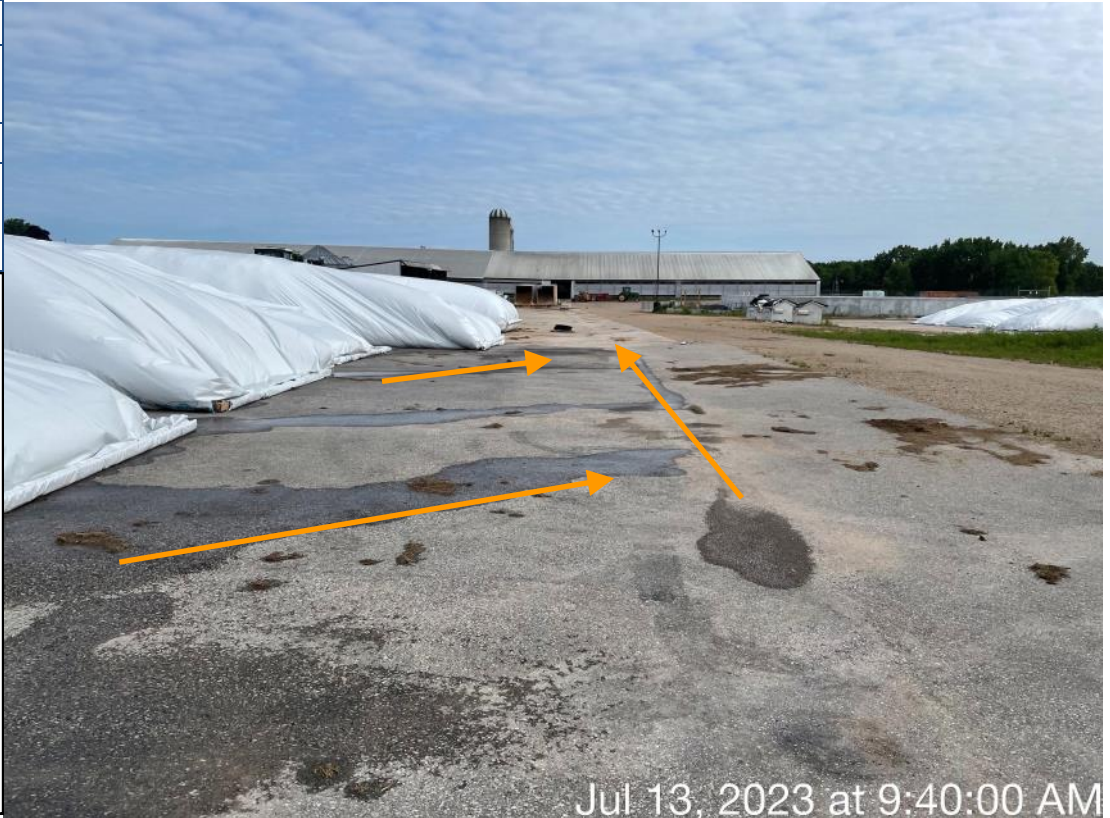
Standing at southeast corner of FSA looking north: View of east edge of FSA used as runoff collection channel. Arrows indicate direction of flow.

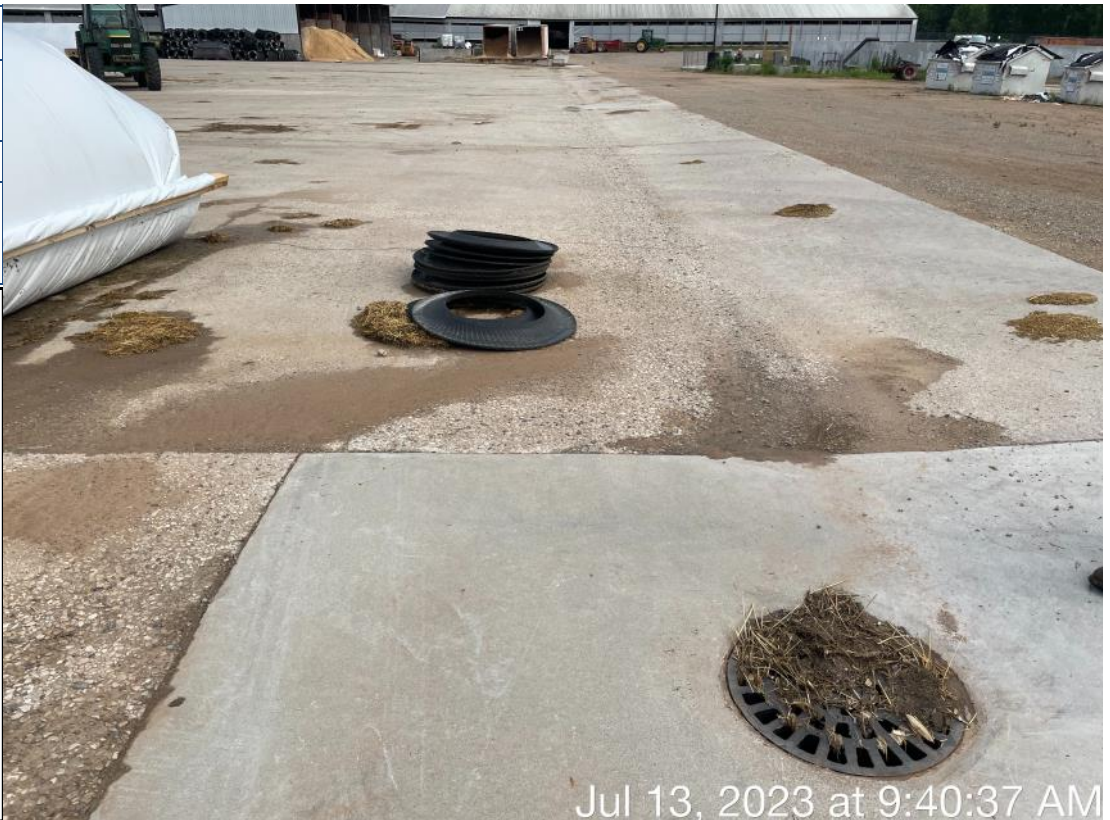
Standing on the east side of FSA looking north: View of runoff collection inlet along east side of FSA. There are 2 of these inlet that flow to stormwater channel east of WSF #5. Grates are normally open when haylage bags are utilized on south 1/2 of FSA. Need to be capped if corn silage is present.

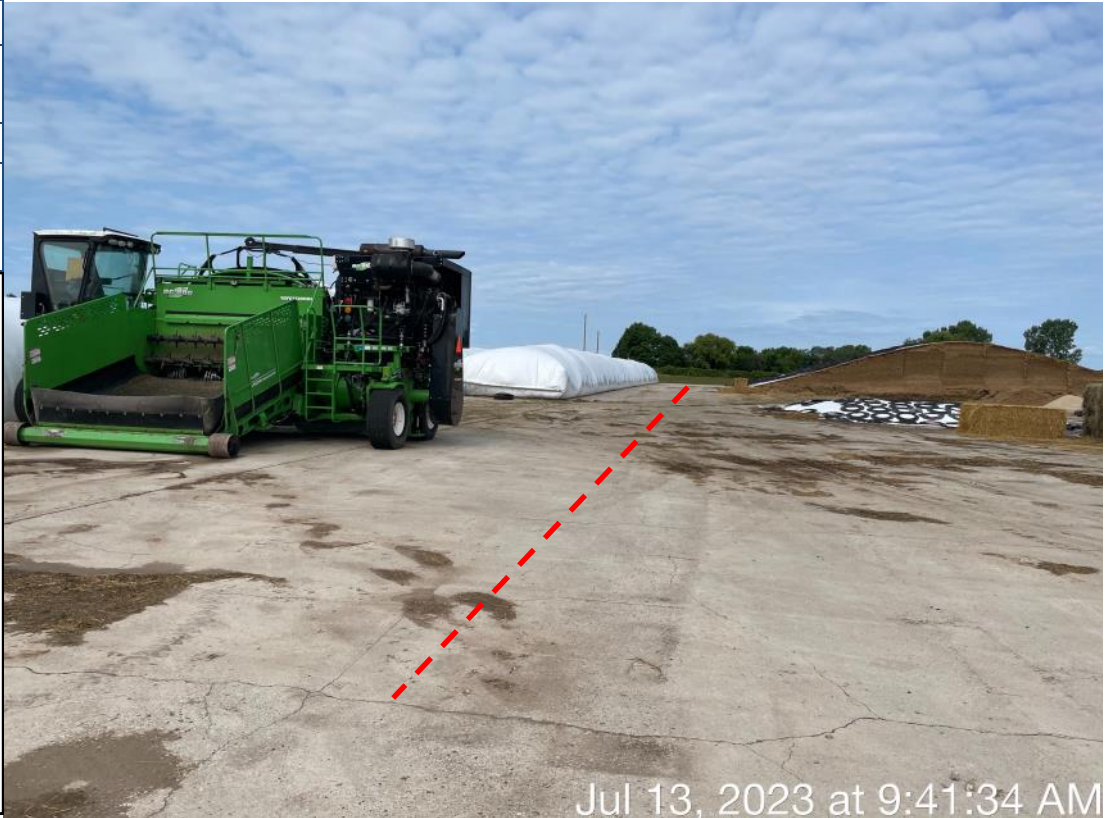
Photo #:	7051
Date/Time of Photo:	7/13/2023 09:41
Photo By:	Brian Hanson
Photo Location:	Main Dairy W. Feed Storage

Standing on east side of FSA looking west: View of center section of FSA. Bags south of this line are haylage and flow to stormwater inlets. Corn silage pile & bags north of this line flow to runoff collection system.

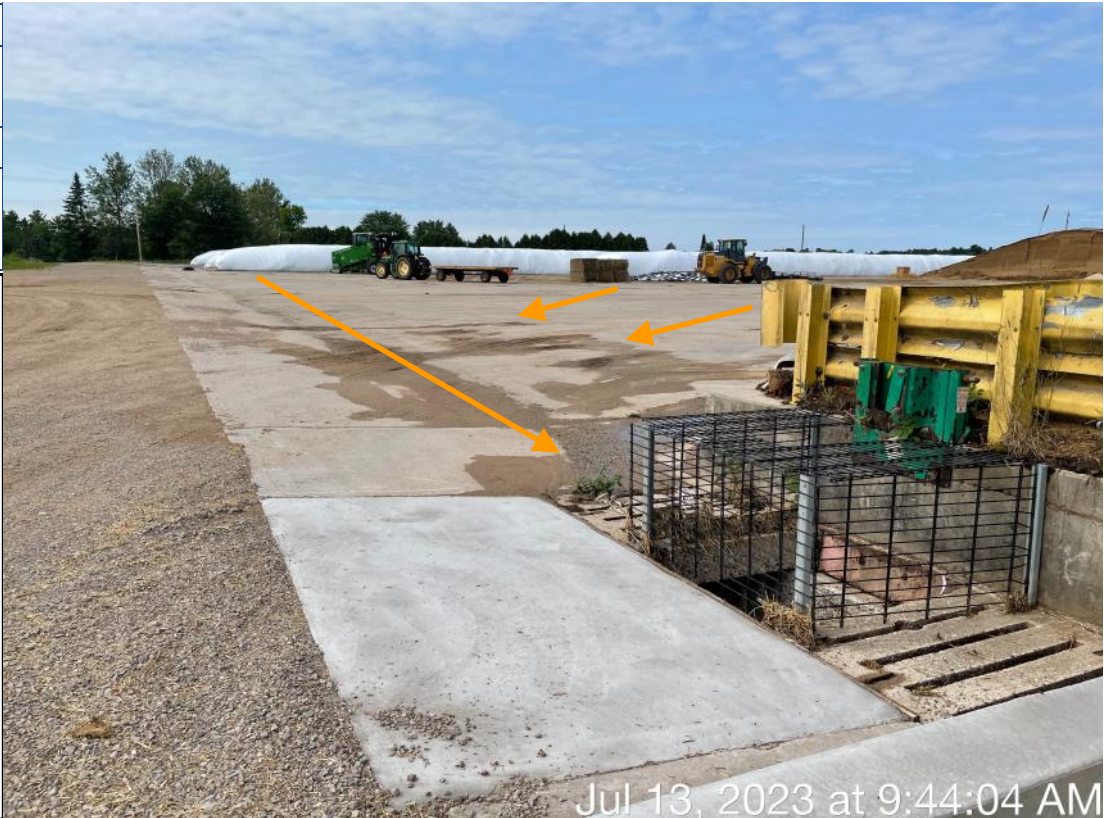
Photo #:	7063
Date/Time of Photo:	7/13/2023 09:44
Photo By:	Brian Hanson
Photo Location:	Main Dairy W. Feed Storage

Standing at northeast corner of FSA looking southwest: View of runoff collection channel & inlet in northeast corner of FSA. Arrows indicate direction of runoff flow.

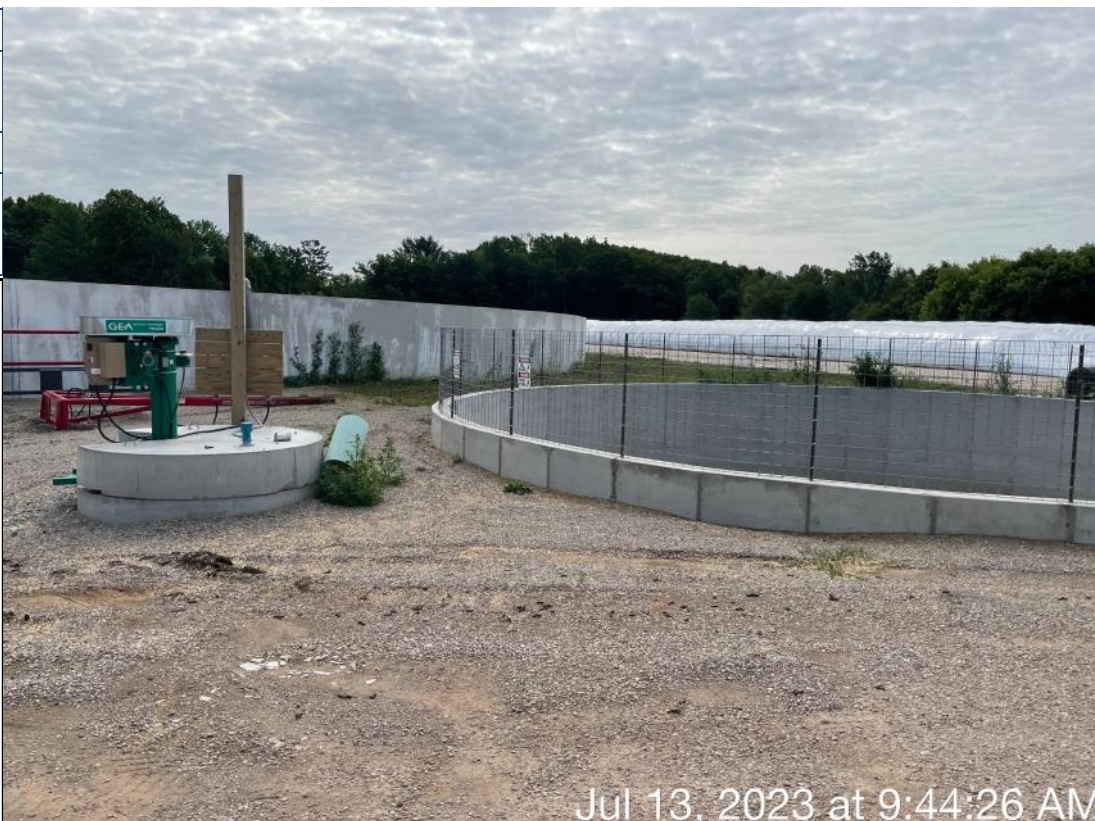
Photo #:	7068
Date/Time of Photo:	7/13/2023 09:44
Photo By:	Brian Hanson
Photo Location:	Main Dairy FSA Runoff Basin

Standing on west side of WSF #5 looking east: View of runoff collection basin with WSF #5 in the background.

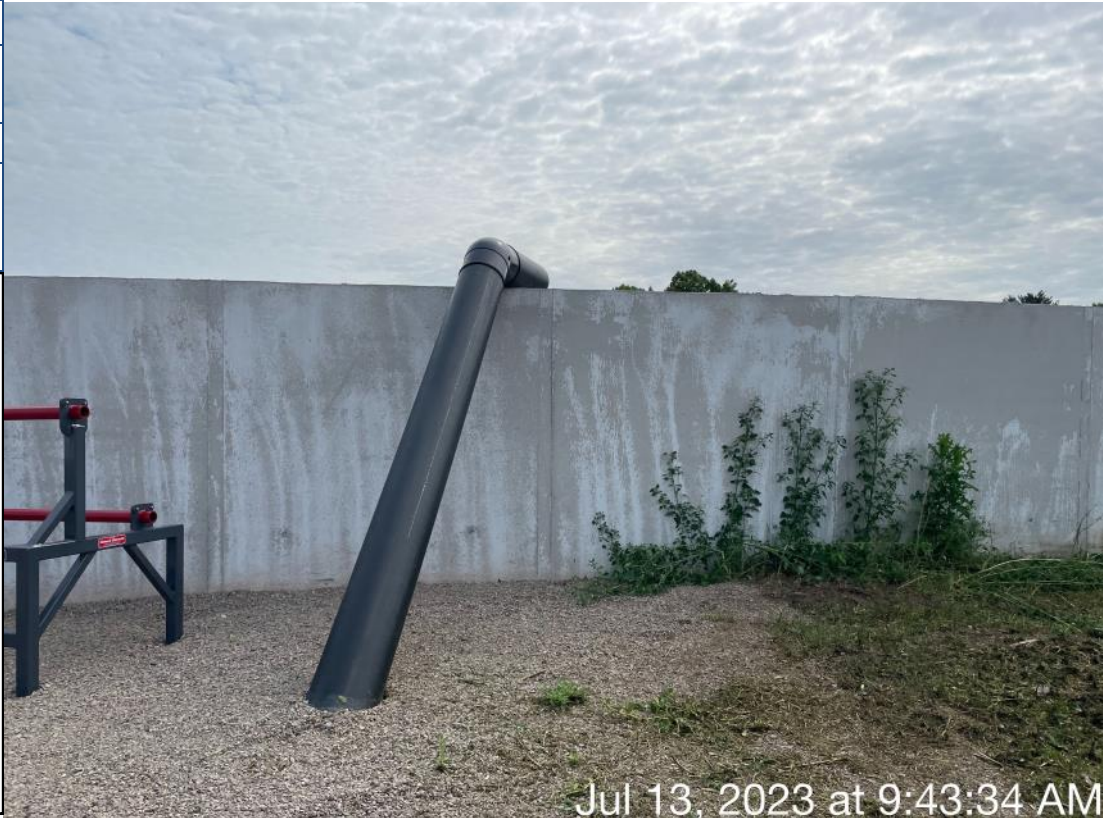
Photo #:	7061
Date/Time of Photo:	7/13/2023 09:43
Photo By:	Brian Hanson
Photo Location:	Main Dairy FSA Runoff Basin

Standing on the west side of WSF #5 looking east: View of out pipe used to pump runoff from runoff collection basin to WSF #5 for long term storage.

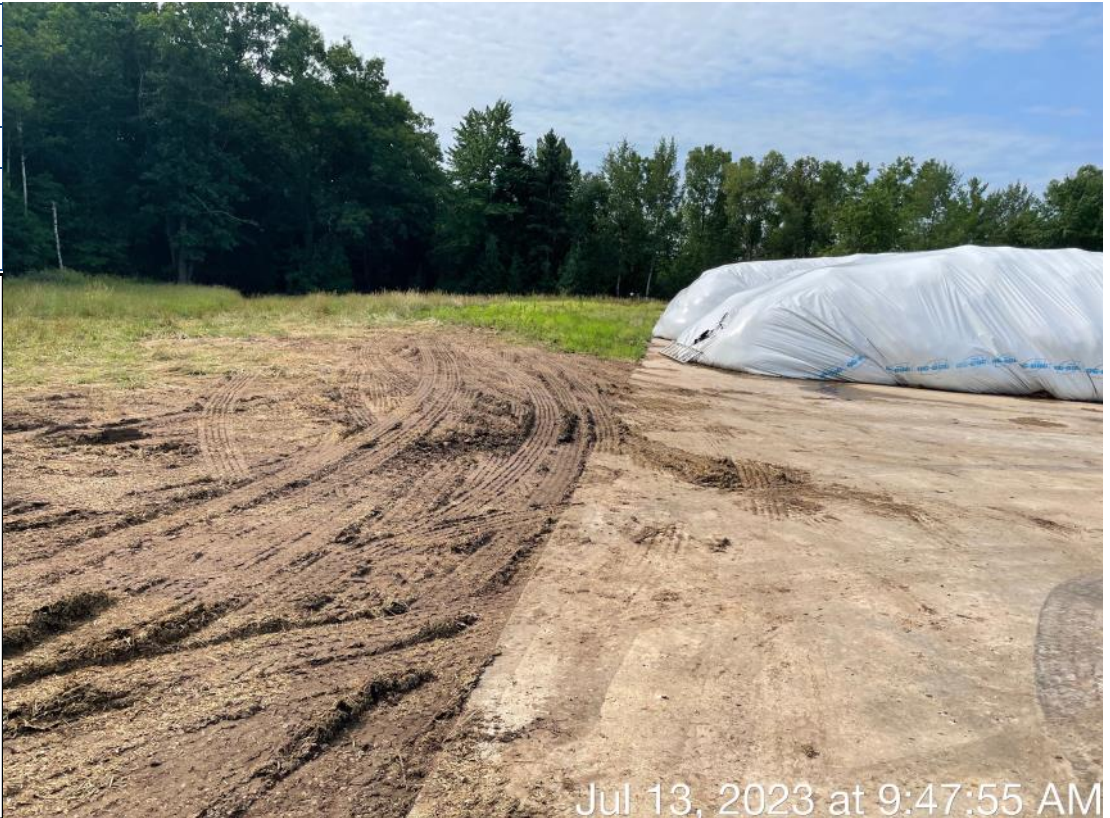
Photo #:	7081
Date/Time of Photo:	7/13/2023 09:47
Photo By:	Brian Hanson
Photo Location:	Main Dairy E. Feed storage

Standing on the east side of FS looking south: View of eastern edge of FSA.

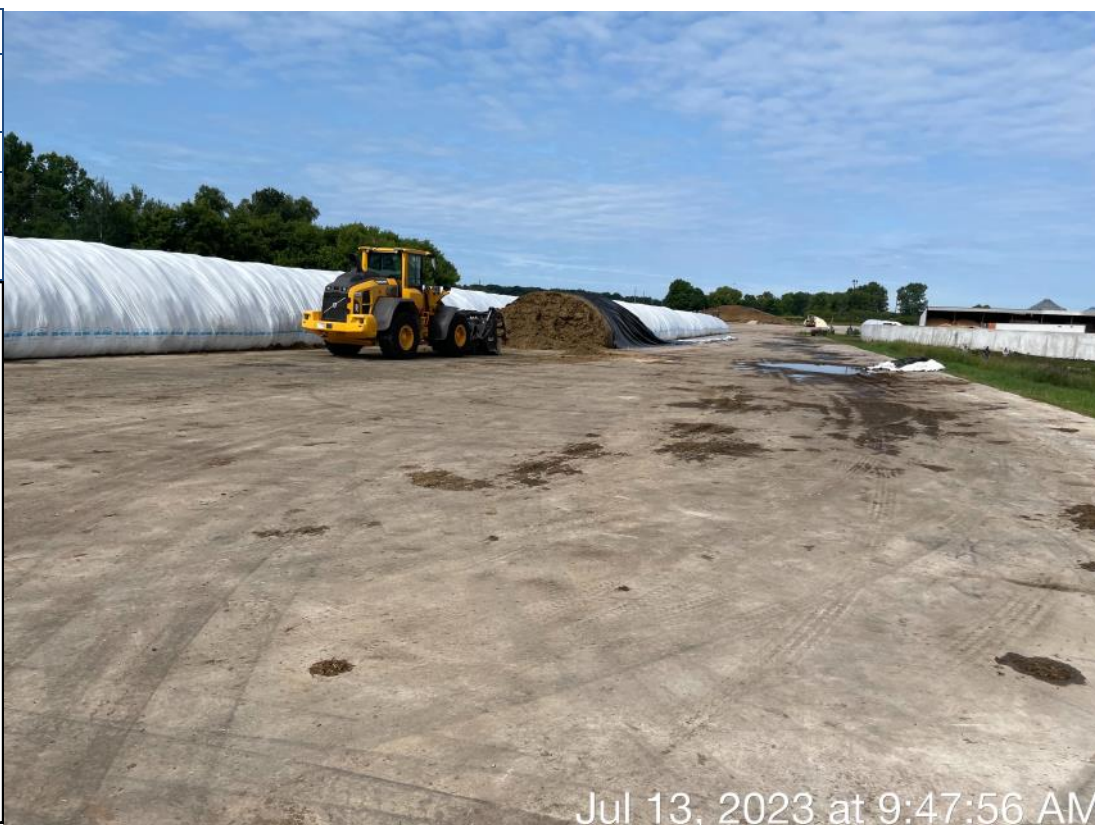
Photo Description:
Standing on the east side of FSA looking west: View of the north edge of FSA. Notice small amounts of waste feed & ponded runoff along edge of pad.

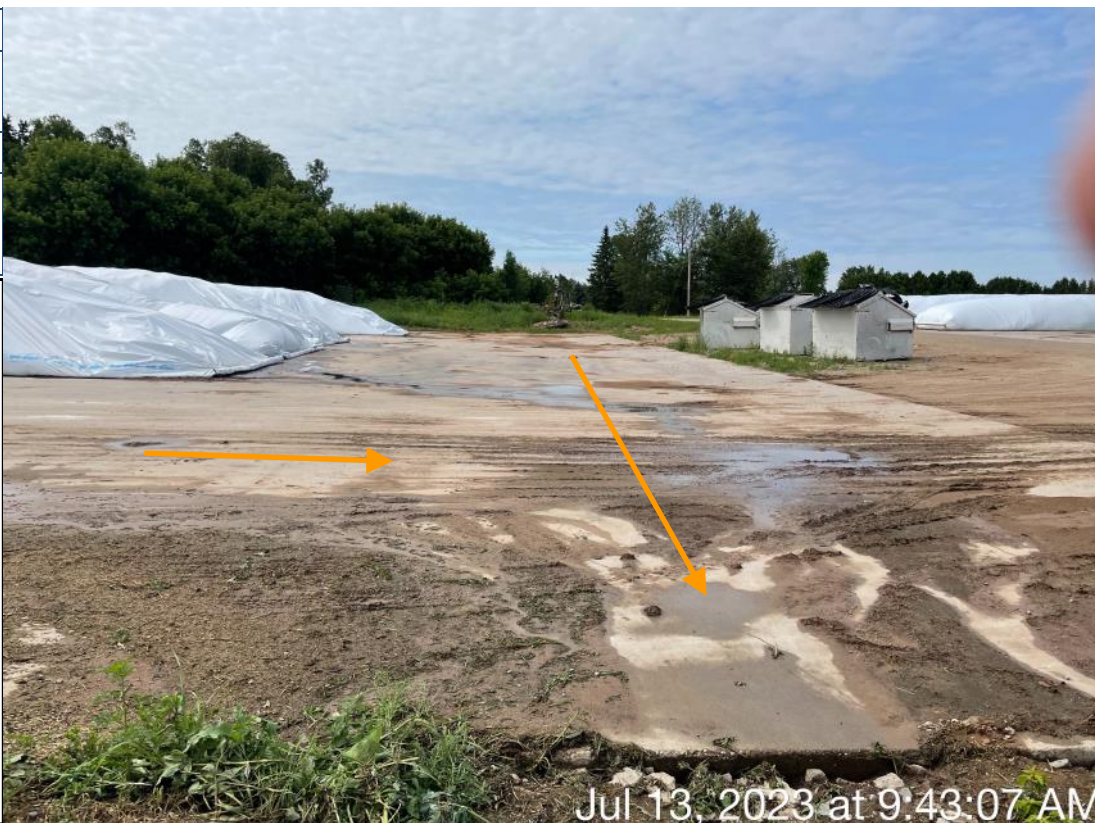
Photo Description:
Standing on the north side of FSA looking south: View of west edge of FSA used to collect runoff from FSA. Runoff from this haylage pad is not collected, but rather flows north than east with the rest of the stormwater.

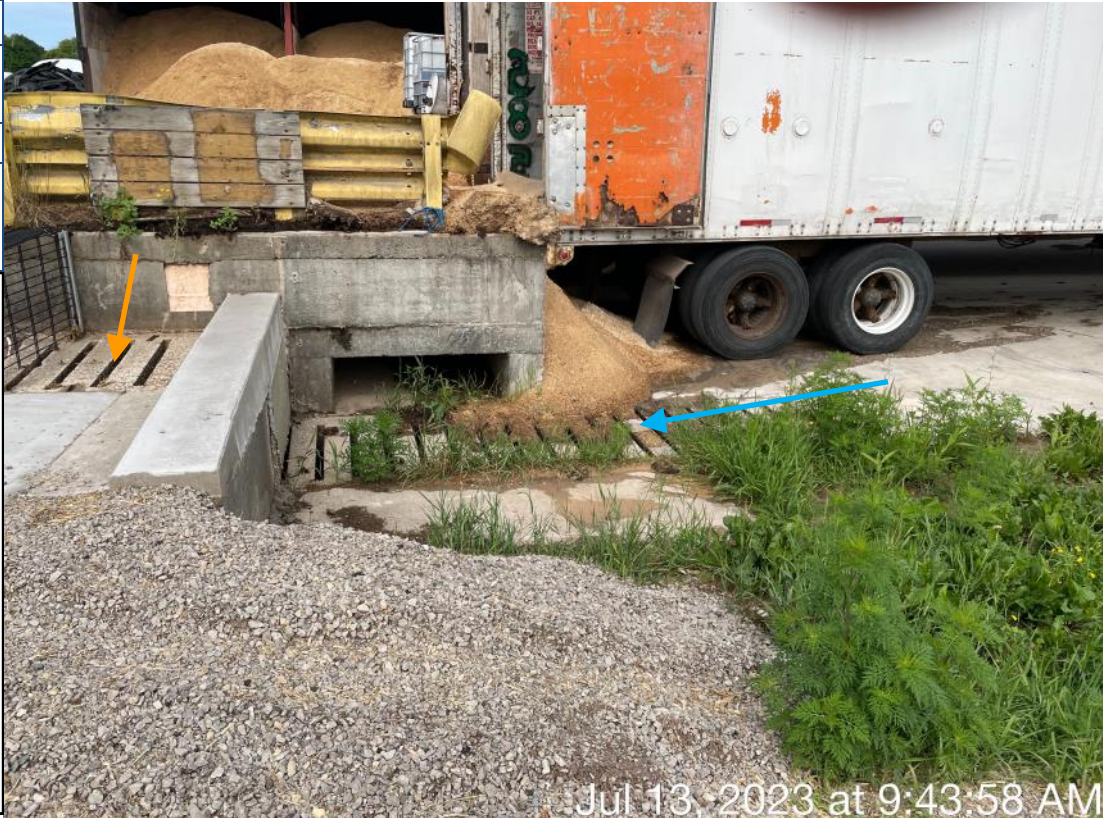
Photo Description:
 Standing off the northeast corner of the west FSA looking west: View of stormwater inlet located on north side of FSA runoff collection inlet. Contaminated runoff flows into left side inlet and flows to collection system. Clean stormwater flows into right side inlet and gravity flows to east side of WSF #5
