Permit Fact Sheet

Permit Number:	WI-0065218-03-0
Permittee Name:	Fendryk Brothers Partnership
Address:	W9075 County Road P
City/State/Zip:	Crivitz WI 54114
Discharge Location:	Main Dairy : W9075 County P, Crivitz, WI 54114 , NW ¼ of NE ¼ Section 30 T31N R20E Rymer Farm: W10054 14 th Road, Pound, WI 54161, SW ¼ of SW ¼ Section 23 T31N R19E
Receiving Water:	Iron Springs Creek & unnamed tributaries within the Little Peshtigo River Watershed, and groundwaters of the state
Discharge Type:	Existing

On Thursday July 13, 2023 Hanson & Arnoldi met with Fendryk, Fendryk, Paulson & Hodkiewicz at 9:00 at Fendryk Brothers Partnership site to conduct a permit reissuance walkover inspection. Both the main production site & the Rymer Farm were inspected. A trace amount of liquid precipitation had fallen recently and the temperature was in the 70's and cloudy. No permit violations were observed, and no water samples were collected. Hanson & Arnoldi departed at approximately 10:50.

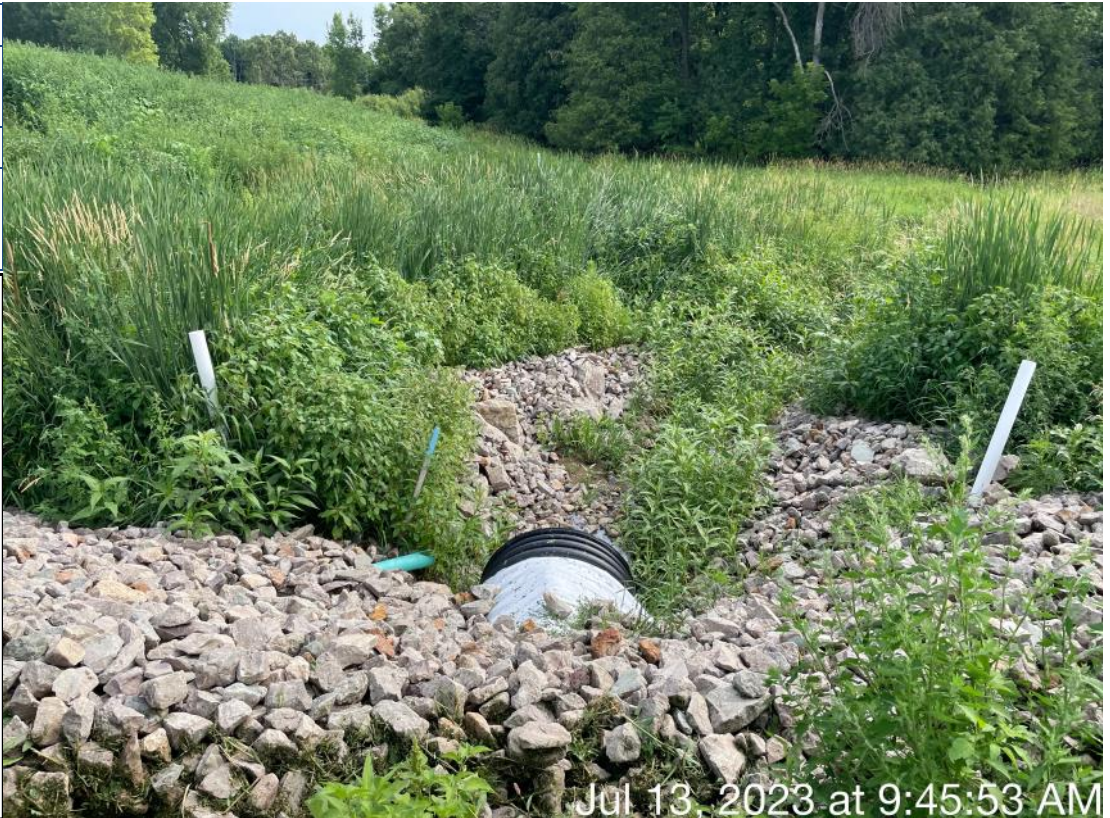
Photo Description:
 Standing on the east side of WSF #5 looking east: View of stormwater outlet pipe on east side of WSF #5. Farmstead stormwater & FSA diverted stormwater flow through this pipe.

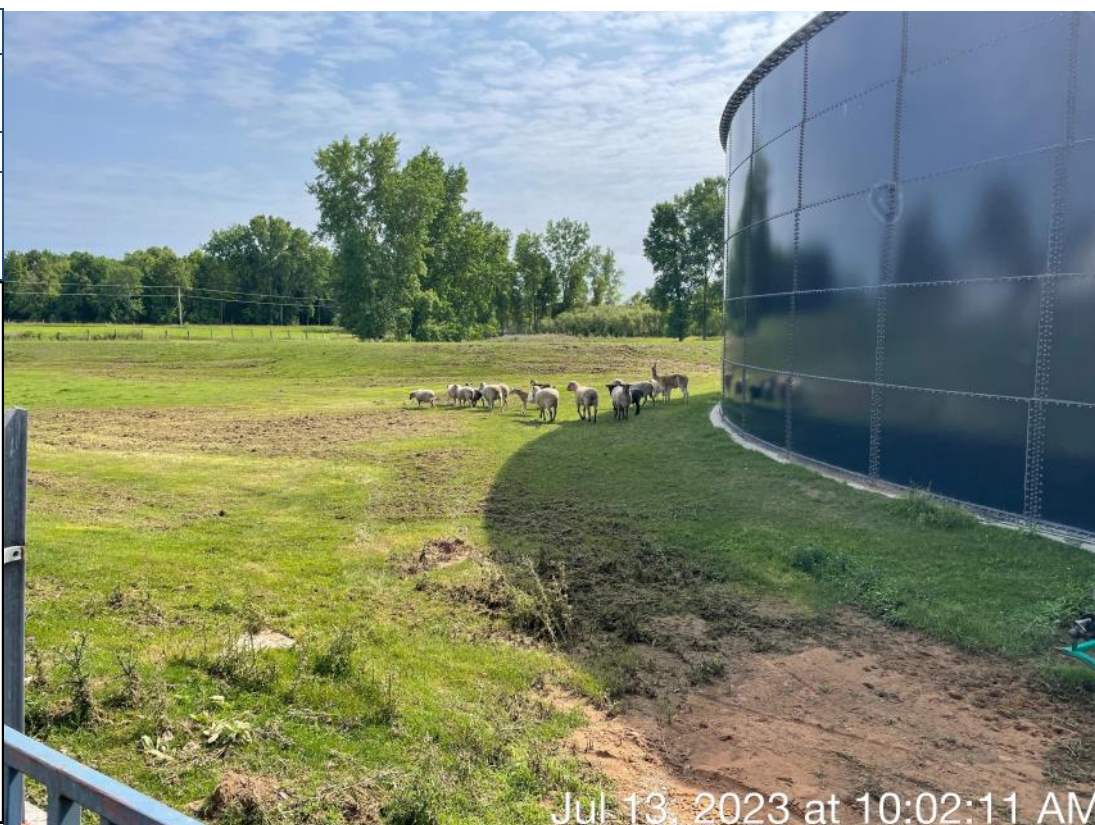
Photo Description:
Standing on the northwest corner of WSF #2 looking northeast: View of southern edge of CAFO Outdoor Vegetated Area.

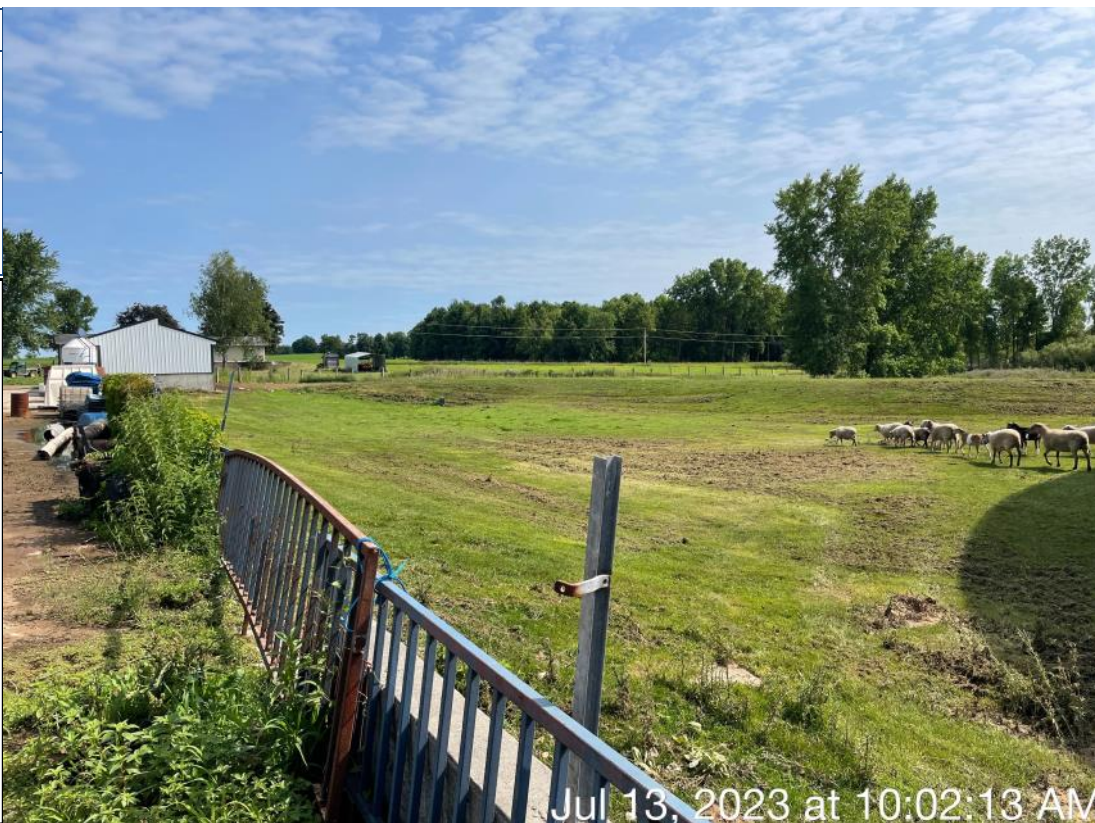
Photo Description:
Standing on the northwest corner of WSF #2 looking north: View of middle section of CAFO Outdoor Vegetated Area.

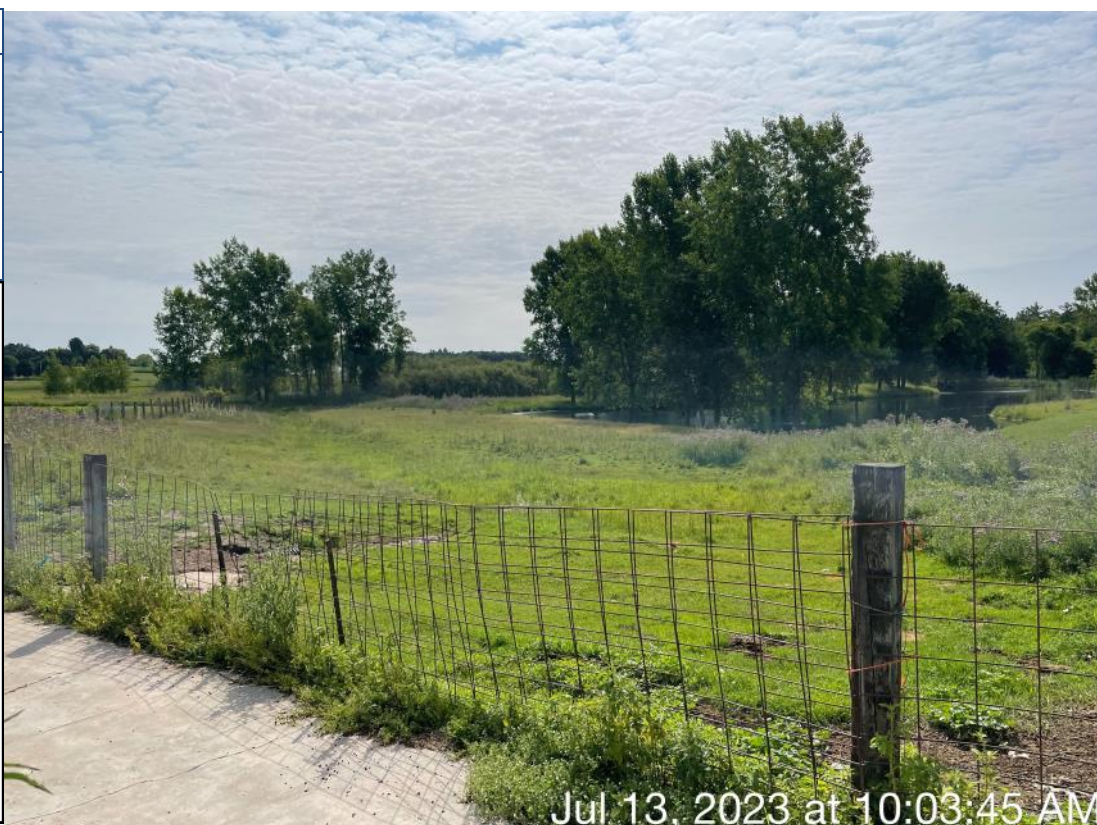
The farm does have 1 CAFO outdoor vegetated area as part of their operation. This area is located to the north & east of WSF #2 and includes a pond. This area is used to pasture a few sheep, llamas, and horses. At the time of the inspection, the area was well-vegetated and in good condition.

Photo #:	7129
Date/Time of Photo:	7/13/2023 10:03
Photo By:	Brian Hanson
Photo Location:	Main Dairy Pasture
Photo Description:	
Standing on the north side of sheep barn looking east: View of north edge of CAFO Outdoor Vegetated Area.

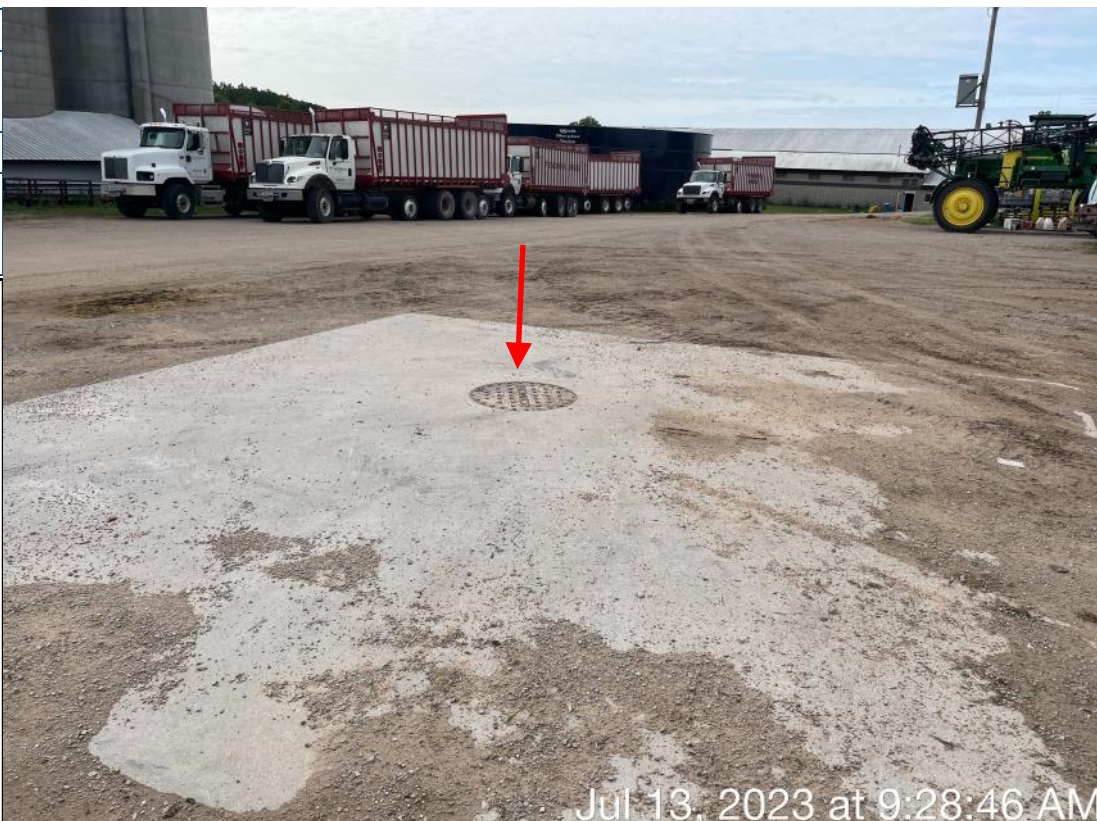
Photo #:	7025
Date/Time of Photo:	7/13/2023 09:28
Photo By:	Brian Hanson
Photo Location:	Main Dairy Well Locations
Photo Description:	
Standing on the east side of the shop looking southeast: View of water supply well location located underground in manhole. Identified as:	
Well ID: 8DK558

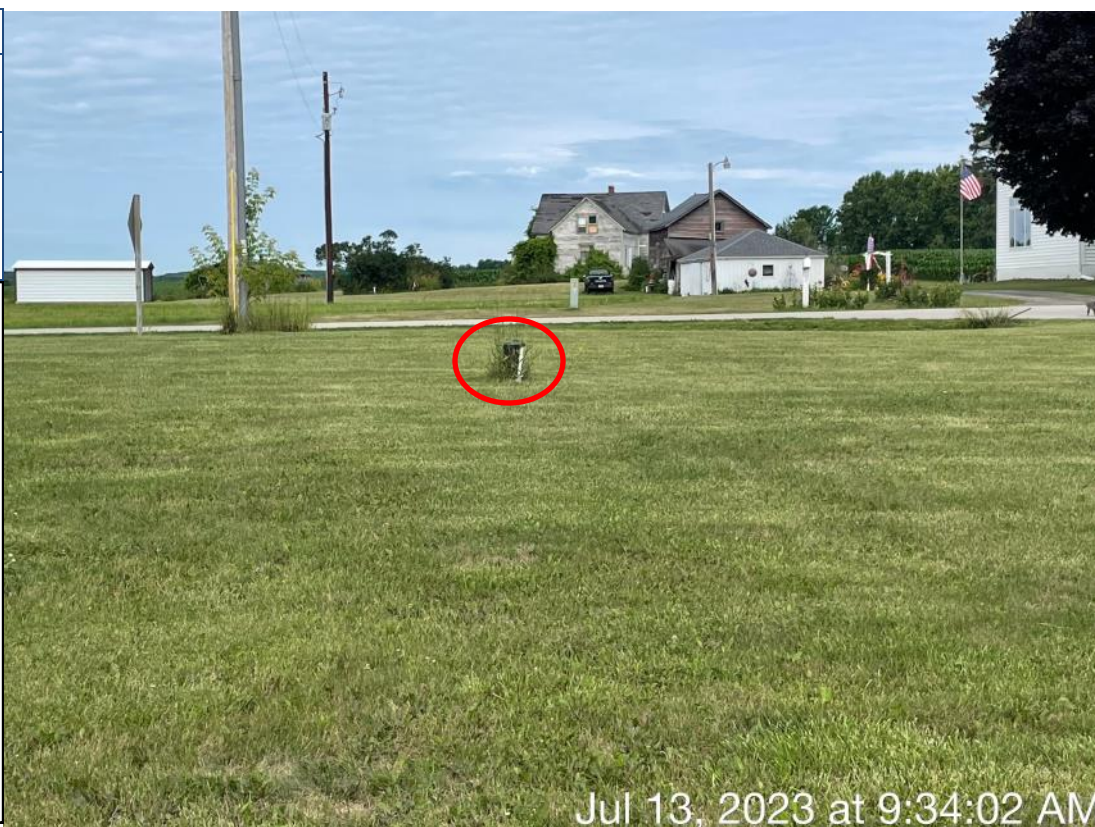
Photo #:	7034
Date/Time of Photo:	7/13/2023 09:34
Photo By:	Brian Hanson
Photo Location:	Main Dairy Well Locations
Photo Description:	Standing on the west side of parlor looking west: View of waters supply well location in grassy area west of parlor & south of calf barn. Well Id: IB342

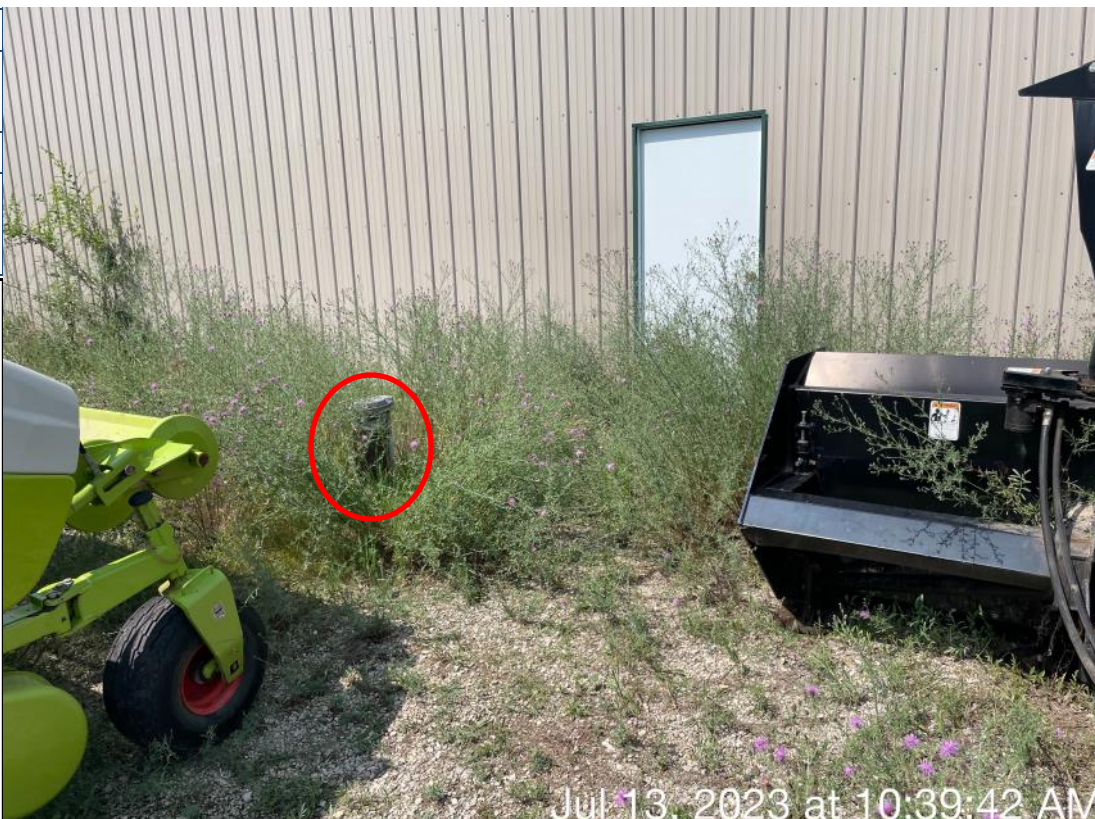
Photo #:	7168
Date/Time of Photo:	7/13/2023 10:39
Photo By:	Brian Hanson
Photo Location:	Rymer Farm Well Locations
Photo Description:	Standing on west side of grain bins looking west: View of water supply well location near machine shed. Well ID: SX615

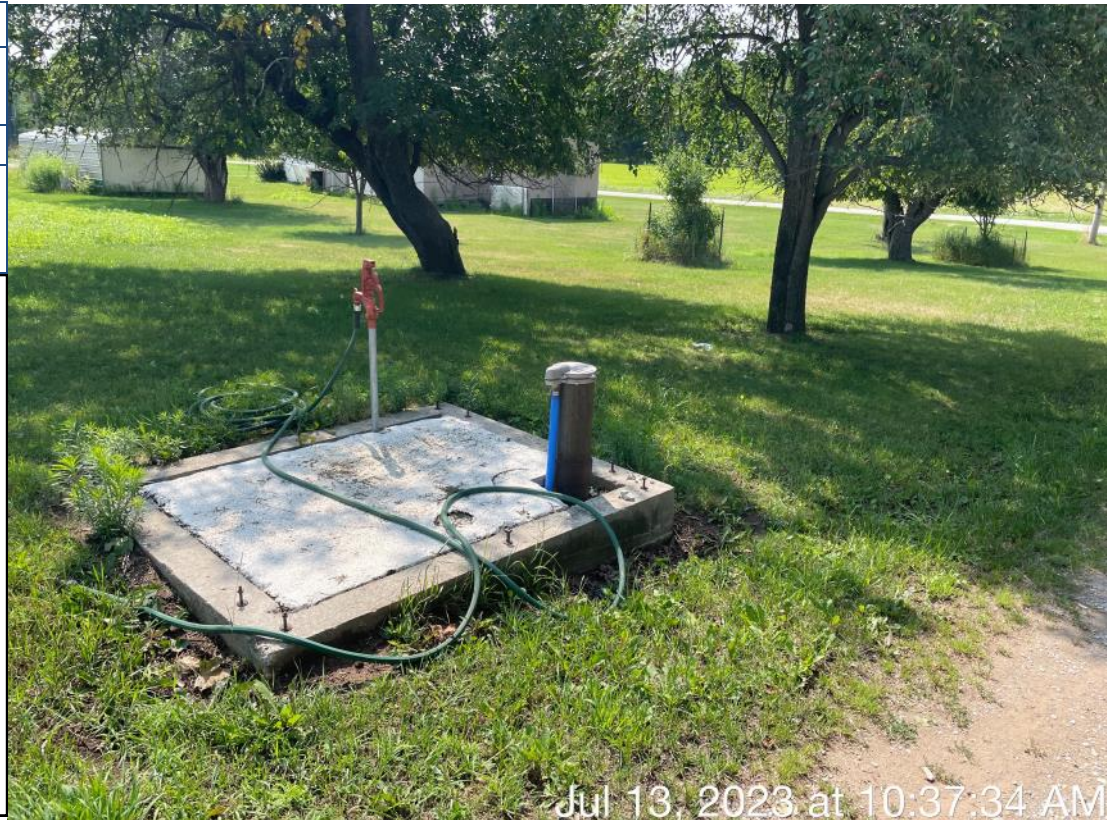
Photo #:	7165
Date/Time of Photo:	7/13/2023 10:37
Photo By:	Brian Hanson
Photo Location:	Rymer Farm Well Location
Photo Description: Standing on east side of house looking east: View of water supply well location on east side of house. Well ID not found. Previous landowner was Boyd Rymer. Most likely constructed in 1960-70's.
