Permit Fact Sheet

Permit Number:	WI-0059544-05-0
Permittee Name:	Matsche Farm Inc
Address:	N9035 River Rd
City/State/Zip:	Birnamwood WI 54414
Discharge Location:	Main Dairy : N9035 River Road & W16550 County Rd N, Birnamwood, WI 54414 ,East 1/2 of Section 7 T28N R12E Pingel Farm: W16233 County Rd N, Birnamwood, WI 54414, NW 1/4 of SE 1/4 Section 8 T28N R12E Korbisch Pit: W18102 Hill Road, Birnamwood, WI, 54414, SW 1/4 of SW 1/4 Section 22 T29N R11E Western Ave Pit: W19069 Western Ave, Birnamwood, WI, 54414, SW 1/4 of SE 1/4 Section 18 T28N R11E Cherry Drive Pit: 216434 Black Cherry Drive, Eland WI 54427 SE ¼ of SE ¼ Section 10 T27N R 10E Sugarbush Pit: Sugar Bush Road, Birnamwood, WI, 54414, SW ¼ of SE ¼ Section 27 T29N R11E
Receiving Water:	the North Branch Embarrass River & unnamed tributaries within the North Branch Embarrass River Watershed, Railroad Creek & Unnamed tributaries to the South Branch Embarrass River Watershed, and groundwaters of the state

On Wednesday August 24th Hanson & Kaczorowski met with Matsche, Matsche & Carlsen 09:00 at Matsche Farms Inc. site to conduct a permit reissuance walkover inspection. All five sites were inspected. No liquid precipitation had

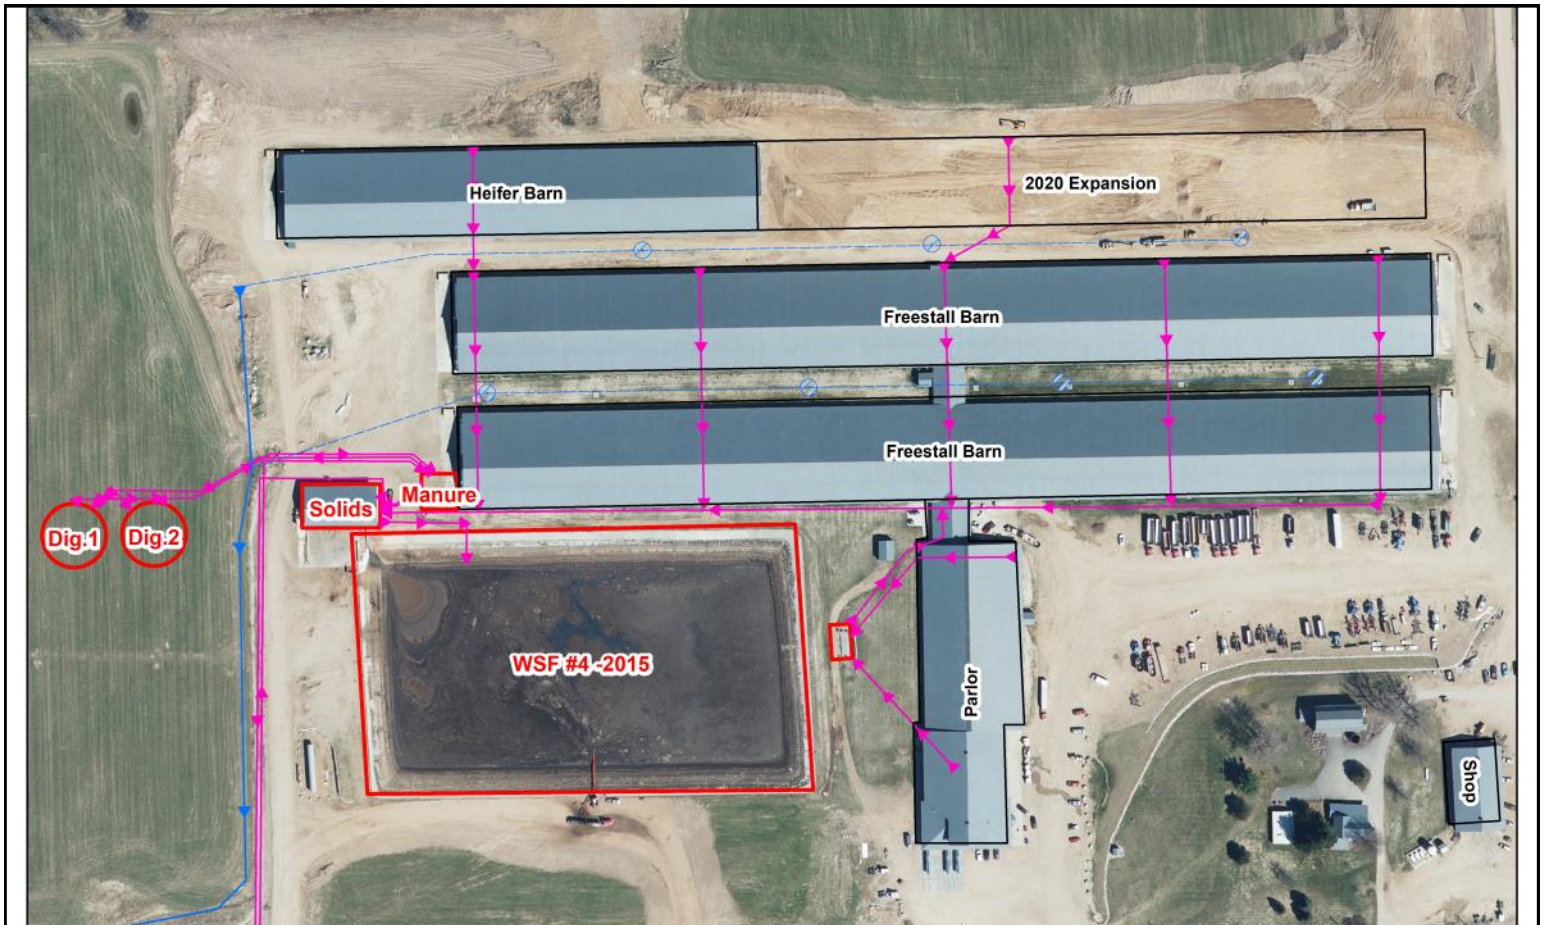
Site Overview Diagram (Main Farm North of County N: orange lines = potential contaminated runoff, blue lines = stormwater flow, pink lines = waste transfer system)

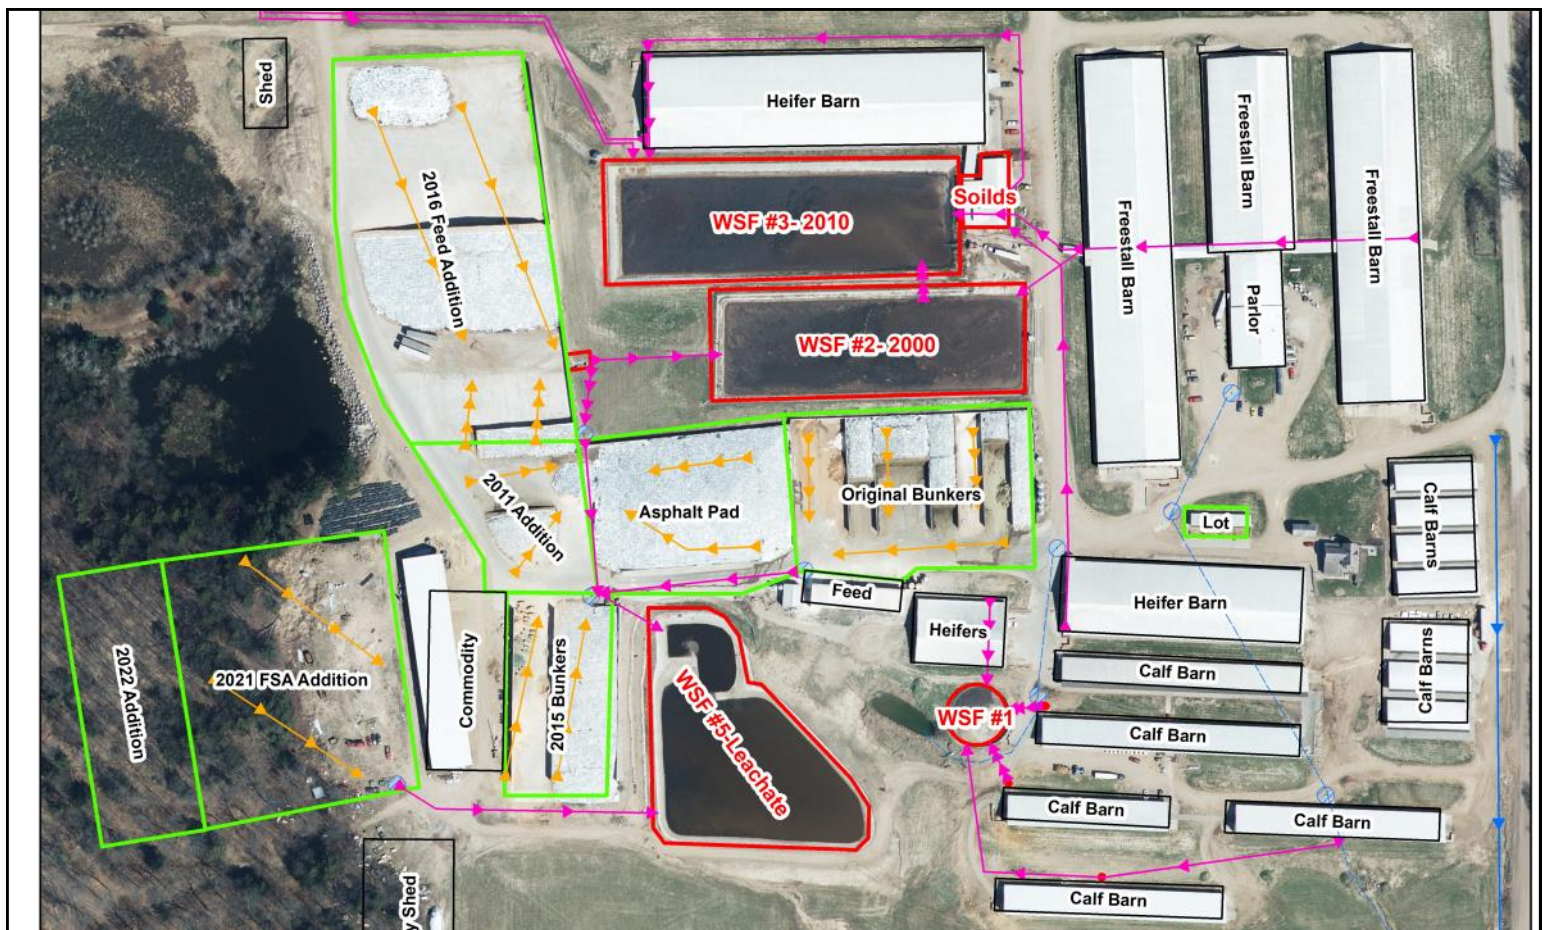
Site Overview Diagram (Main Farm South of County N: orange lines = potential contaminated runoff, blue lines = stormwater flow, pink lines = waste transfer system)

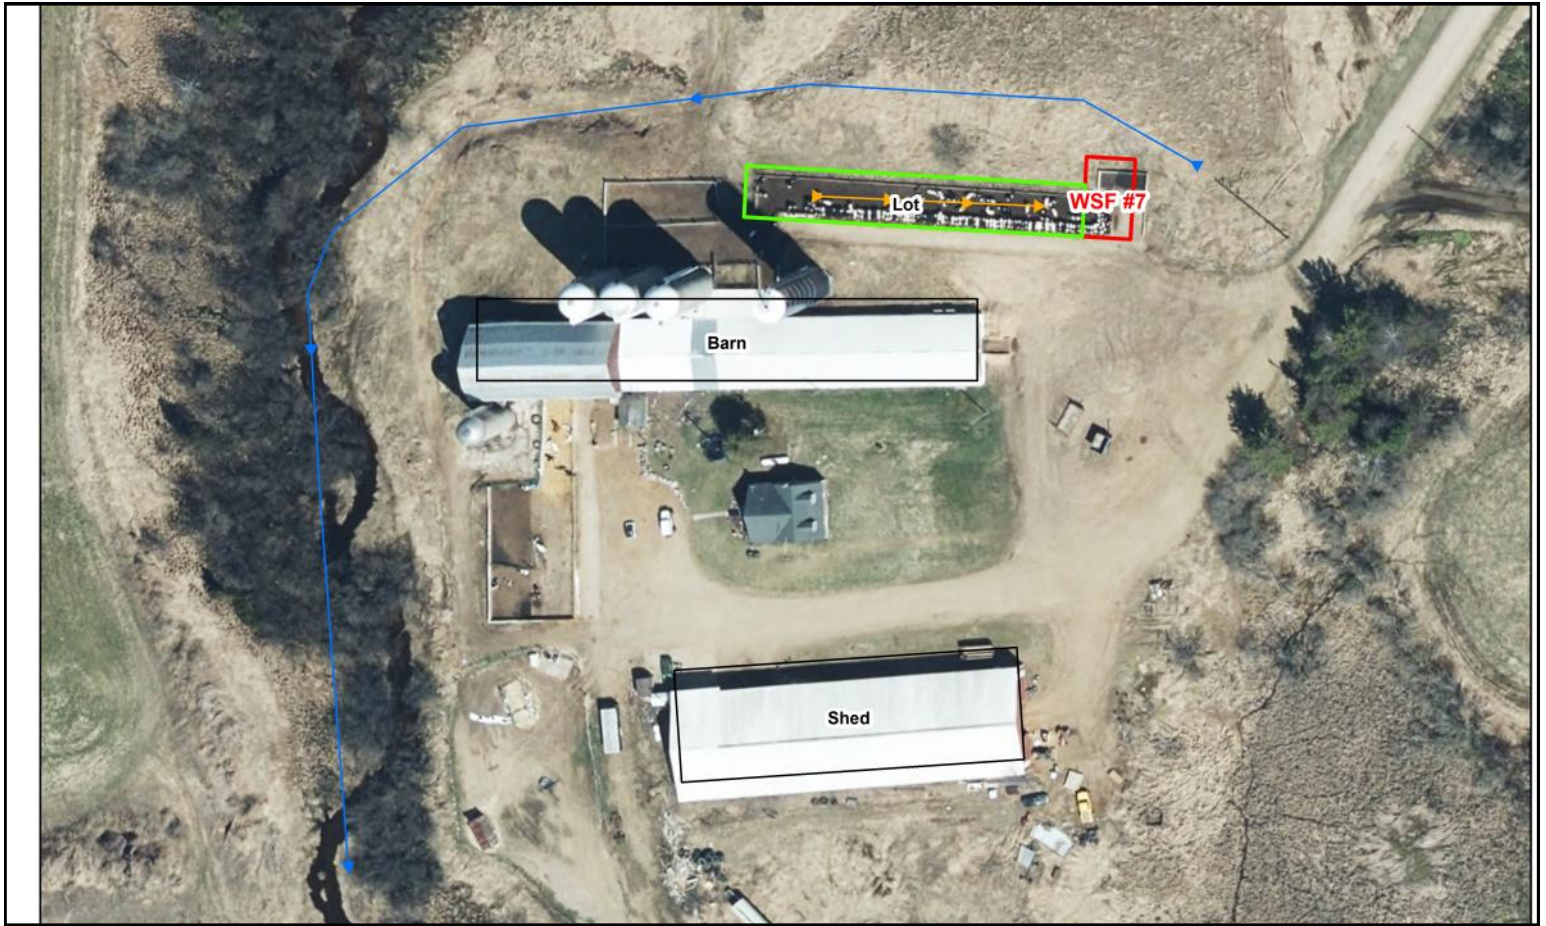
Site Overview Diagram (Home Farm: orange lines = potential contaminated runoff, blue lines = stormwater flow, pink lines = waste transfer system)

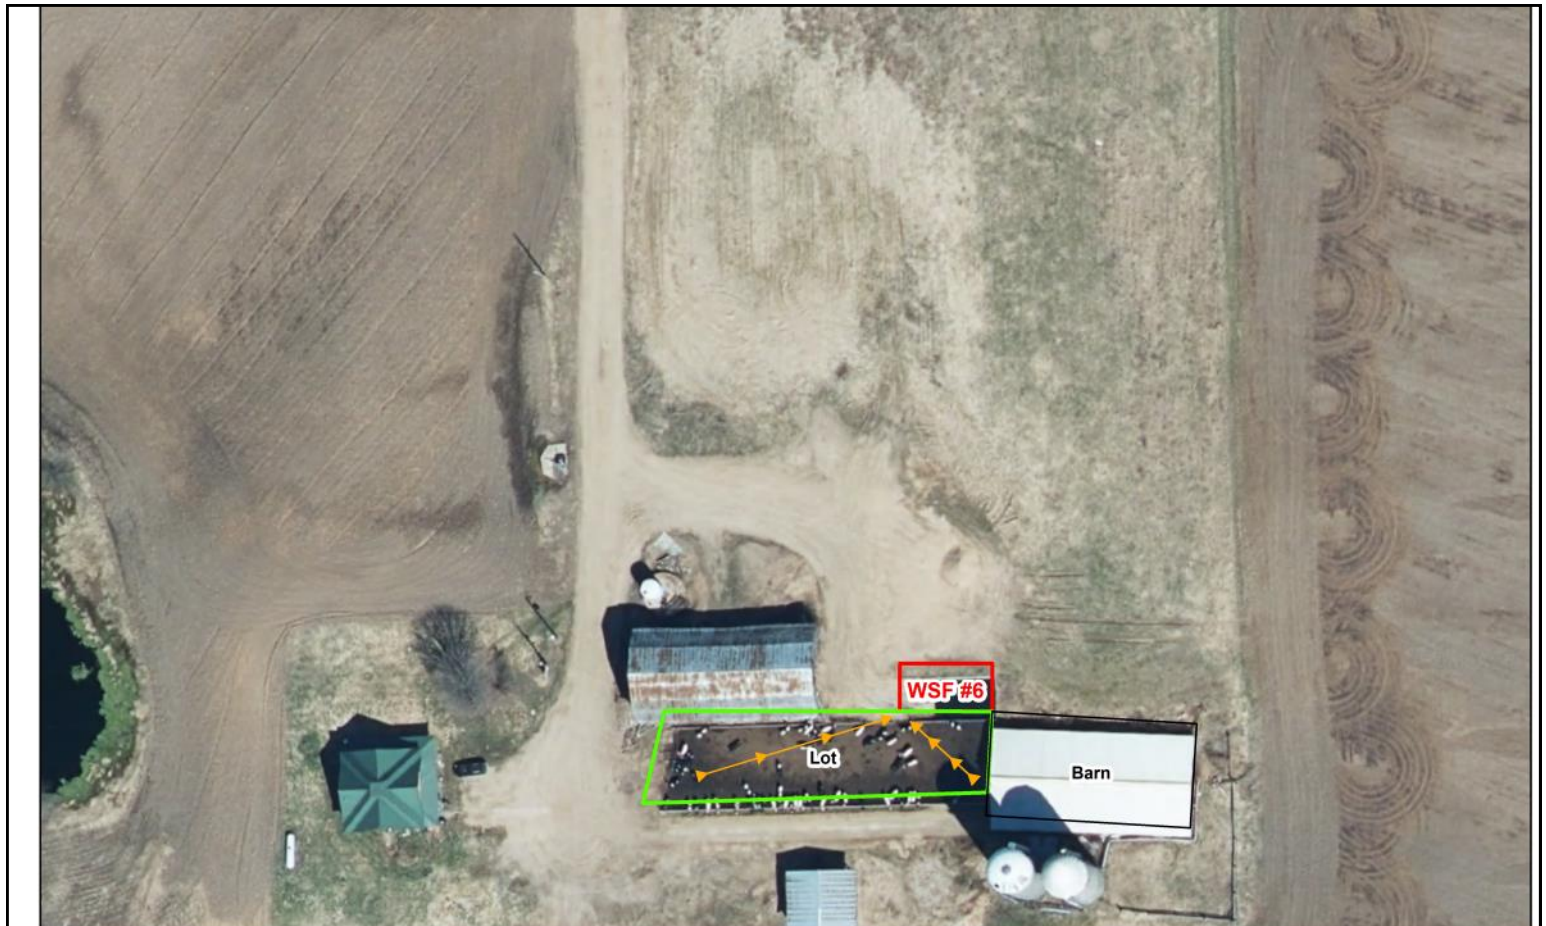
Site Overview Diagram (Pingel Farm: orange lines = potential contaminated runoff, blue lines= stormwater flow, pink lines= waste transfer system)

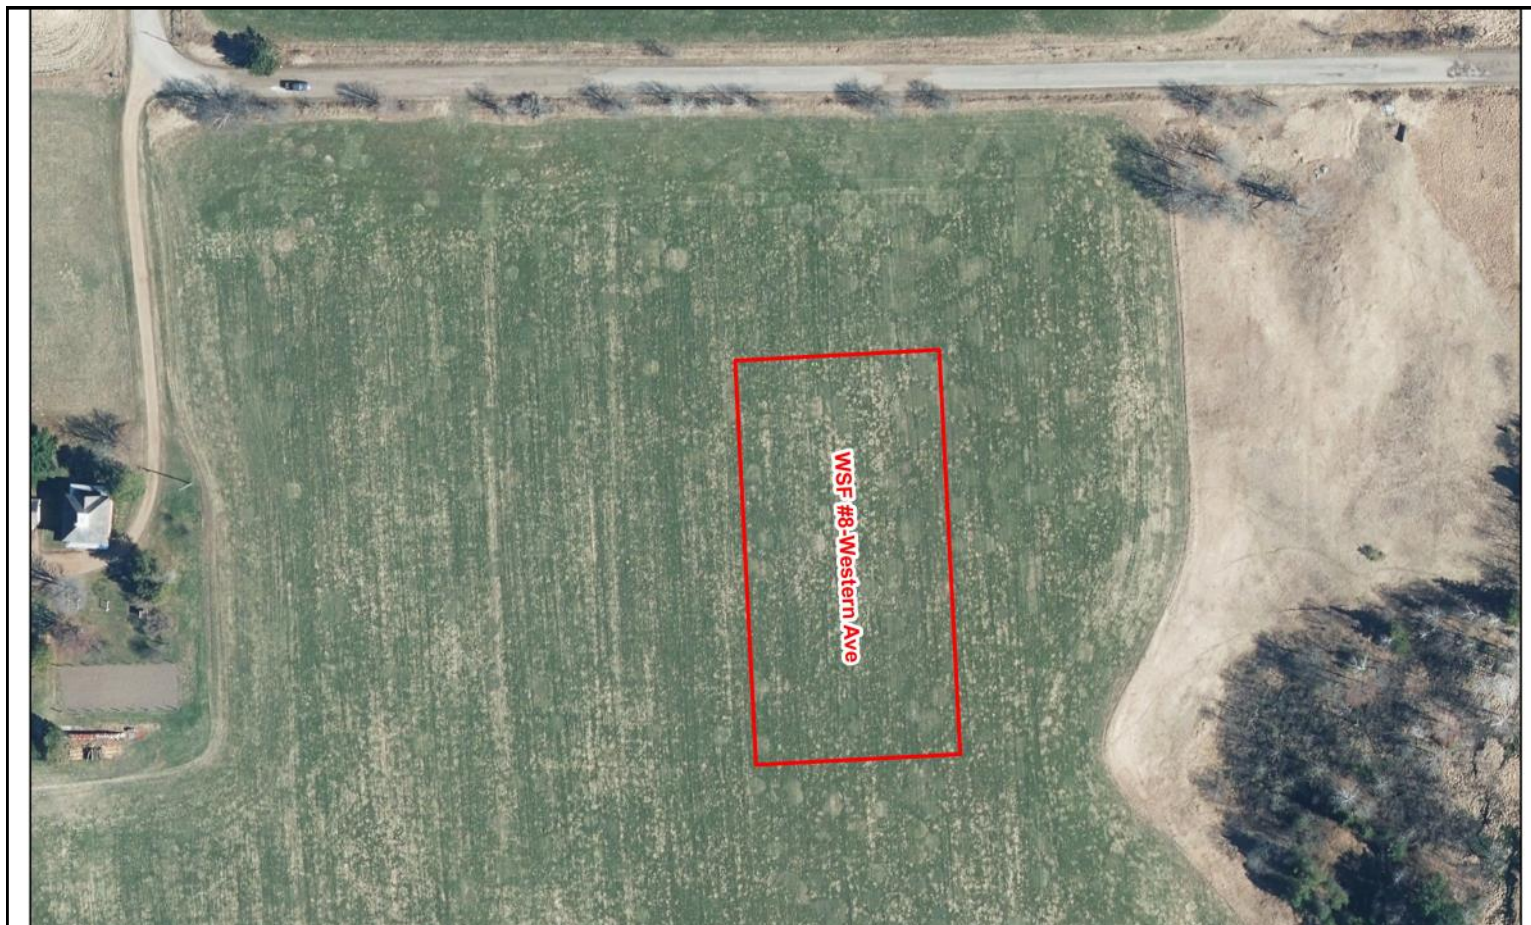
Site Overview Diagram (Western Ave Pit: orange lines = potential contaminated runoff, blue lines = stormwater flow, pink lines = waste transfer system)

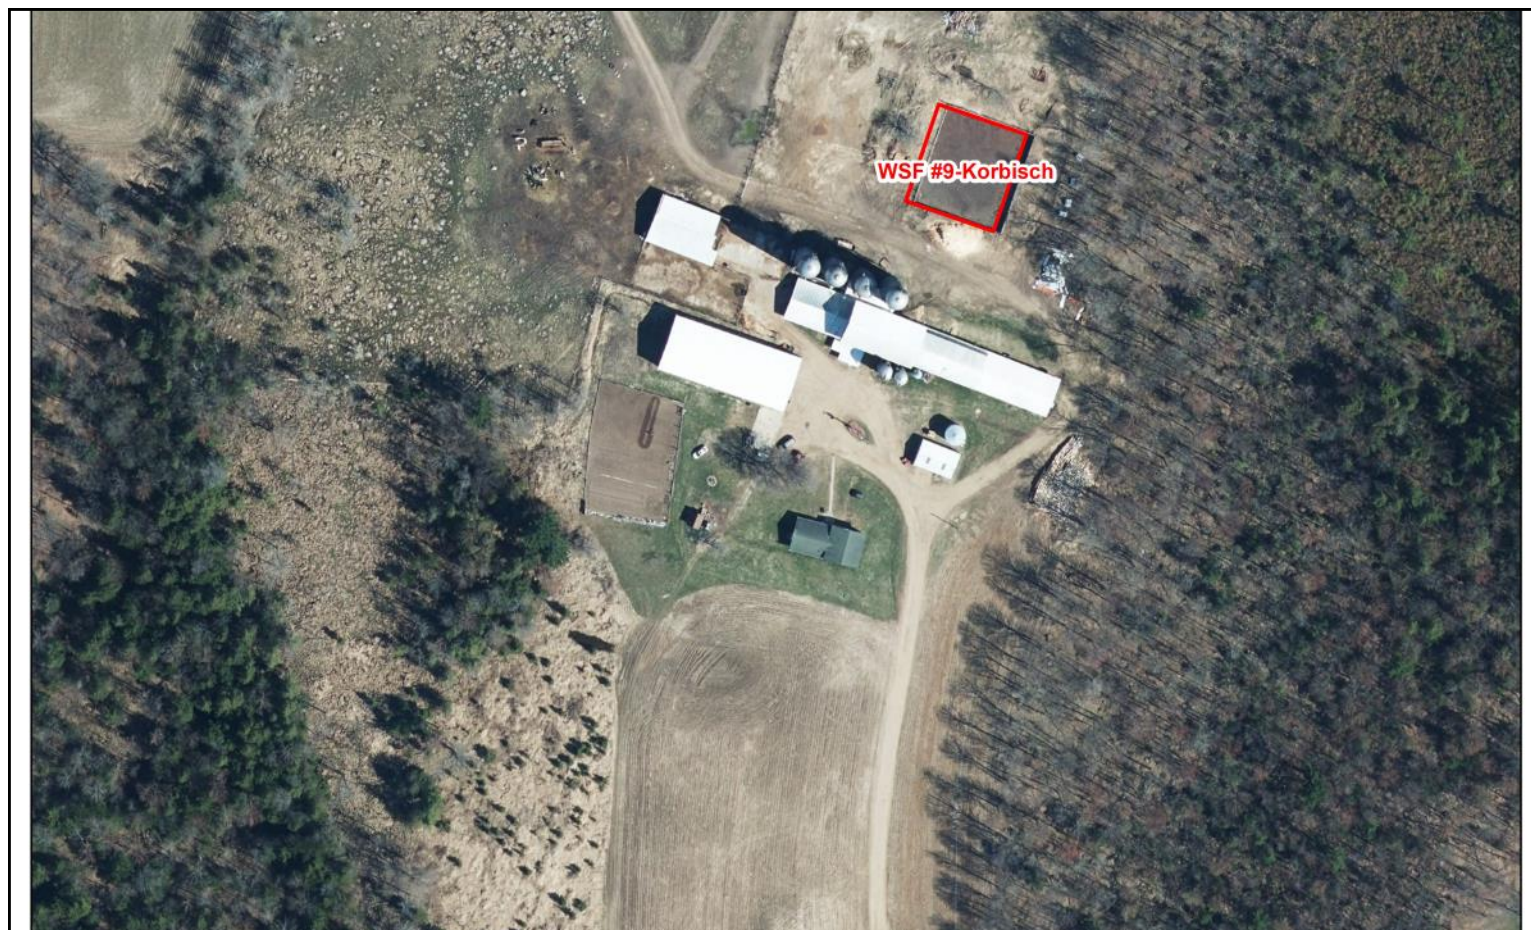
Site Overview Diagram (Korbisch Pit: orange lines = potential contaminated runoff, blue lines= stormwater flow, pink lines= waste transfer system)

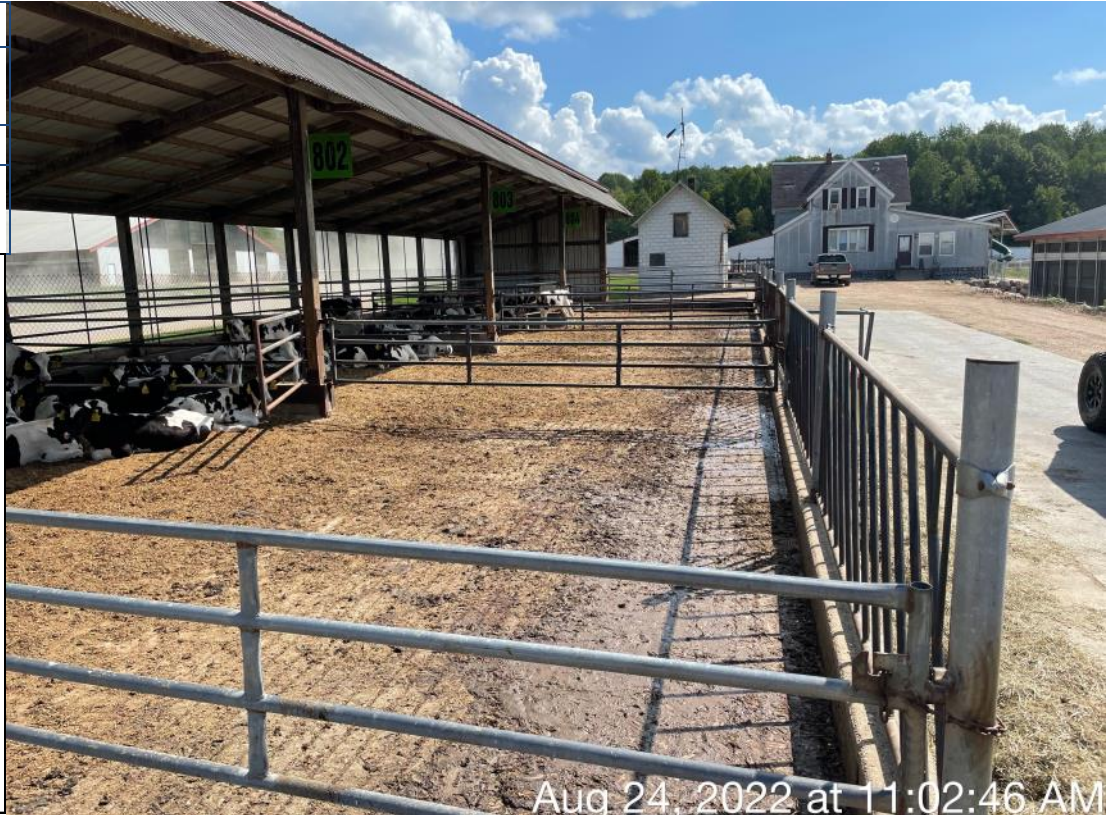
Standing on the west end of the outdoor calf lot looking east: View of outdoor calf lot. Raised curb at west entrance keeps runoff from leaving the lot. Manure & runoff manually scraped up and hauled away.

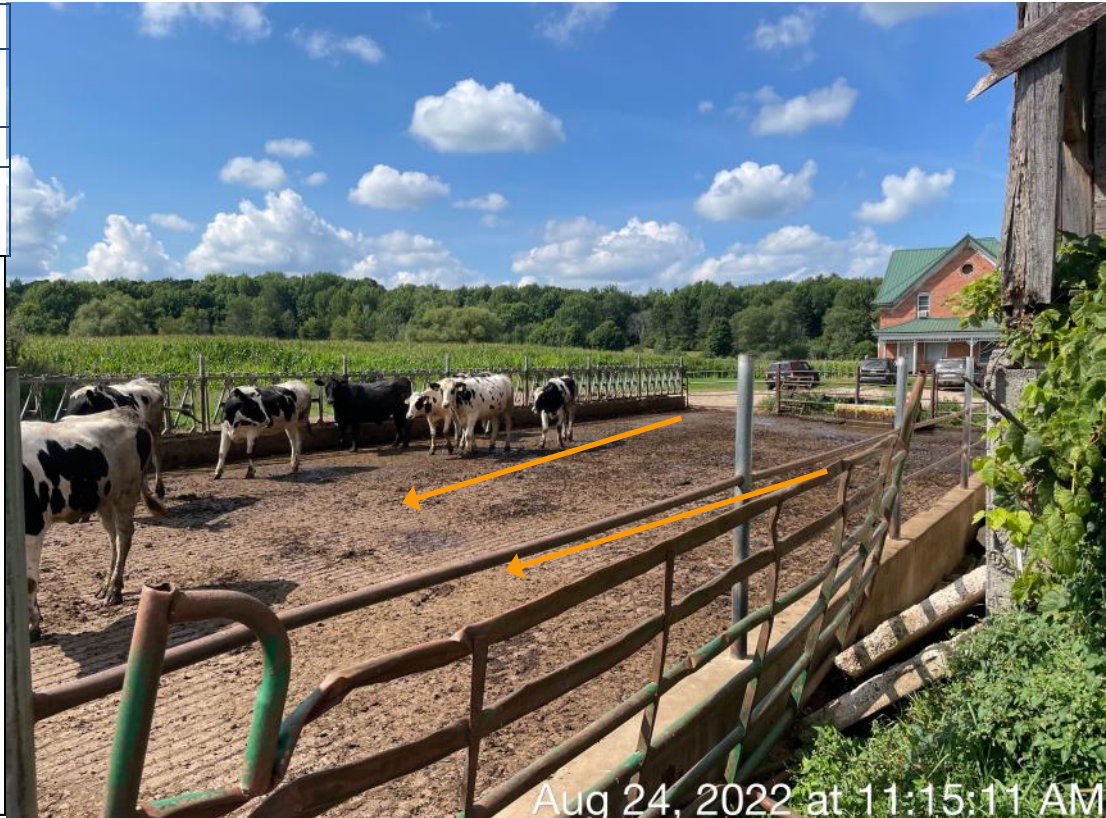
Photo #:	3314
Date/Time of Photo:	8/24/2022 11:15
Photo By:	Brian Hanson
Photo Location:	Pingel Farm

Standing on the north side of the outdoor lot at the Pingel farm looking west: View of the west half of the outdoor lot. Arrows indicate direction of runoff flow.

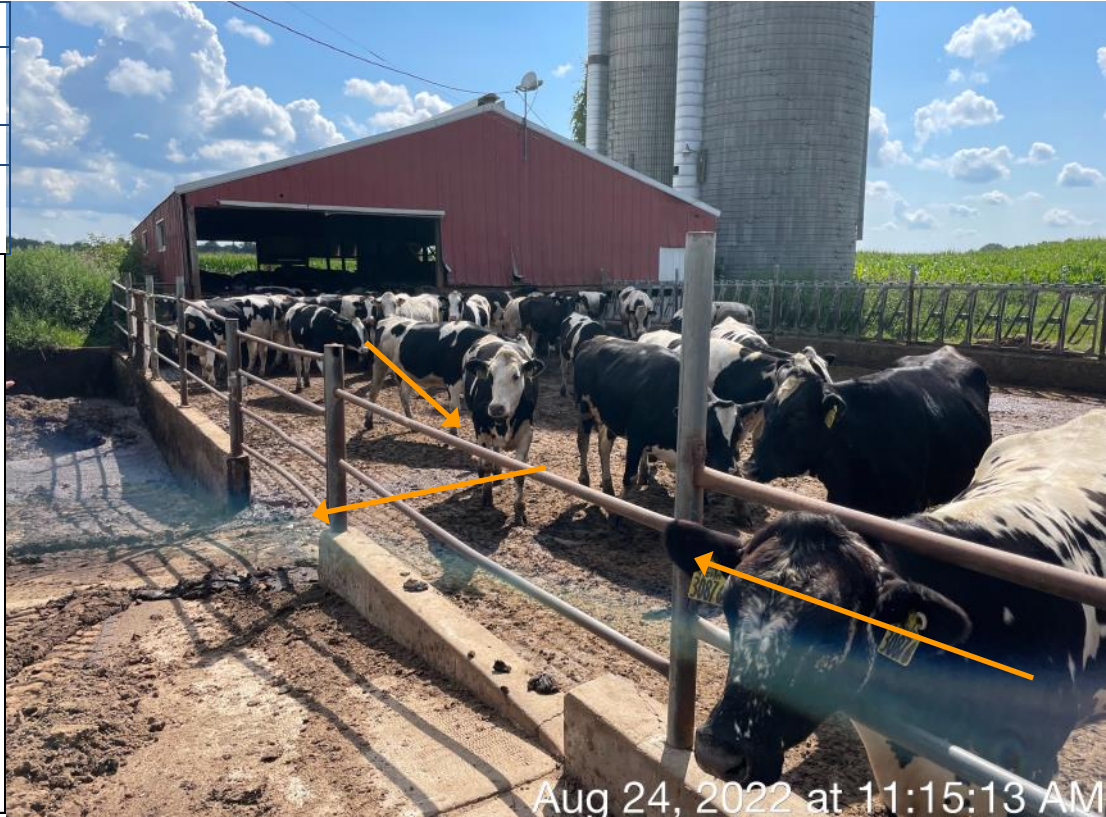
Photo #:	3317
Date/Time of Photo:	8/24/2022 11:15
Photo By:	Brian Hanson
Photo Location:	Pingel Farm

Standing on the north side of the outdoor lot at the Pingel farm looking east: View of the east half of the outdoor lot. Notice gap in wall where runoff exits lot and flows into storage structure. Arrows indicate direction of flow.

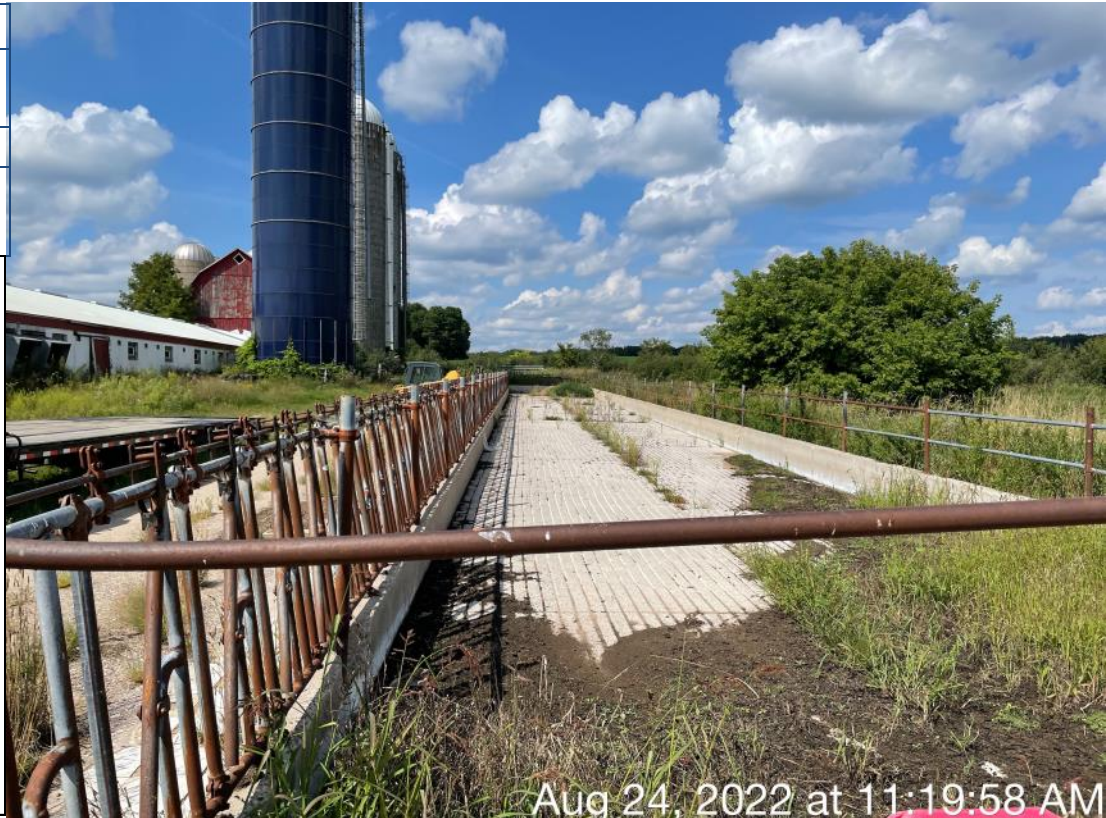
Photo #:	3322
Date/Time of Photo:	8/24/2022 11:19
Photo By:	Brian Hanson
Photo Location:	Home Farm

Standing on the east end of the outdoor lot at the home farm looking west: View of abandoned outdoor lot at the home farm.

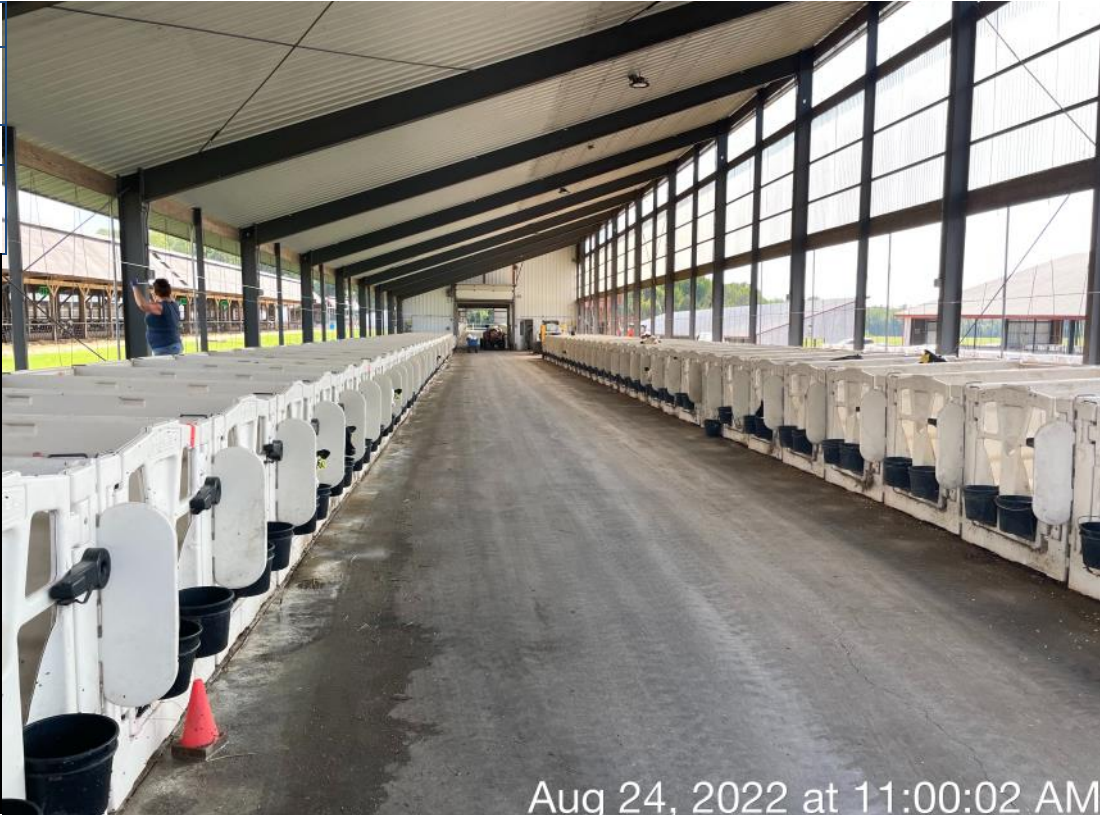
Photo #:	3290
Date/Time of Photo:	8/24/2022 11:00
Photo By:	Brian Hanson
Photo Location:	Main Dairy South

Standing at the west end of a calf barn looking east: Typical view of the interior of the calf hutch barns. Barns have floor drains that collect any liquid in the barn and pump it to WSF #1.

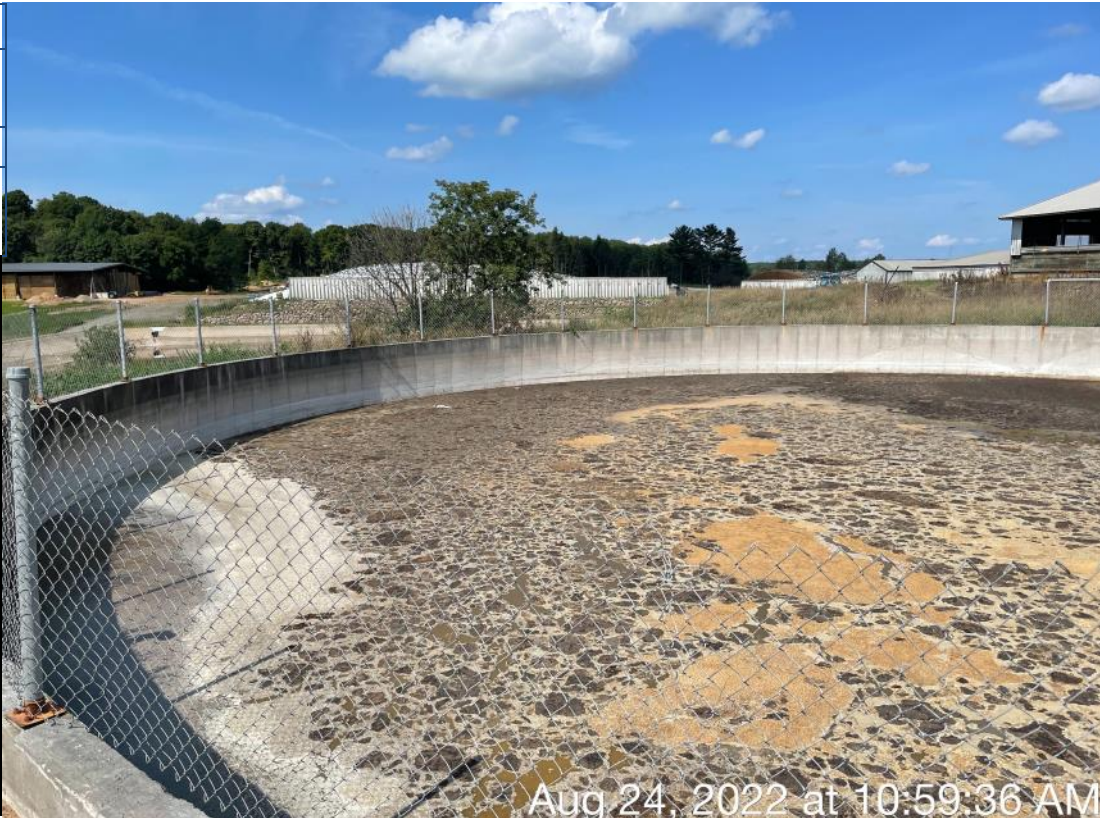
Standing on the south side of WSF #1 looking northwest: View of WSF #1

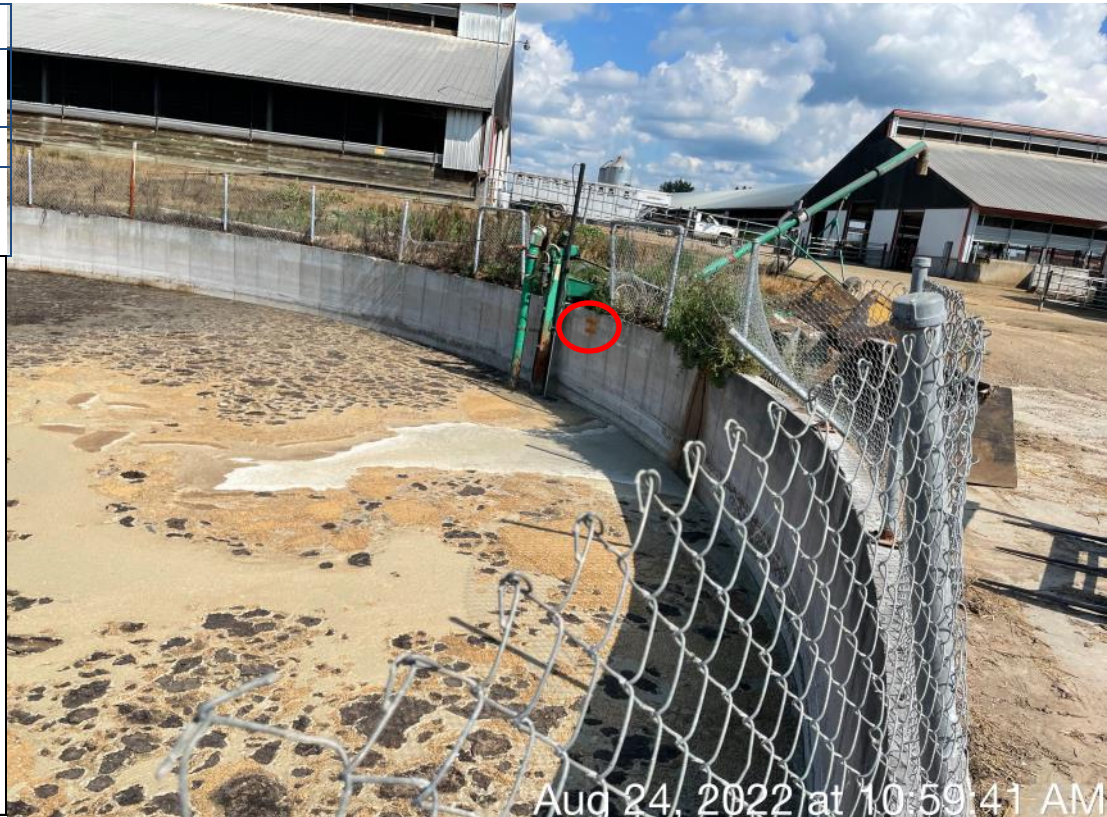
Standing on the east side of WSF #1 looking north: View of east side of WSF #1. MOL & MOS markers highlighted.

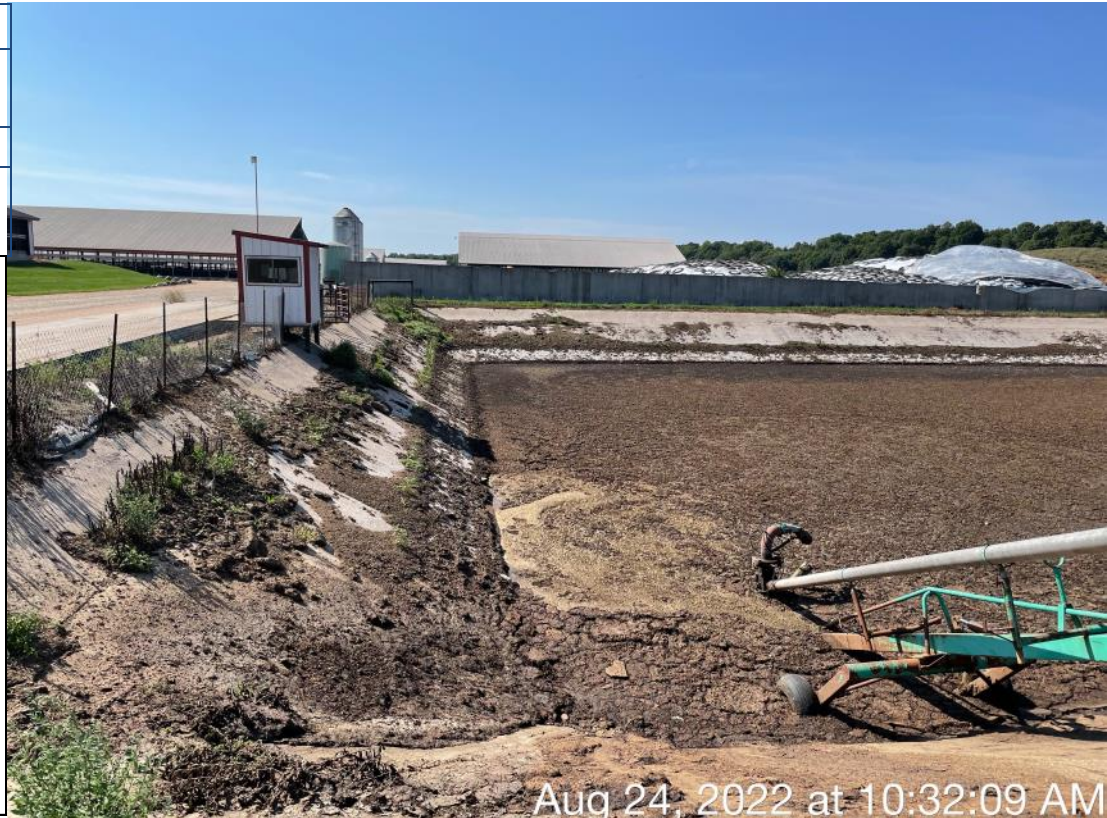
Photo #:	3198
Date/Time of Photo:	8/24/2022 10:32
Photo By:	Brian Hanson
Photo Location:	WSF #2

Standing at the northeast corner of WSF #2 looking south: View of east end of WSF #2.

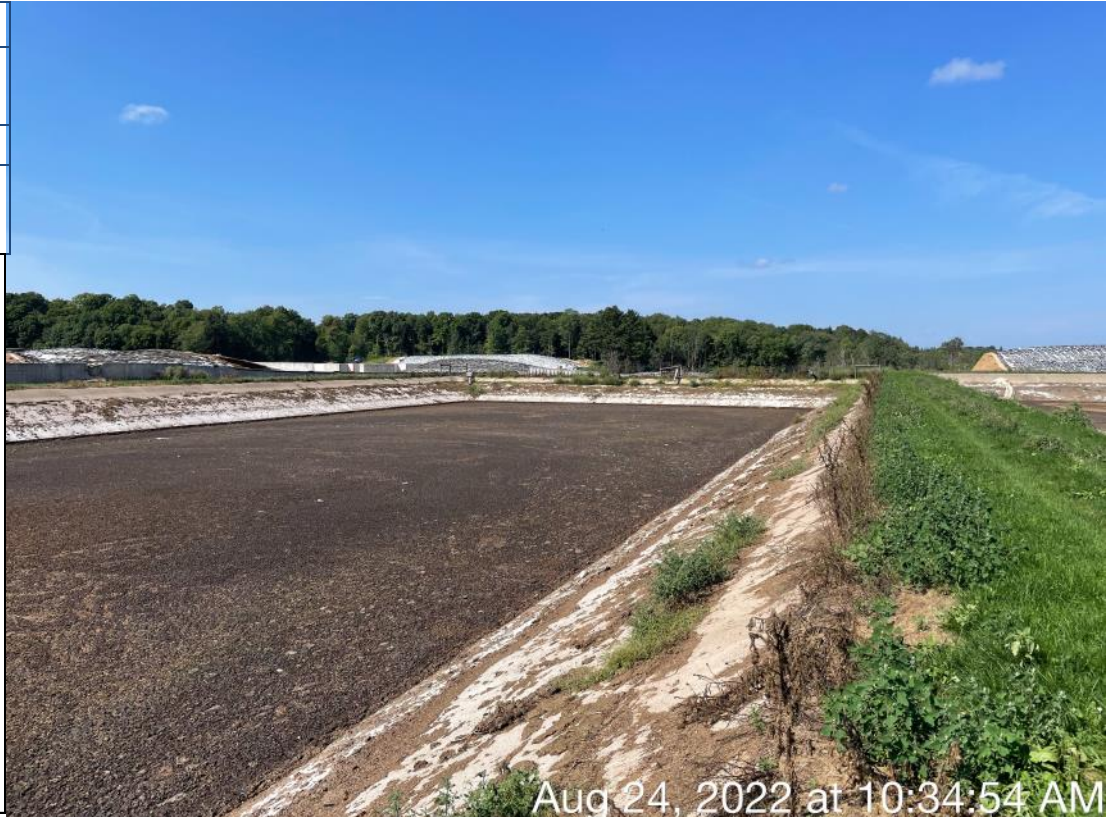
Photo #:	3212
Date/Time of Photo:	8/24/2022 10:34
Photo By:	Brian Hanson
Photo Location:	WSF #2

Standing on the north side of WSF #2 looking west: view of north side of WSF #2.

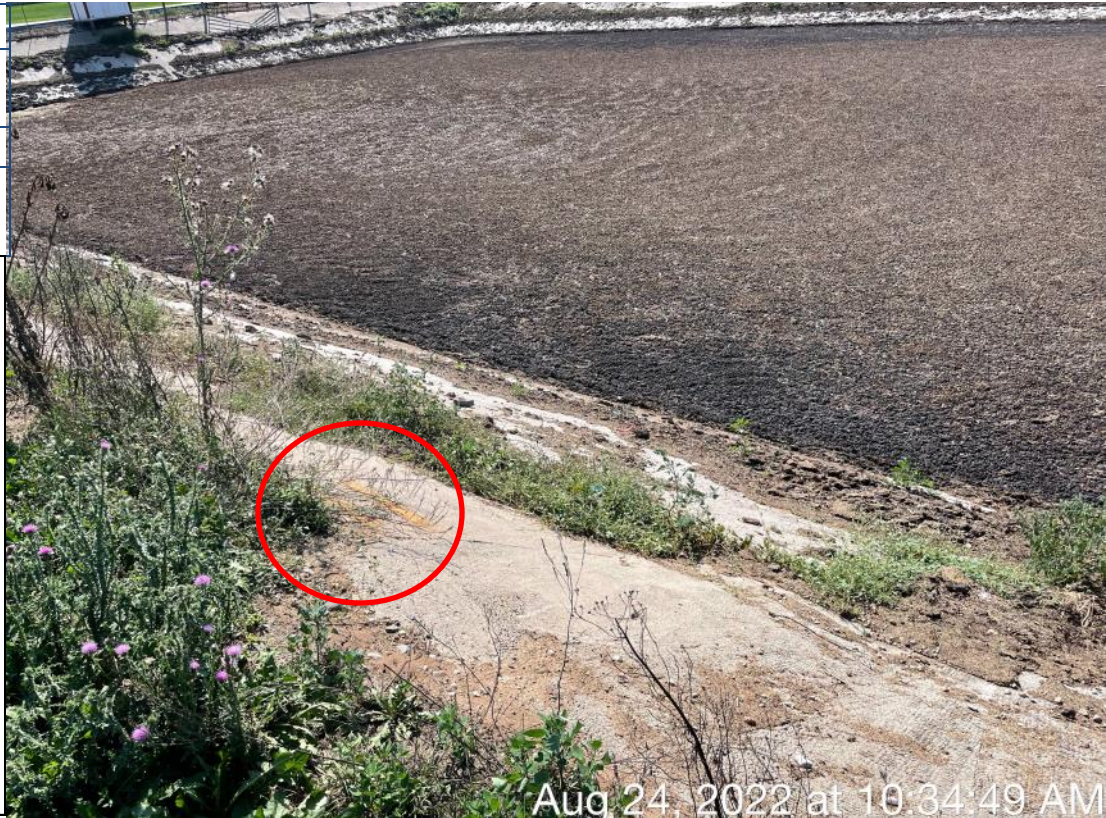
Photo #:	3209
Date/Time of Photo:	8/24/2022 10:34
Photo By:	Brian Hanson
Photo Location:	WSF #2

Standing on the north side of WSF #2 looking southeast & down: View of permanent markers in WSF #2.

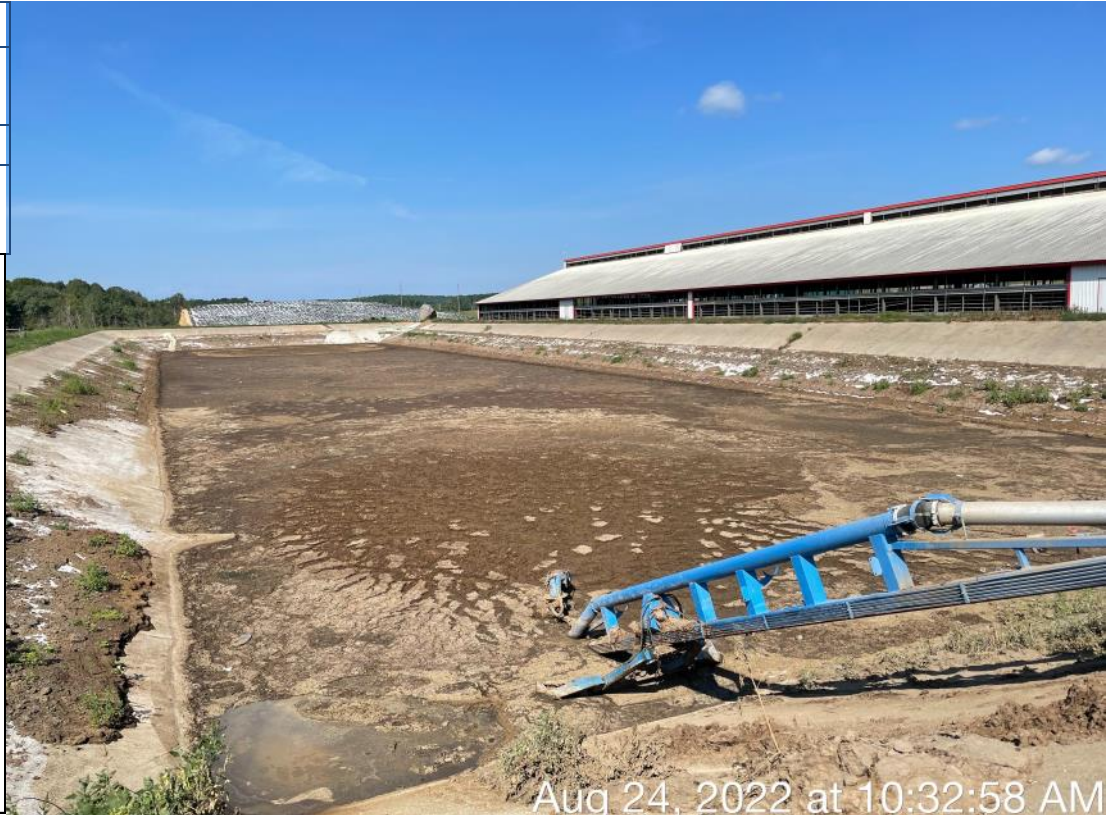
Photo #:	3203
Date/Time of Photo:	8/24/2022 10:32
Photo By:	Brian Hanson
Photo Location:	WSF #3

Standing on the east side of WSF #3 looking west: View of WSF #3.

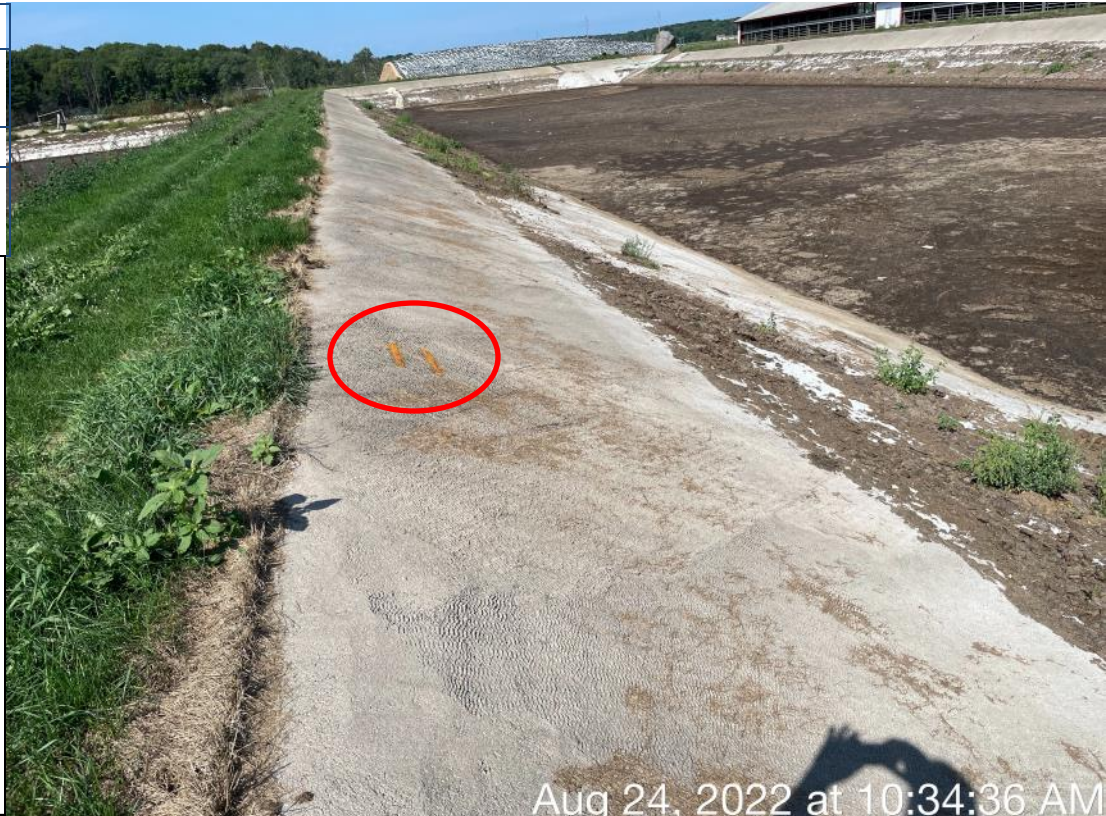
Standing on the south side of WSF #3 looking west: View of permanent markers in WSF #3.

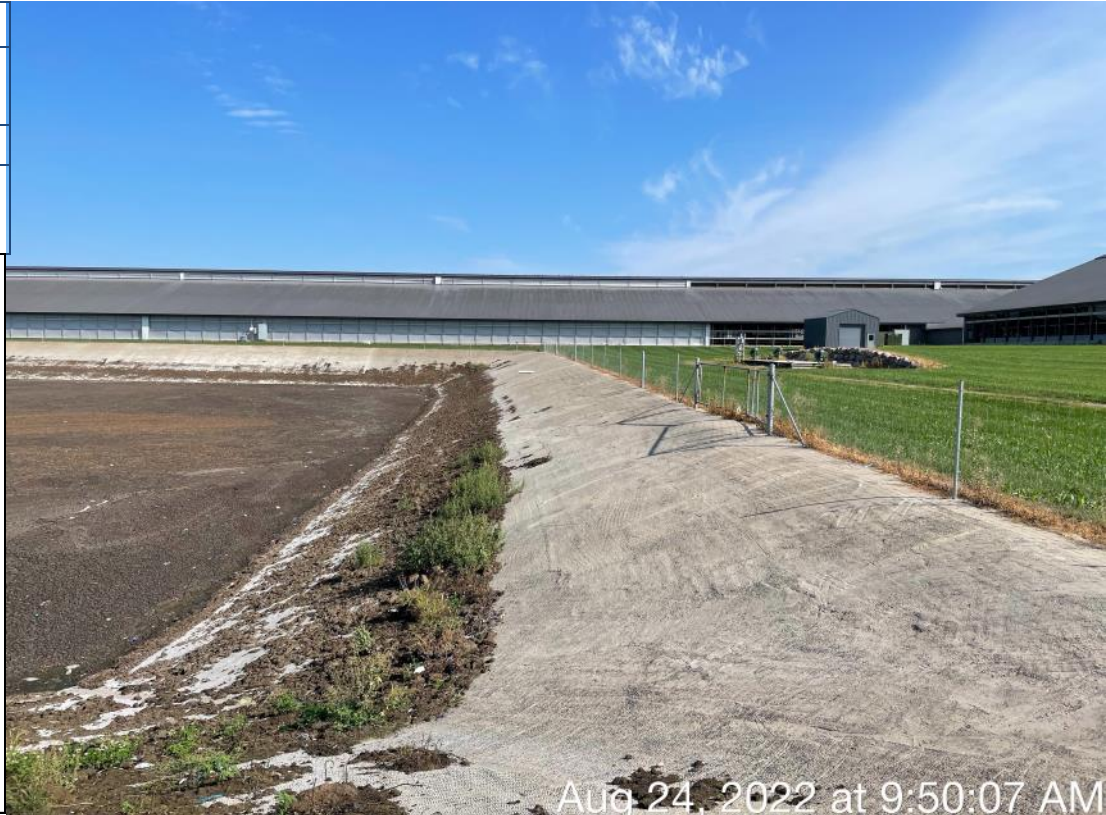
Standing at the southeast corner of WSF #4 looking north: View of east edge of WSF #4.

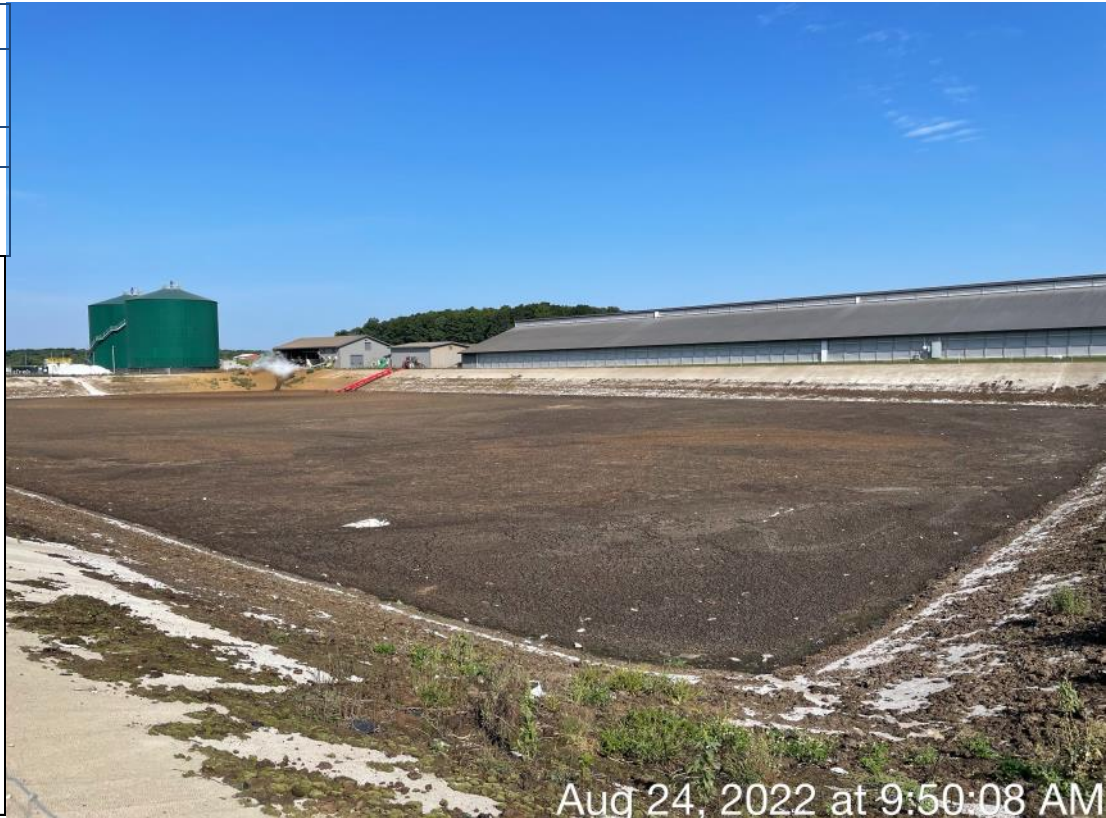
Photo #:	3152
Date/Time of Photo:	8/24/2022 09:50
Photo By:	Brian Hanson
Photo Location:	WSF #4

Standing at the southeast corner of WSF #4 looking northwest: View of east half of WSF #4.
