Permit Fact Sheet

Permit Number:	WI-0059544-05-0
Permittee Name:	Matsche Farm Inc
Address:	N9035 River Rd
City/State/Zip:	Birnamwood WI 54414
Discharge Location:	Main Dairy : N9035 River Road & W16550 County Rd N, Birnamwood, WI 54414 ,East 1/2 of Section 7 T28N R12E Pingel Farm: W16233 County Rd N, Birnamwood, WI 54414, NW 1/4 of SE 1/4 Section 8 T28N R12E Korbisch Pit: W18102 Hill Road, Birnamwood, WI, 54414, SW 1/4 of SW 1/4 Section 22 T29N R11E Western Ave Pit: W19069 Western Ave, Birnamwood, WI, 54414, SW 1/4 of SE 1/4 Section 18 T28N R11E Cherry Drive Pit: 216434 Black Cherry Drive, Eland WI 54427 SE ¼ of SE ¼ Section 10 T27N R 10E Sugarbush Pit: Sugar Bush Road, Birnamwood, WI, 54414, SW ¼ of SE ¼ Section 27 T29N R11E
Receiving Water:	the North Branch Embarrass River & unnamed tributaries within the North Branch Embarrass River Watershed, Railroad Creek & Unnamed tributaries to the South Branch Embarrass River Watershed, and groundwaters of the state

On Wednesday August 24th Hanson & Kaczorowski met with Matsche, Matsche & Carlsen 09:00 at Matsche Farms Inc. site to conduct a permit reissuance walkover inspection. All five sites were inspected. No liquid precipitation had

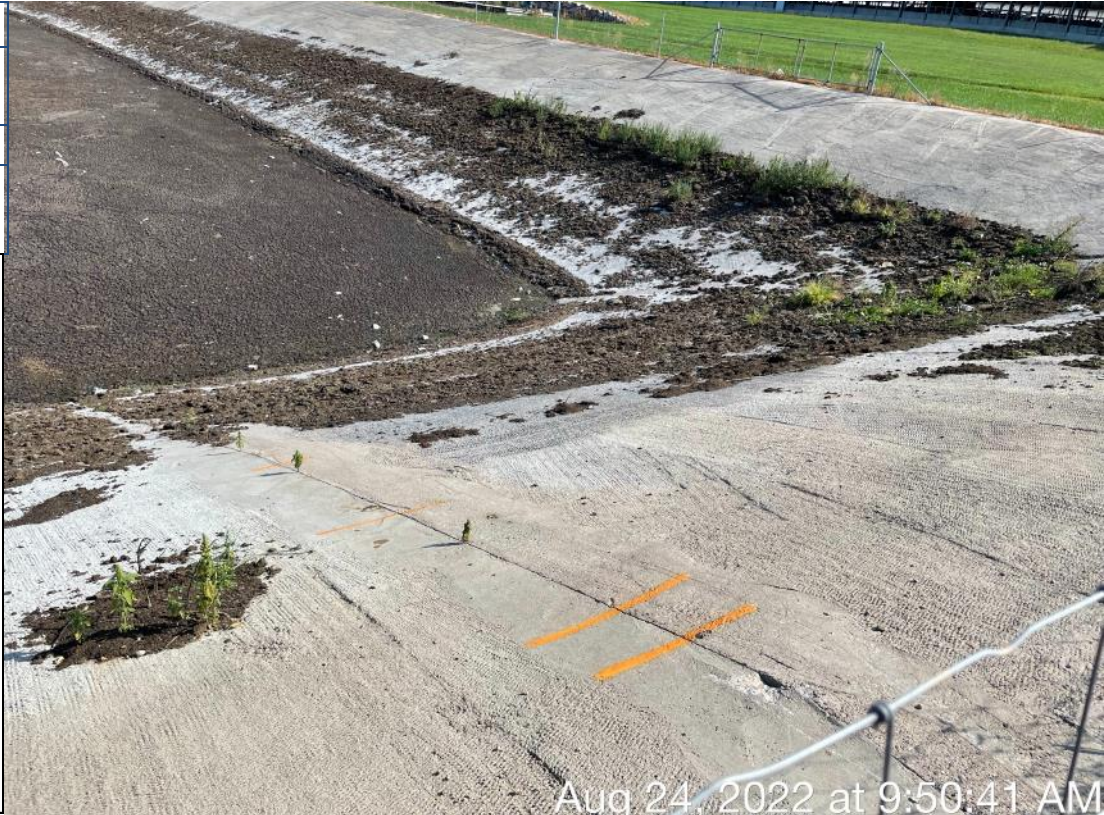
Photo #:	3155
Date/Time of Photo:	8/24/2022 09:50
Photo By:	Brian Hanson
Photo Location:	WSF #4
Photo Description:	
<p>Standing on the south side of WSF #4 looking northeast & down: View of permanent markers in WSF #4.</p>

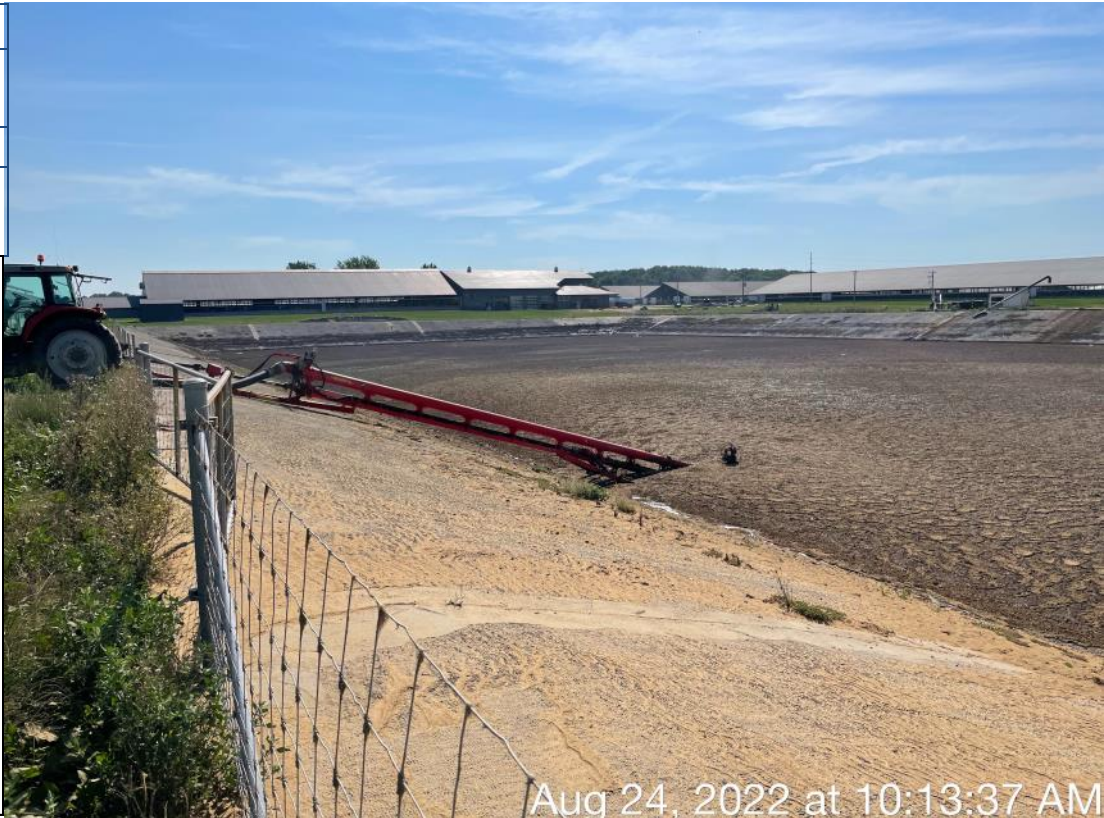
Photo #:	3181
Date/Time of Photo:	8/24/2022 10:13
Photo By:	Brian Hanson
Photo Location:	WSF #4
Photo Description:	
<p>Standing at the northwest corner of WSF #4 looking southeast: View of north edge of WSF #4.</p>

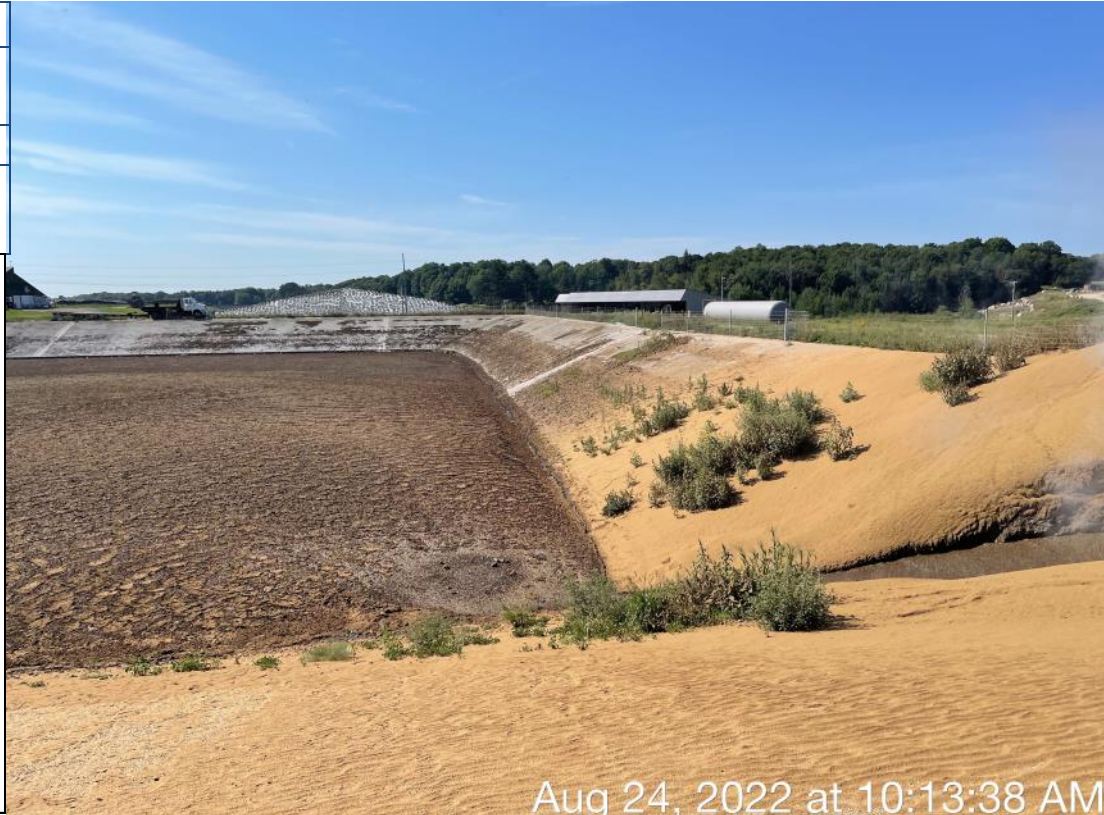
Photo #:	3182
Date/Time of Photo:	8/24/2022 10:13
Photo By:	Brian Hanson
Photo Location:	WSF #4

Standing at the northwest corner of WSF #4 looking south: View of northwest corner of WSF #4 where dried manure solids accumulate from exhaust pipe. More solids in the pit and less outside of pit in comparison to previous inspections.

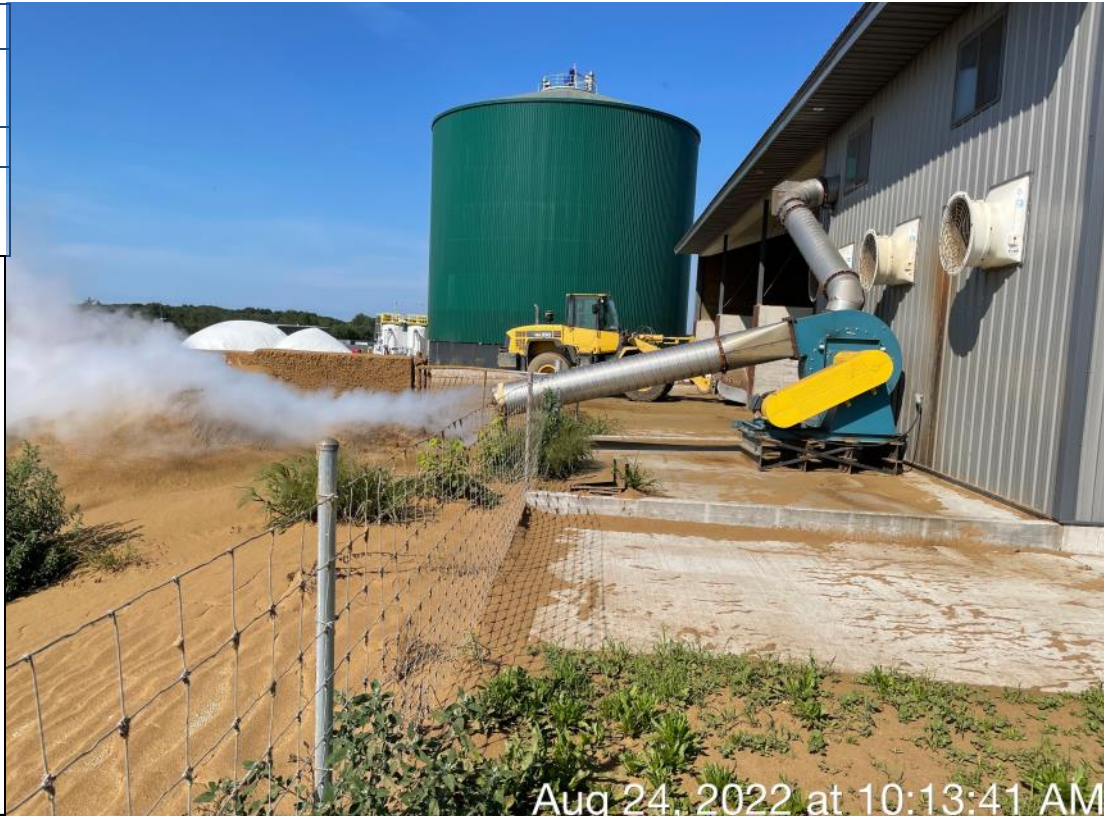
Photo #:	3184
Date/Time of Photo:	8/24/2022 10:13
Photo By:	Brian Hanson
Photo Location:	WSF #4

Standing at the northwest corner of WSF #4 looking west: Alternate view of dryer exhaust pipe from manure separation building.

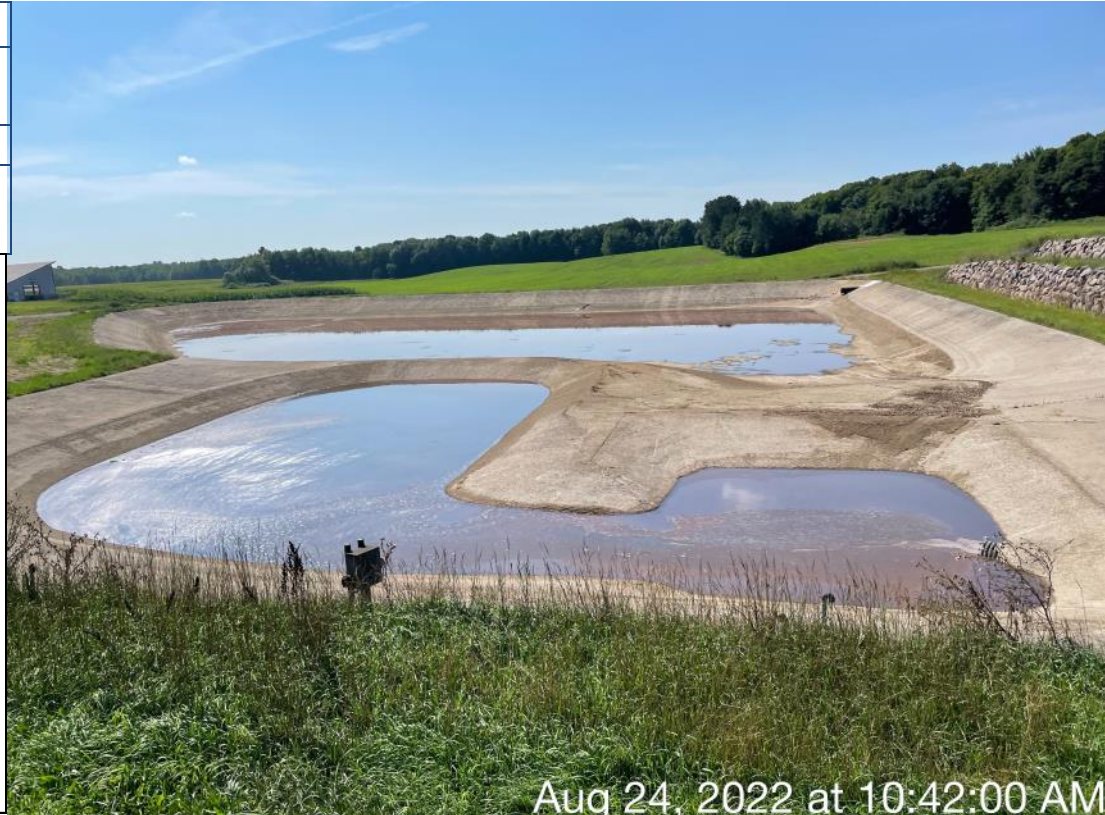
Photo #:	3230
Date/Time of Photo:	8/24/2022 10:42
Photo By:	Brian Hanson
Photo Location:	WSF #5 Leachate

Standing on the north end of the leachate basin looking south: Overview of leachate basin.

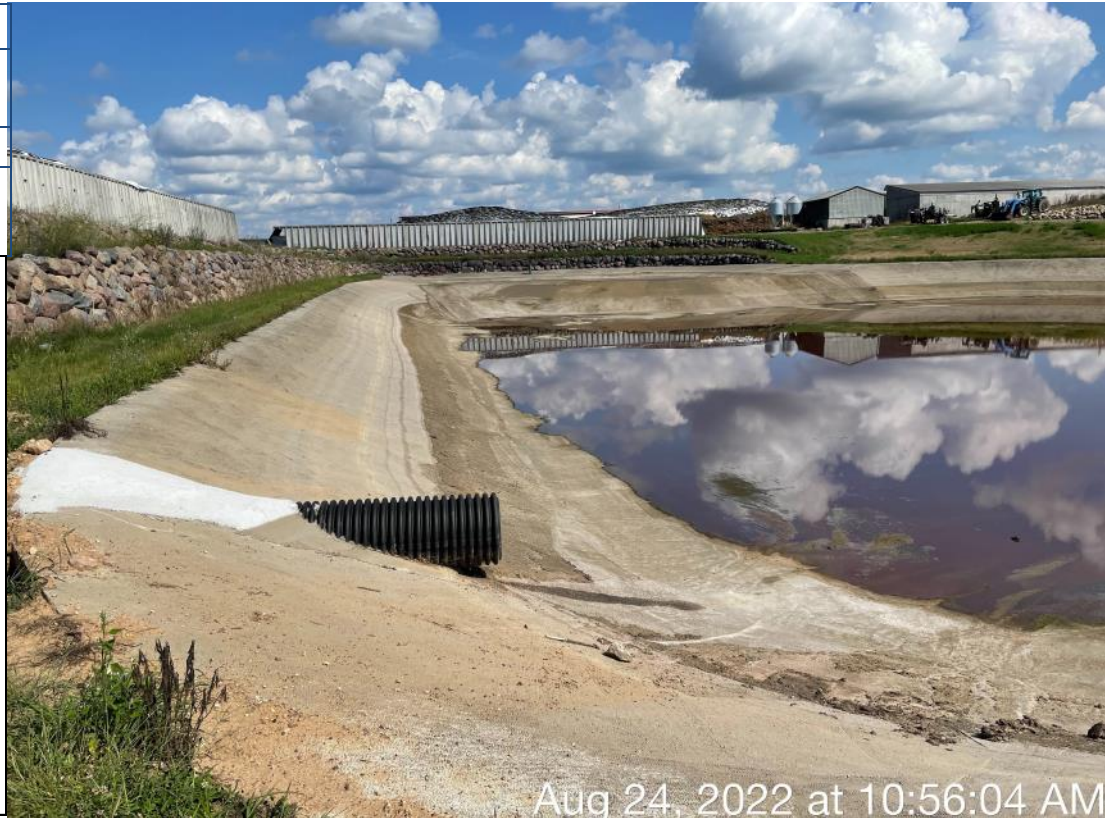
Photo #:	3278
Date/Time of Photo:	8/24/2022 10:56
Photo By:	Brian Hanson
Photo Location:	WSF #5 Leachate

Standing at the southwest corner of WSF #5 looking north: View of outlet pipe from 2021 & 2022 feed storage area expansions.

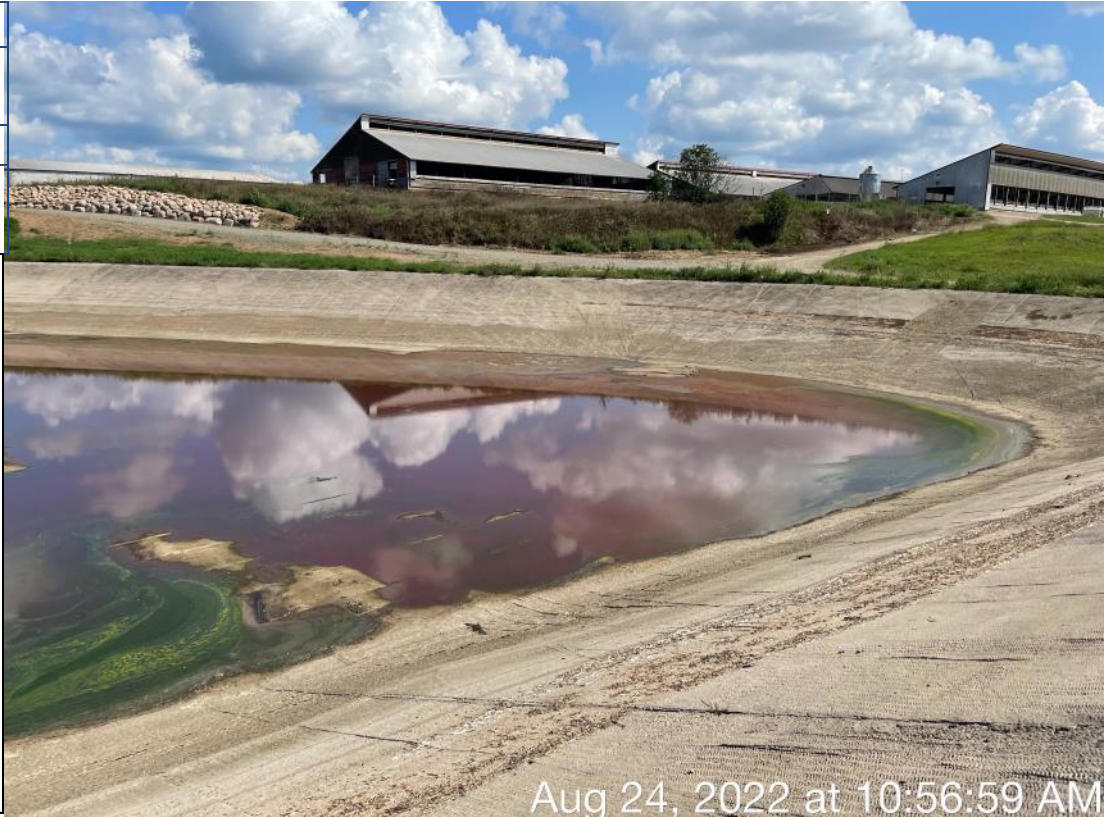
Photo #:	3281
Date/Time of Photo:	8/24/2022 10:56
Photo By:	Brian Hanson
Photo Location:	WSF #5 Leachate
Photo Description:	
Standing on the south side of WSF #5 looking east: View of southeast corner of leachate pond.

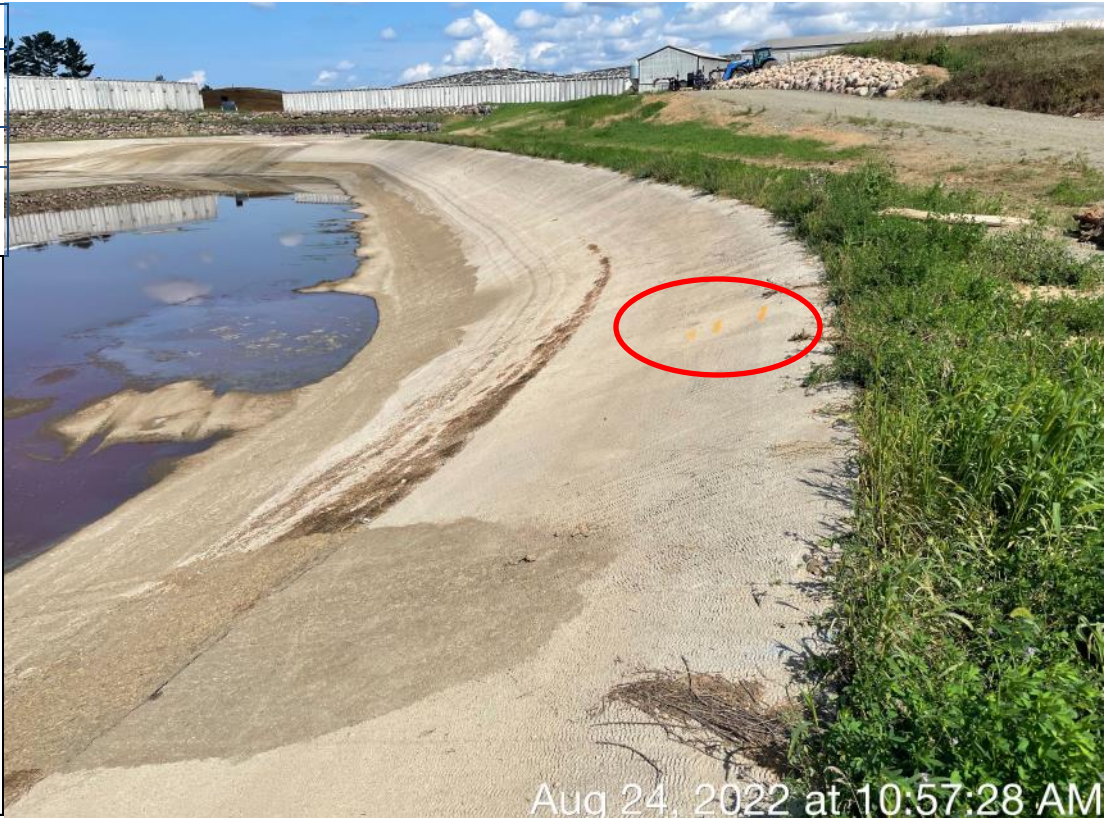
Photo #:	3282
Date/Time of Photo:	8/24/2022 10:57
Photo By:	Brian Hanson
Photo Location:	WSF #5 Leachate
Photo Description:	
Standing on the east side of WSF #5 looking north: View of permanent markers in WSF #5.

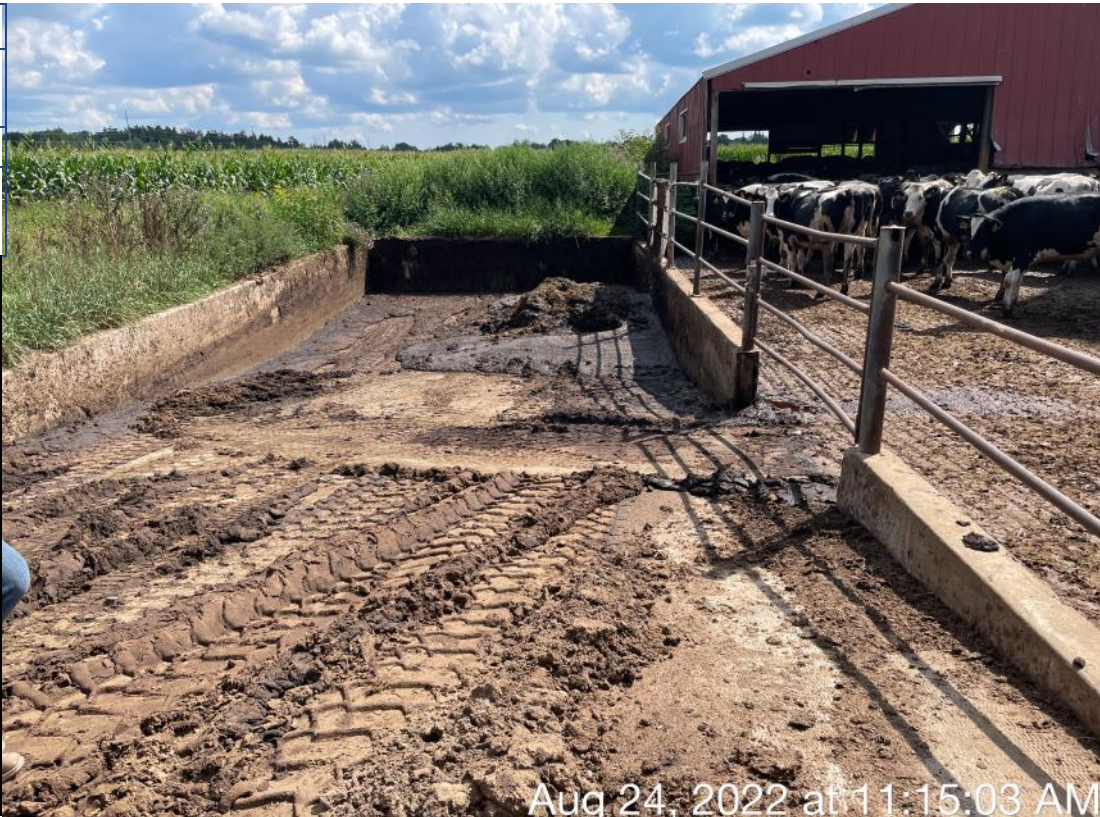
Photo #:	3313
Date/Time of Photo:	8/24/2022 11:15
Photo By:	Brian Hanson
Photo Location:	WSF #6 Pingel Farm
Photo Description:	
<p>Standing on the north side of outdoor lot at Pingel Farm looking east: View of temporary waste storage and runoff collection area for outdoor lot.</p>

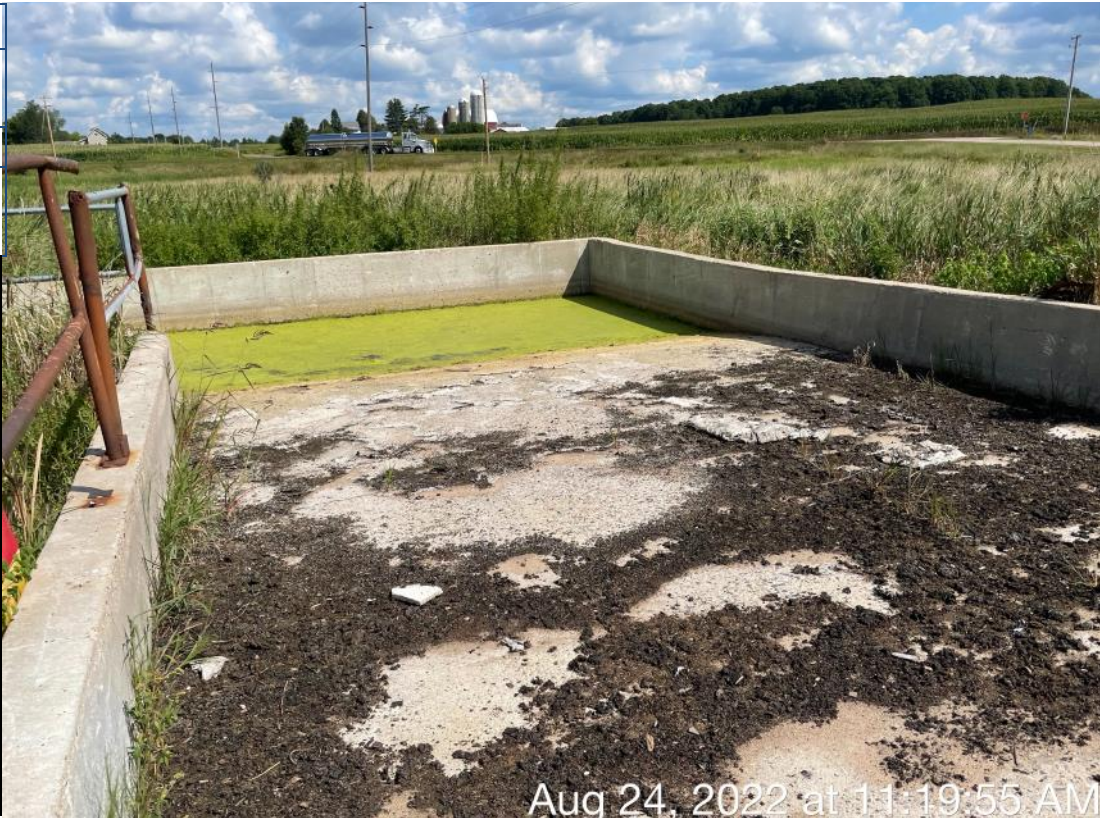
Photo #:	3320
Date/Time of Photo:	8/24/2022 11:19
Photo By:	Brian Hanson
Photo Location:	WSF #7 Home Farm
Photo Description:	
<p>Standing on the east end of outdoor lot at Home Farm looking north: View of temporary waste storage facility & runoff collection area for outdoor lot. Lot & storage area no longer in use.</p>

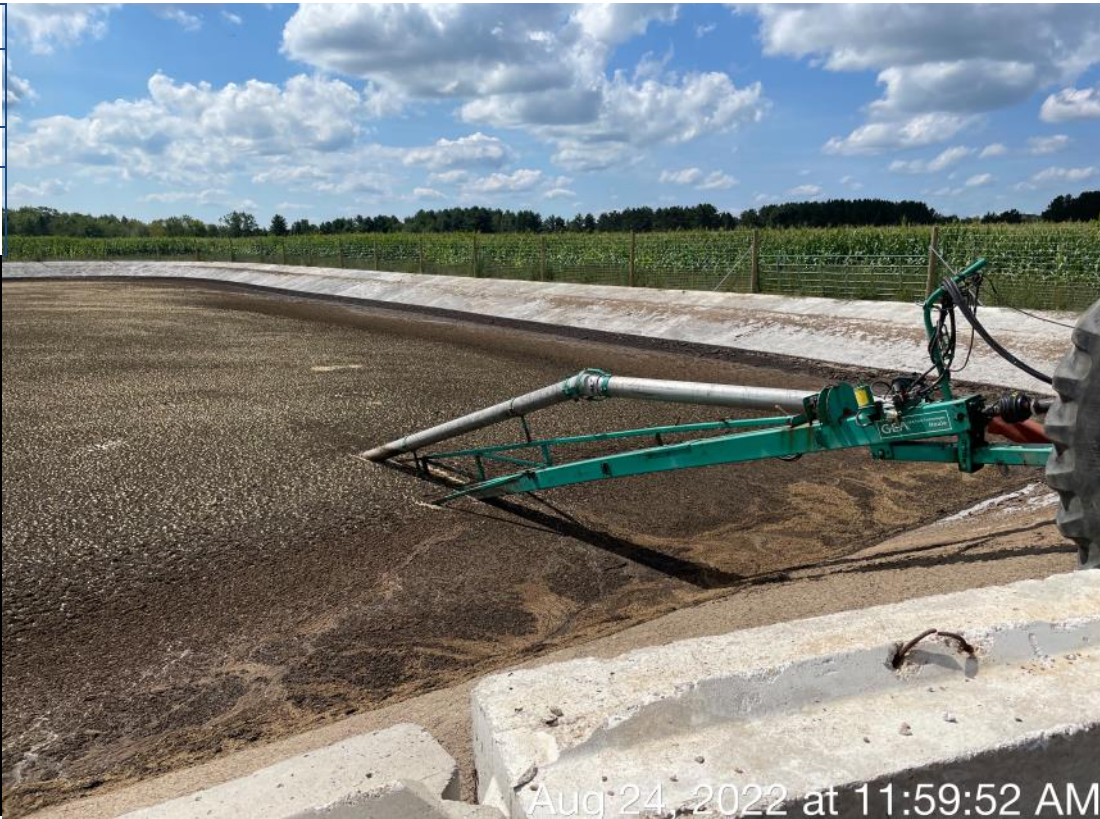
Photo #:	3330
Date/Time of Photo:	8/24/2022 11:59
Photo By:	Brian Hanson
Photo Location:	WSF #8 Western Ave
Photo Description:	
<p>Standing on the north side of WSF #8 looking southwest: View of west half of WSF #8.</p>

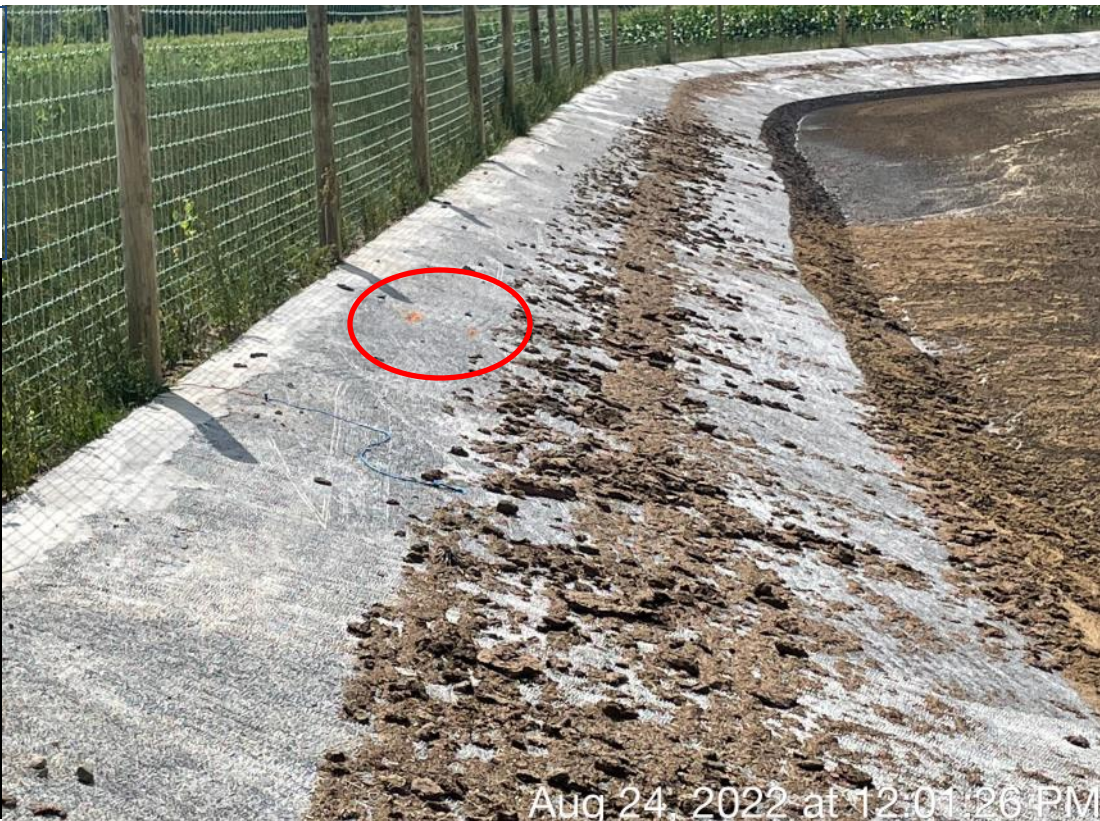
Photo #:	3335
Date/Time of Photo:	8/24/2022 12:01
Photo By:	Brian Hanson
Photo Location:	WSF #8
Photo Description:	
<p>Standing at the northeast corner of WSF #8 looking south: View of permanent markers in WSF #8</p>

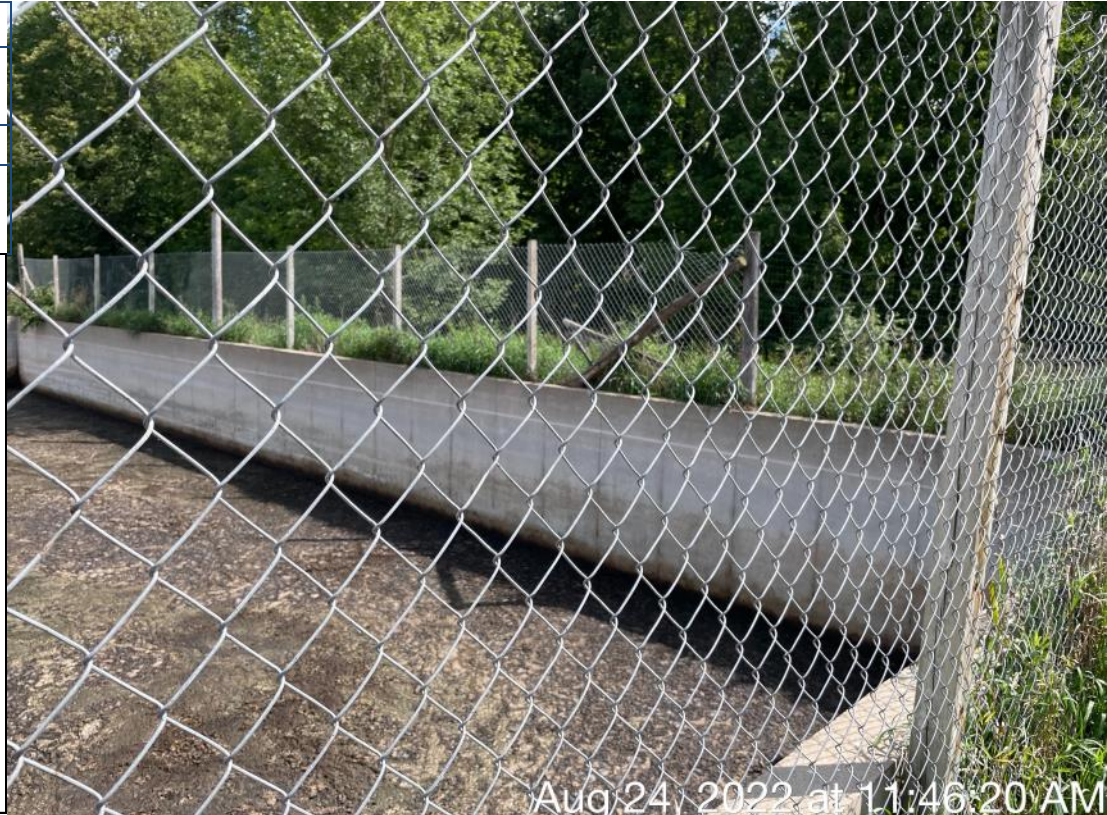
Photo #:	3324
Date/Time of Photo:	8/24/2022 11:46
Photo By:	Brian Hanson
Photo Location:	WSF #9 Korbisch Pit

Standing on the south side of WSF #9 looking northeast:
View of east side of WSF #9

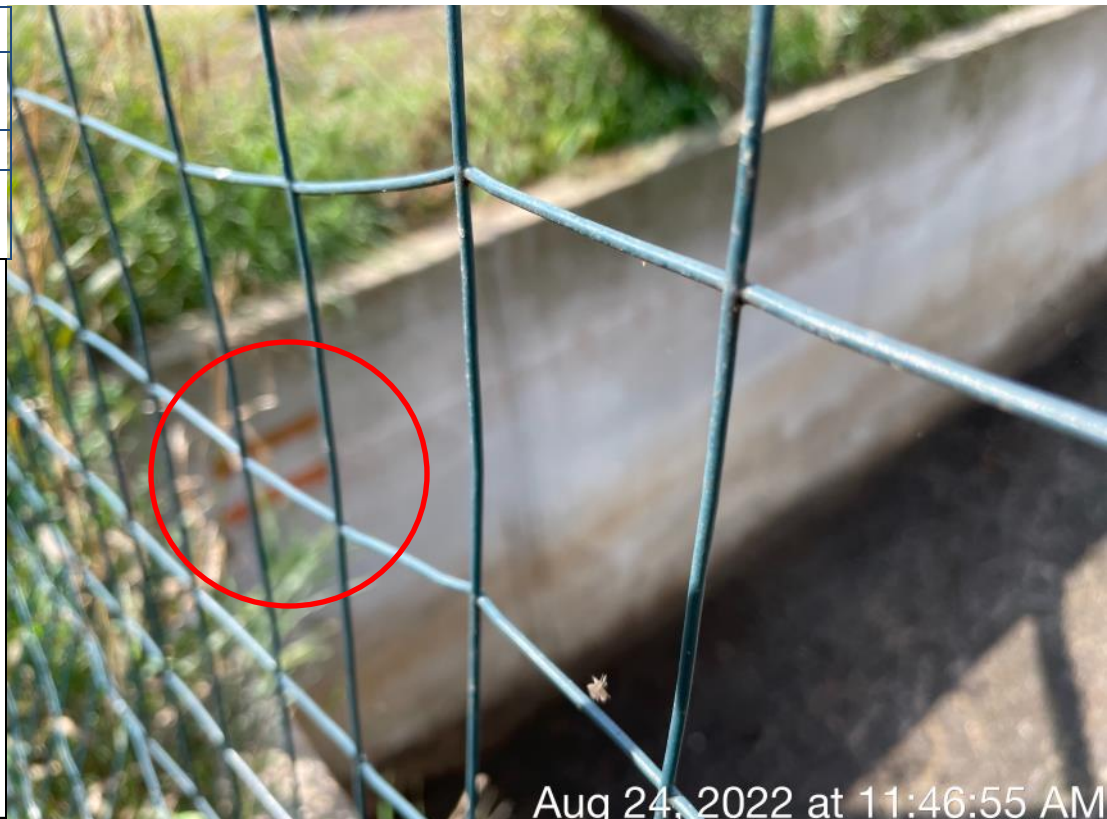
Photo #:	3329
Date/Time of Photo:	8/24/2022 11:46
Photo By:	Brian Hanson
Photo Location:	WSF #9 Korbisch Pit

Standing on the east side of WSF #9 looking southwest:
View of permanent markers in WSF #9.

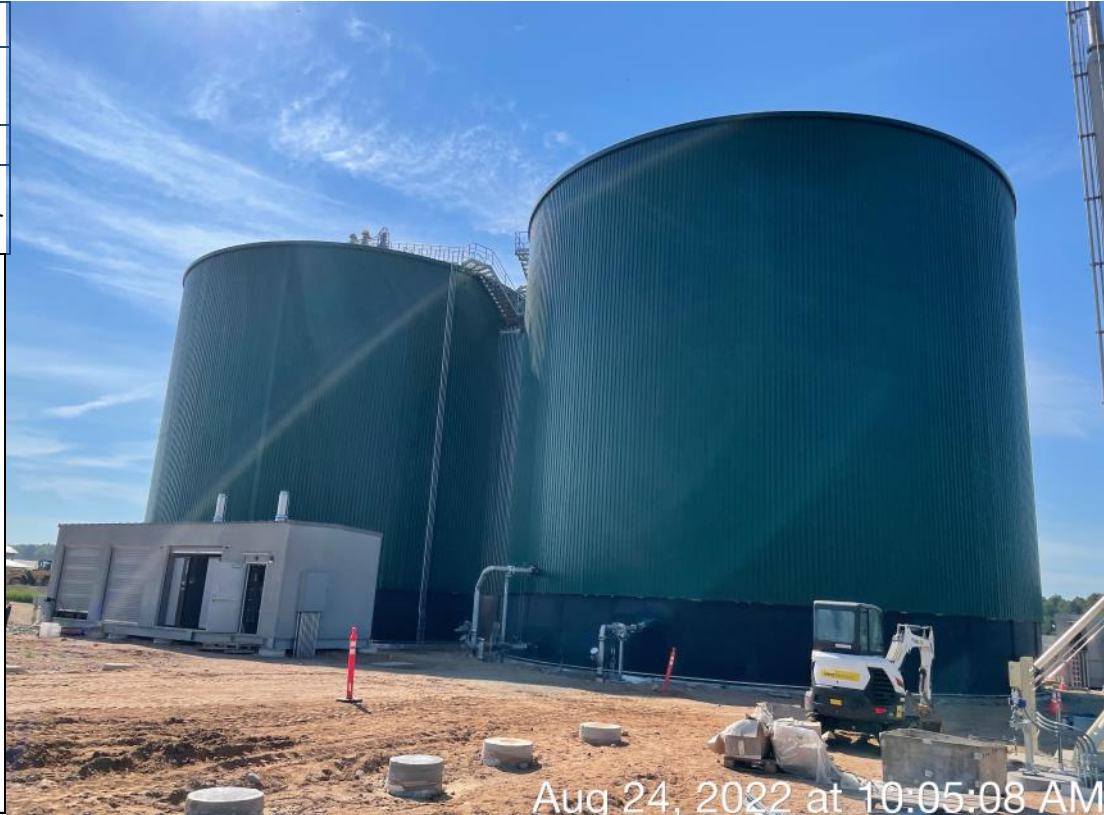
Photo #:	3173
Date/Time of Photo:	8/24/2022 10:05
Photo By:	Brian Hanson
Photo Location:	Main Dairy North—Digester

Standing on the north side of digesters looking south: View of newly constructed digesters. 1st digester was undergoing initial filling and startup at time of inspection.

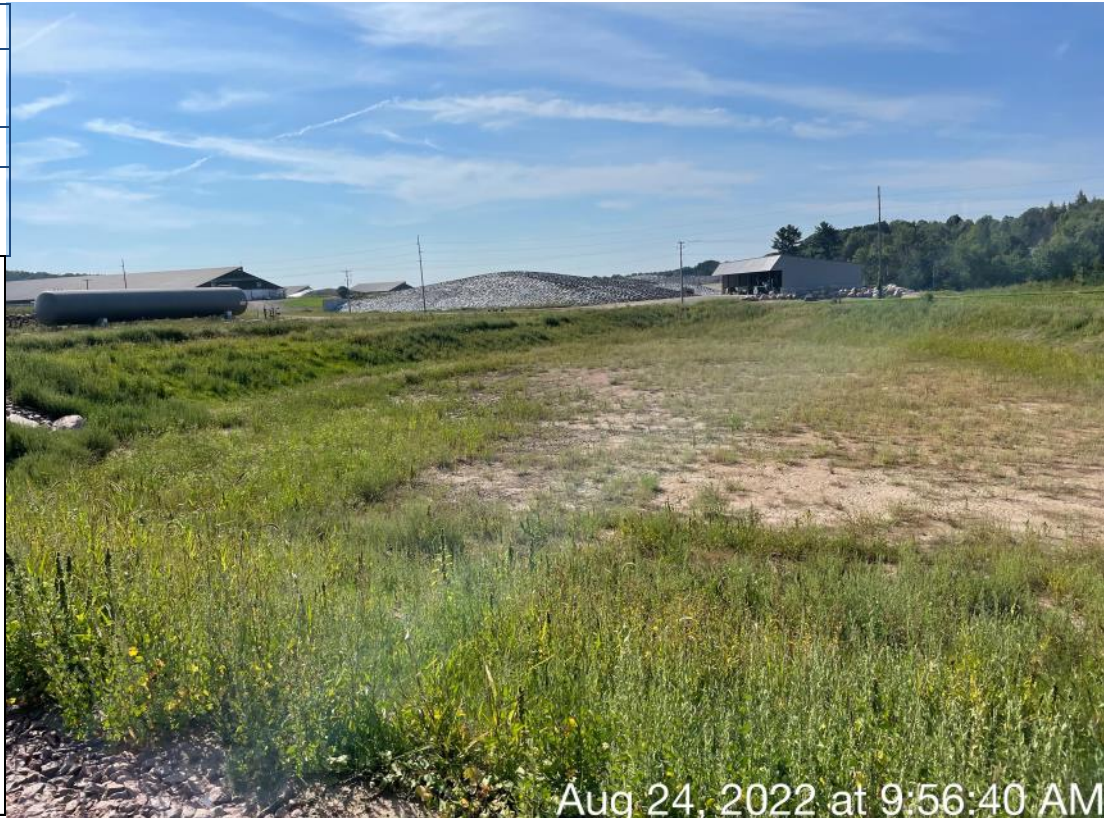
Photo #:	3158
Date/Time of Photo:	8/24/2022 09:56
Photo By:	Brian Hanson
Photo Location:	Main Dairy North-Digester

Standing on the south side of digesters looking south: View of stormwater pond directly south of digesters. Area also designed to be utilized as emergency collection area in case of digester failure.

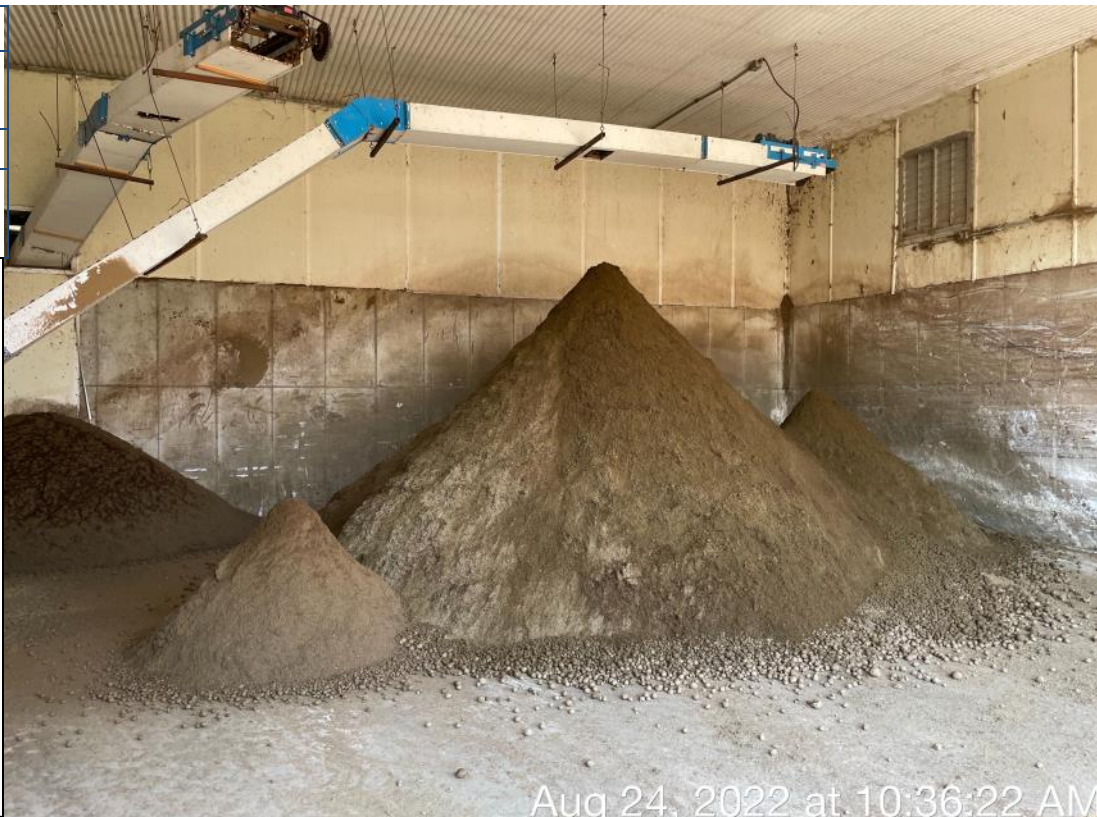
Photo #:	3216
Date/Time of Photo:	8/24/2022 10:36
Photo By:	Brian Hanson
Photo Location:	Main Dairy South-Solids

Standing on the east side of solids separation building looking west: View of bedding solids stacking area on the south side of the road. Solids used to bed freestall barns.

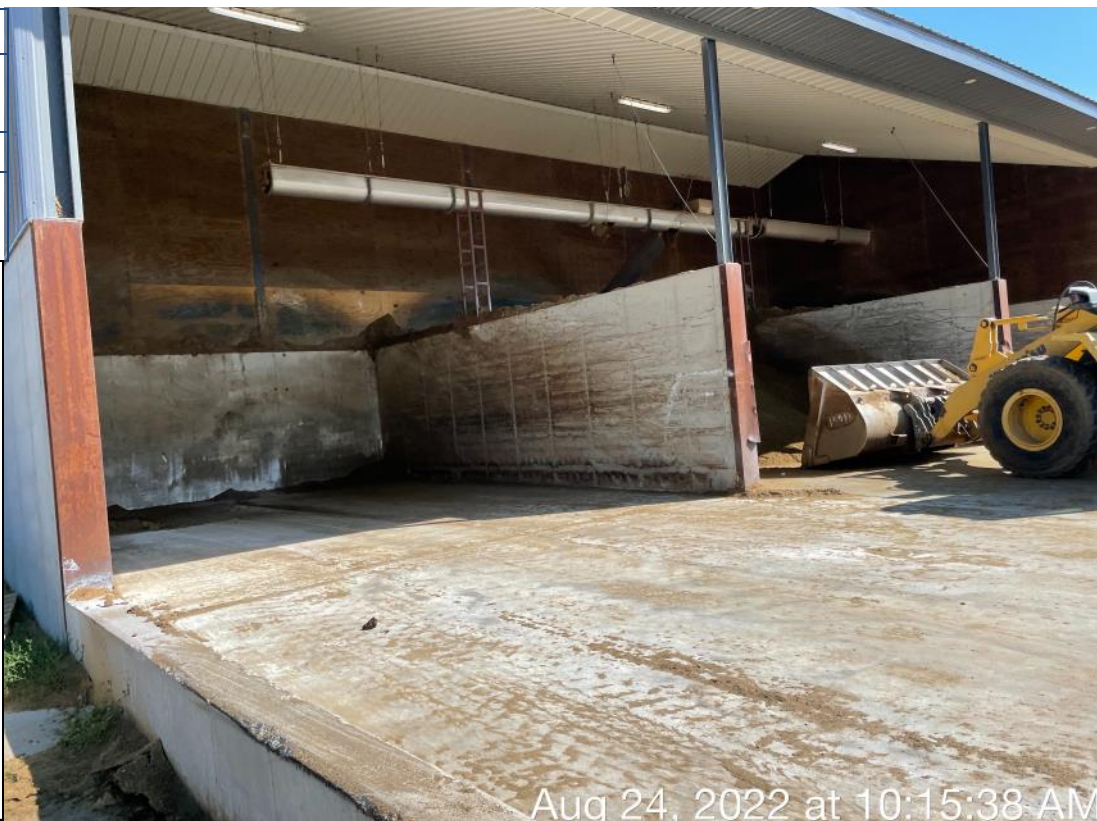
Photo #:	3186
Date/Time of Photo:	8/24/2022 10:15
Photo By:	Brian Hanson
Photo Location:	Main Dairy North-Solids

Standing on the west side of solids separation building looking northeast: View of bedding solids stacking area on the north side of the road. Solids used to bed freestall barns.

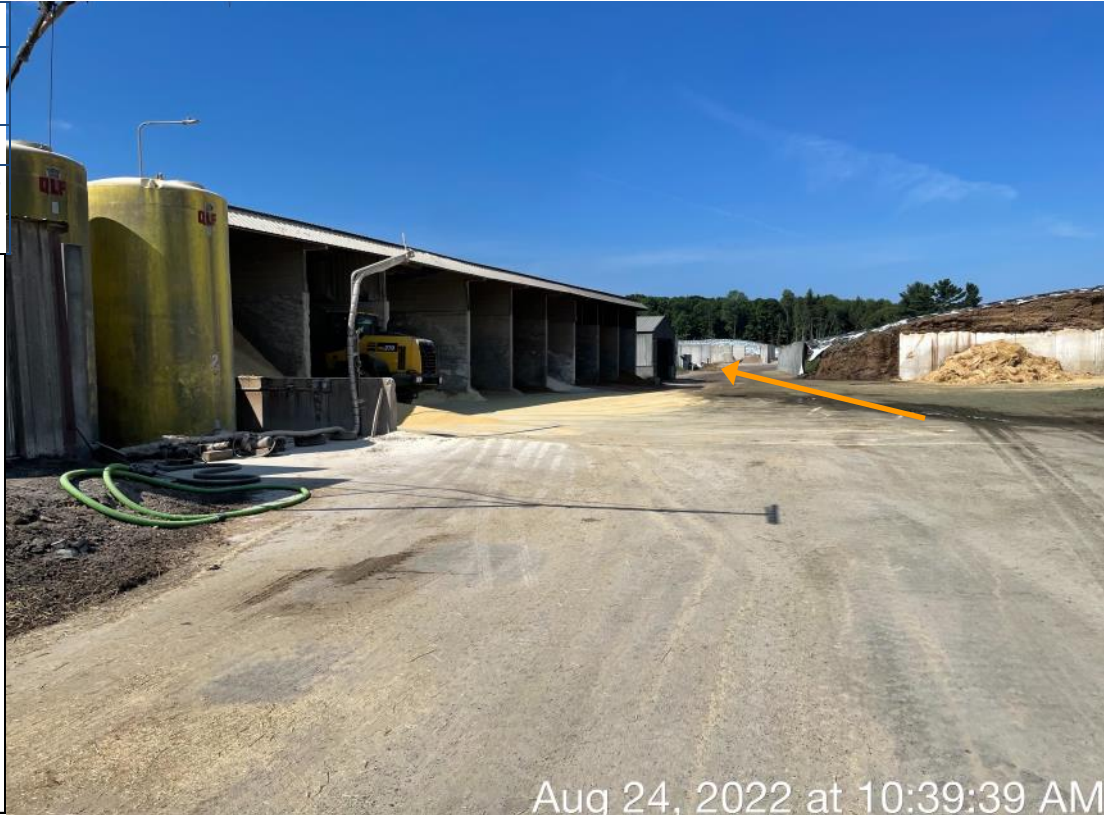
Standing on the east side of the bunkers looking west: View of original commodity shed and apron area for bunkers. Arrows indicate direction of runoff flow.

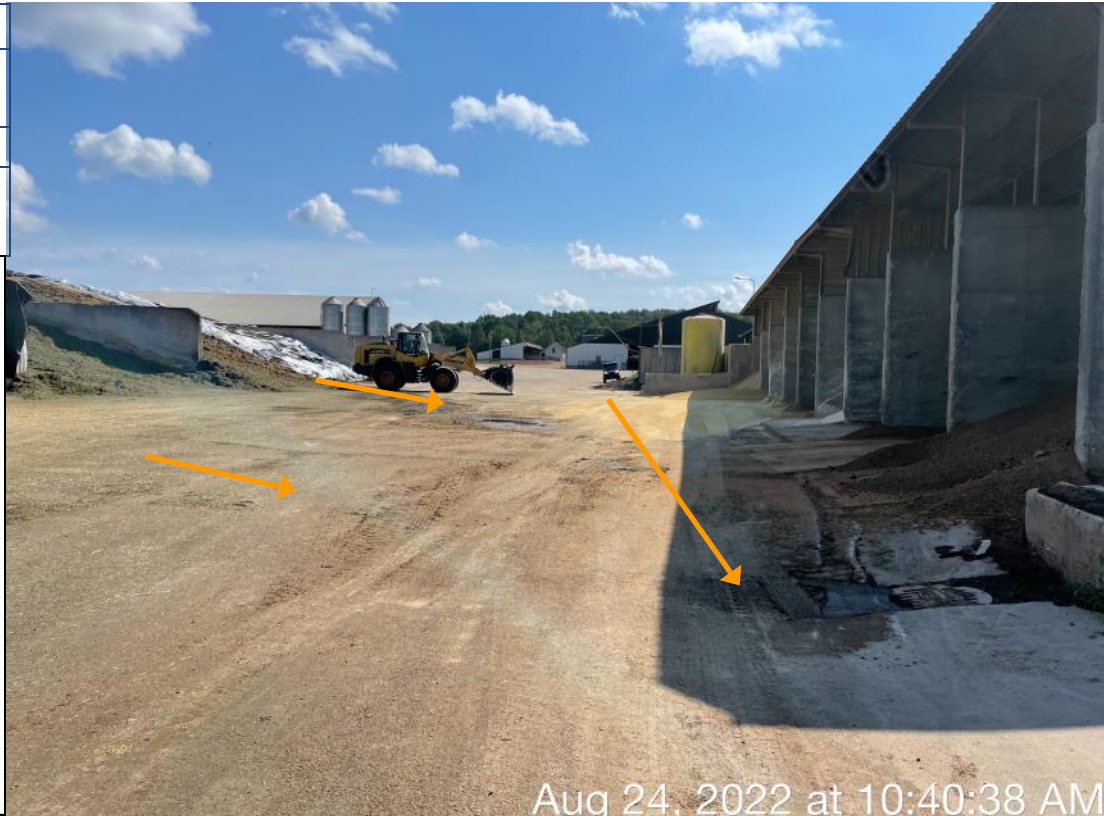
Photo #:	3225
Date/Time of Photo:	8/24/2022 10:40
Photo By:	Brian Hanson
Photo Location:	Feed Storage Bunkers

Standing at the southwest corner of bunkers looking east: Alternate view of commodity shed & bunker apron. Arrows indicate direction of runoff flow.

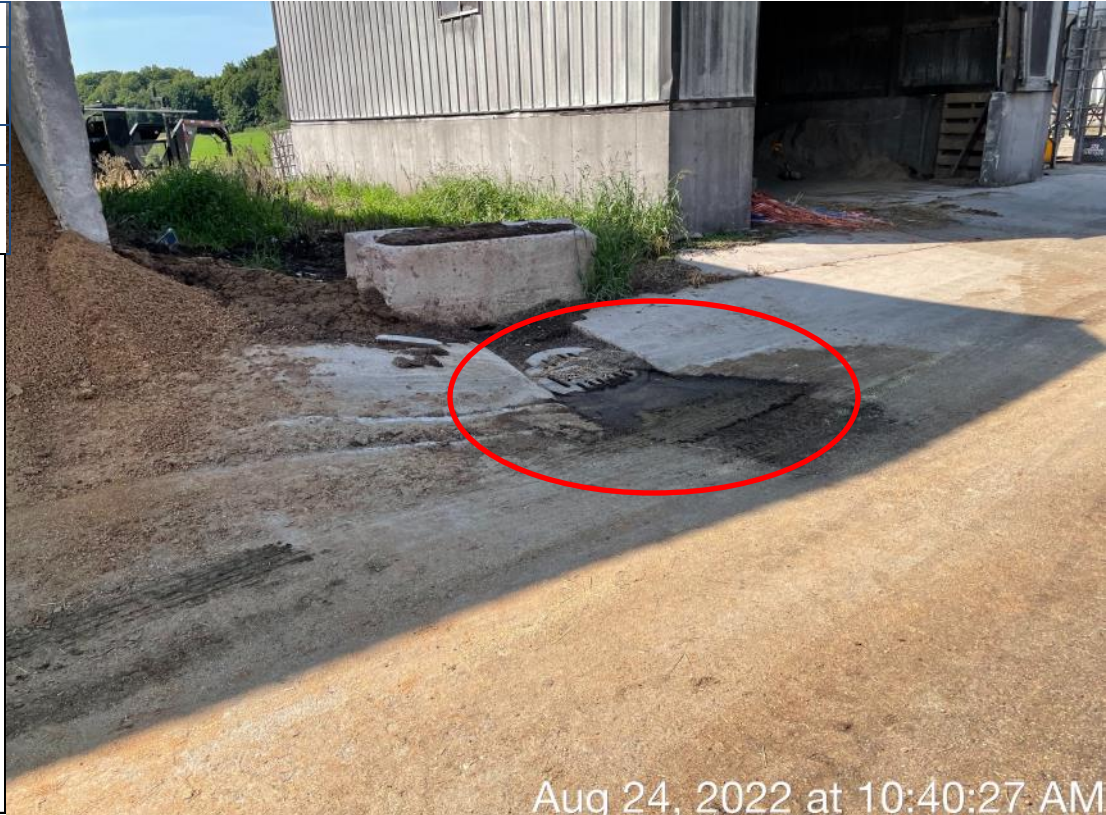
Photo #:	3223
Date/Time of Photo:	8/24/2022 10:40
Photo By:	Brian Hanson
Photo Location:	Feed Storage-Bunkers

Standing at the southwest corner of the bunkers looking southwest: View of grated inlet used to collect runoff from bunkers and commodity shed.

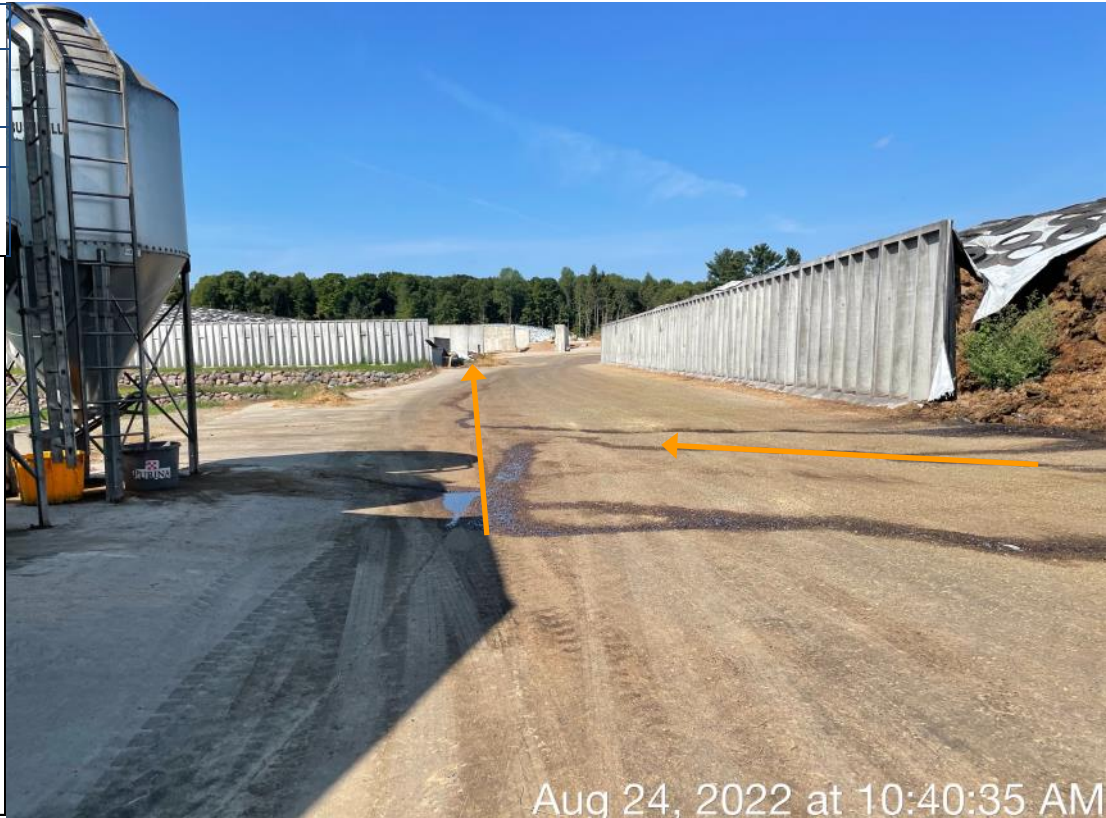
Photo #:	3224
Date/Time of Photo:	8/24/2022 10:40
Photo By:	Brian Hanson
Photo Location:	Feed Storage-Asphalt Pad

Standing at the southeast corner of asphalt pad: View of concrete apron on south side of asphalt pad used to convey runoff to WSF #5. Arrows indicate direction of runoff flow.

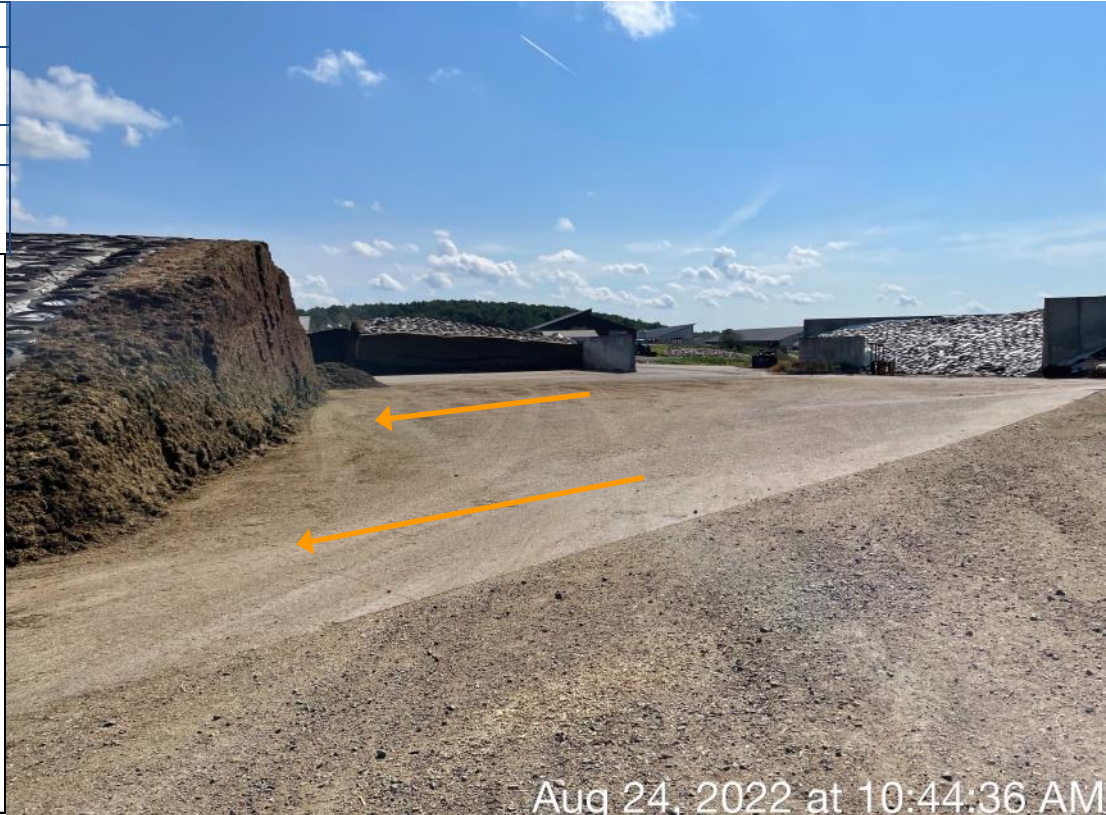
Photo #:	3243
Date/Time of Photo:	8/24/2022 10:44
Photo By:	Brian Hanson
Photo Location:	Feed Storage- 2011 Addition
Photo Description:	
<p>Standing on the west side of feedpad looking southeast: View of west edge of Feedpad. Arrows indicate direction of runoff flow.</p>
