Permit Fact Sheet

Permit Number:	WI-0059544-05-0
Permittee Name:	Matsche Farm Inc
Address:	N9035 River Rd
City/State/Zip:	Birnamwood WI 54414
Discharge Location:	Main Dairy : N9035 River Road & W16550 County Rd N, Birnamwood, WI 54414 ,East 1/2 of Section 7 T28N R12E Pingel Farm: W16233 County Rd N, Birnamwood, WI 54414, NW 1/4 of SE 1/4 Section 8 T28N R12E Korbisch Pit: W18102 Hill Road, Birnamwood, WI, 54414, SW 1/4 of SW 1/4 Section 22 T29N R11E Western Ave Pit: W19069 Western Ave, Birnamwood, WI, 54414, SW 1/4 of SE 1/4 Section 18 T28N R11E Cherry Drive Pit: 216434 Black Cherry Drive, Eland WI 54427 SE ¼ of SE ¼ Section 10 T27N R 10E Sugarbush Pit: Sugar Bush Road, Birnamwood, WI, 54414, SW ¼ of SE ¼ Section 27 T29N R11E
Receiving Water:	the North Branch Embarrass River & unnamed tributaries within the North Branch Embarrass River Watershed, Railroad Creek & Unnamed tributaries to the South Branch Embarrass River Watershed, and groundwaters of the state

On Wednesday August 24th Hanson & Kaczorowski met with Matsche, Matsche & Carlsen 09:00 at Matsche Farms Inc. site to conduct a permit reissuance walkover inspection. All five sites were inspected. No liquid precipitation had

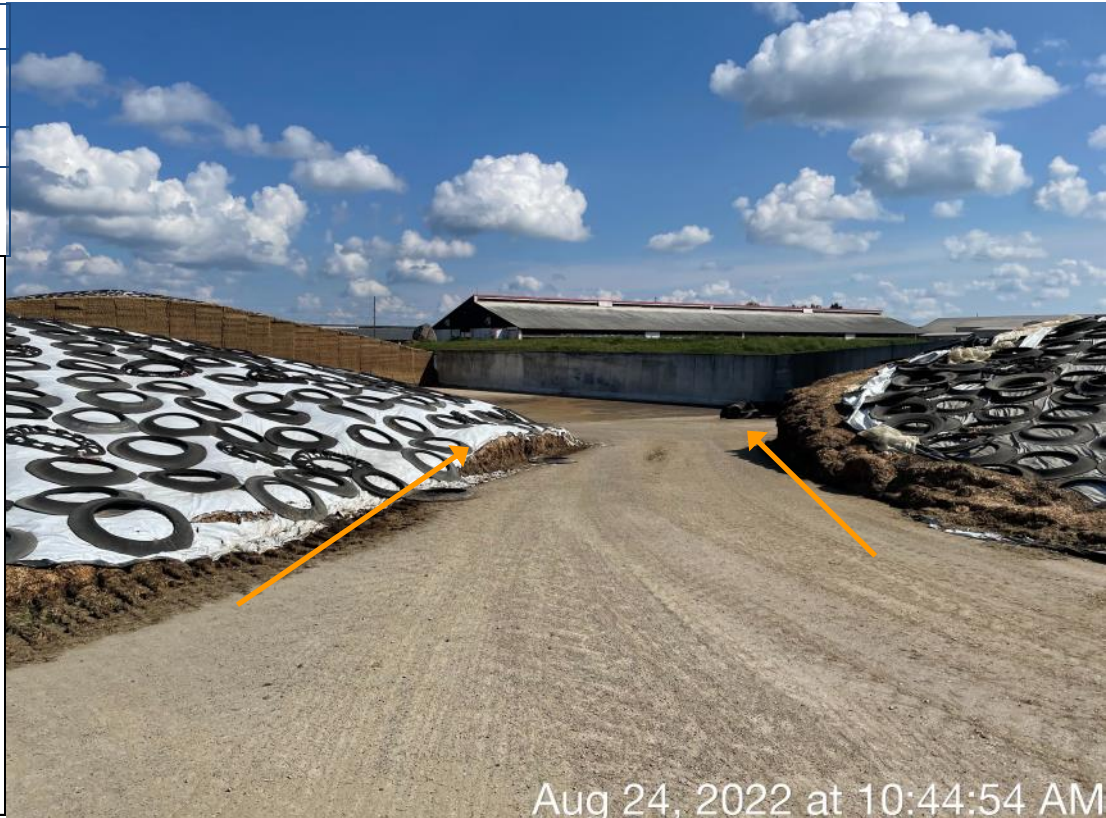
Photo #:	3245
Date/Time of Photo:	8/24/2022 10:44
Photo By:	Brian Hanson
Photo Location:	Feed Storage- 2016 Addition
Photo Description:	
<p>Standing at the southwest corner of feedpad looking northeast: View of south portion of this feed storage area. Arrows indicate direction of runoff flow.</p>

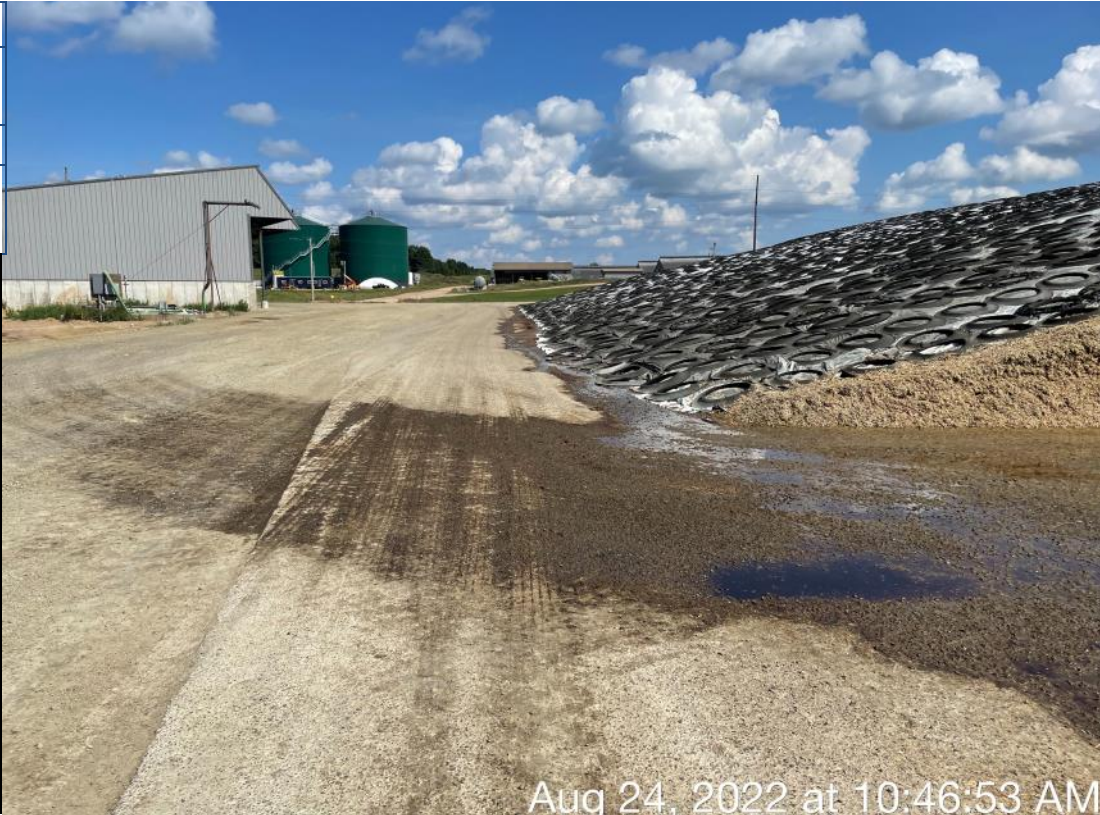
Photo #:	3250
Date/Time of Photo:	8/24/2022 10:46
Photo By:	Brian Hanson
Photo Location:	Feed Storage 2016 Addition
Photo Description:	
Standing on the west side of feedpad looking north: View of western edge of feedpad.

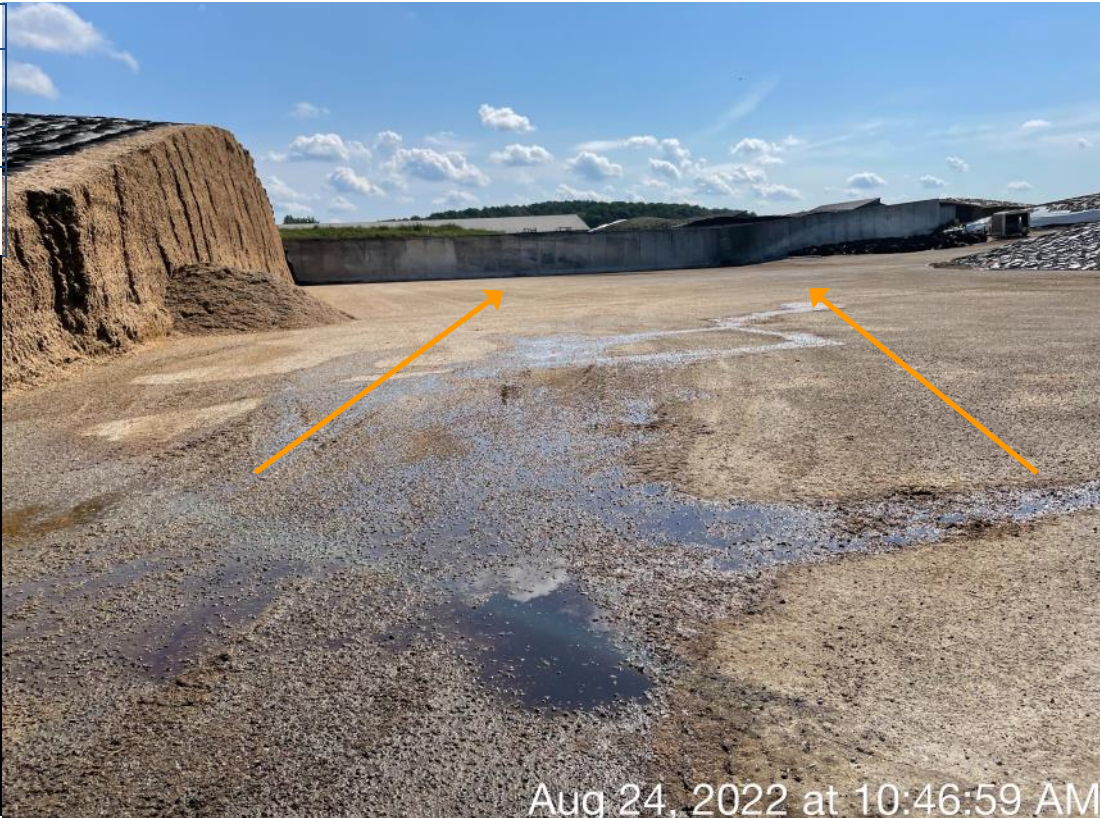
Photo #:	3251
Date/Time of Photo:	8/24/2022 10:46
Photo By:	Brian Hanson
Photo Location:	Feed Storage- 2016 Addition
Photo Description:	
Standing on the west side of feedpad looking east: View of middle section of FSA. Arrows indicate direction of flow.

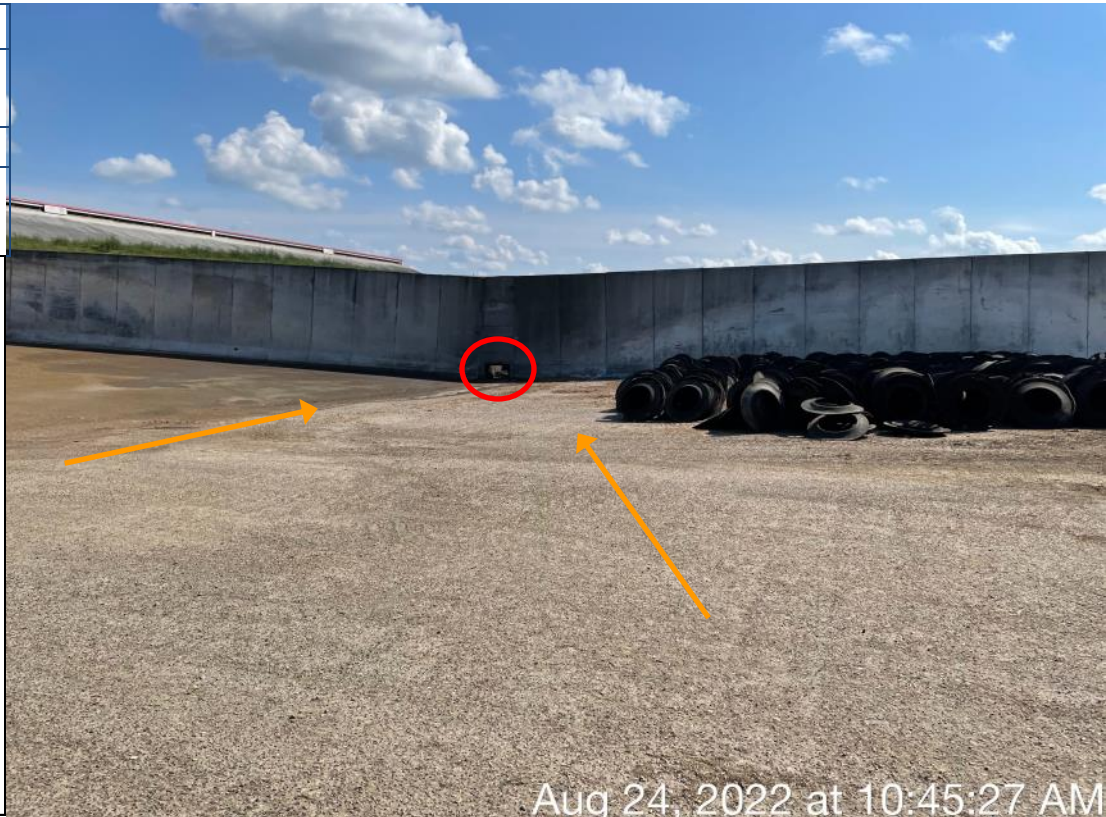
Photo #:	3246
Date/Time of Photo:	8/24/2022 10:45
Photo By:	Brian Hanson
Photo Location:	Feed Storage-2016 Addition
Photo Description:	
<p>Standing in the middle of feedpad looking east: View of runoff collection area for 2016 expansion. Inlet highlighted and arrows indicate direction of flow.</p>

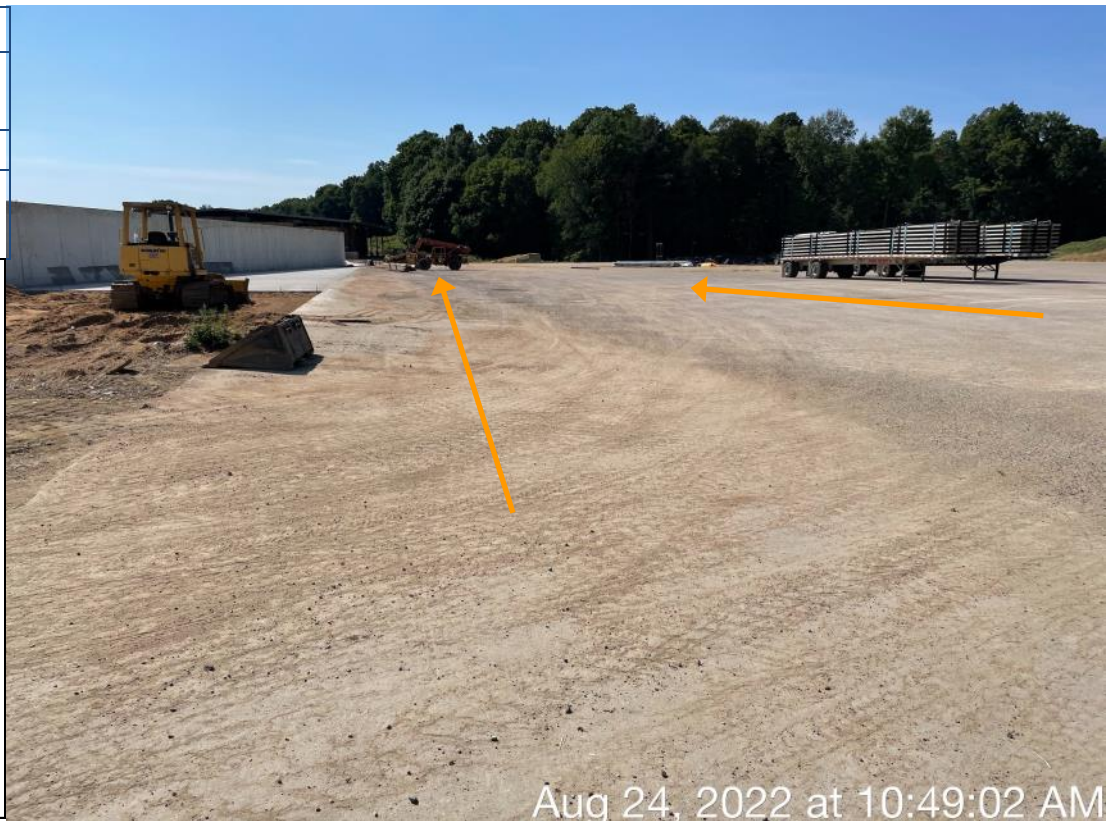
Photo #:	3254
Date/Time of Photo:	8/24/2022 10:49
Photo By:	Brian Hanson
Photo Location:	Feed Storage-2021 Addition
Photo Description:	
<p>Standing at the northeast corner of feedpad looking south: View of eastern edge of FSA. Also notice new commodity she under construction. Arrows indicate direction of runoff flow.</p>

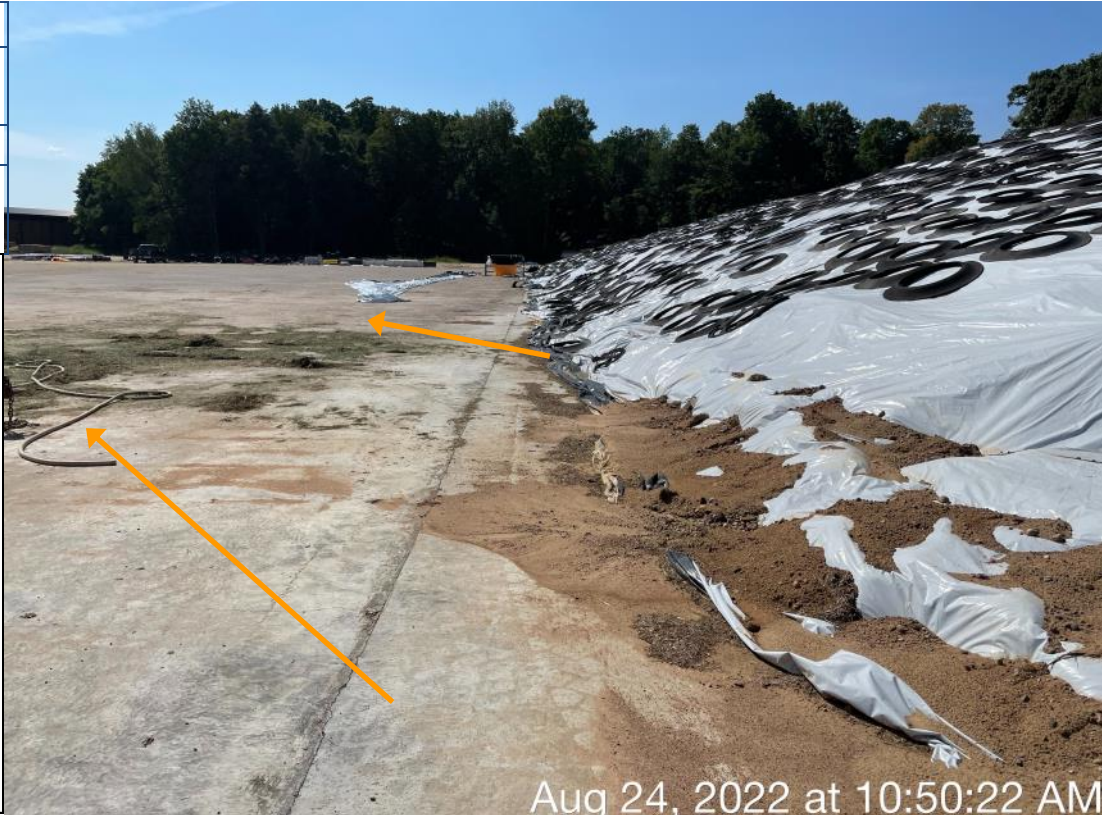
Photo #:	3258
Date/Time of Photo:	8/24/2022 10:50
Photo By:	Brian Hanson
Photo Location:	Feed Storage- 2021 Addition
Photo Description:	
<p>Standin at the northwest corner of feedpad looking south: View of north end of FSA where 2022 addition meets 2021 addition. Arrows indicate direction of runoff flow.</p>

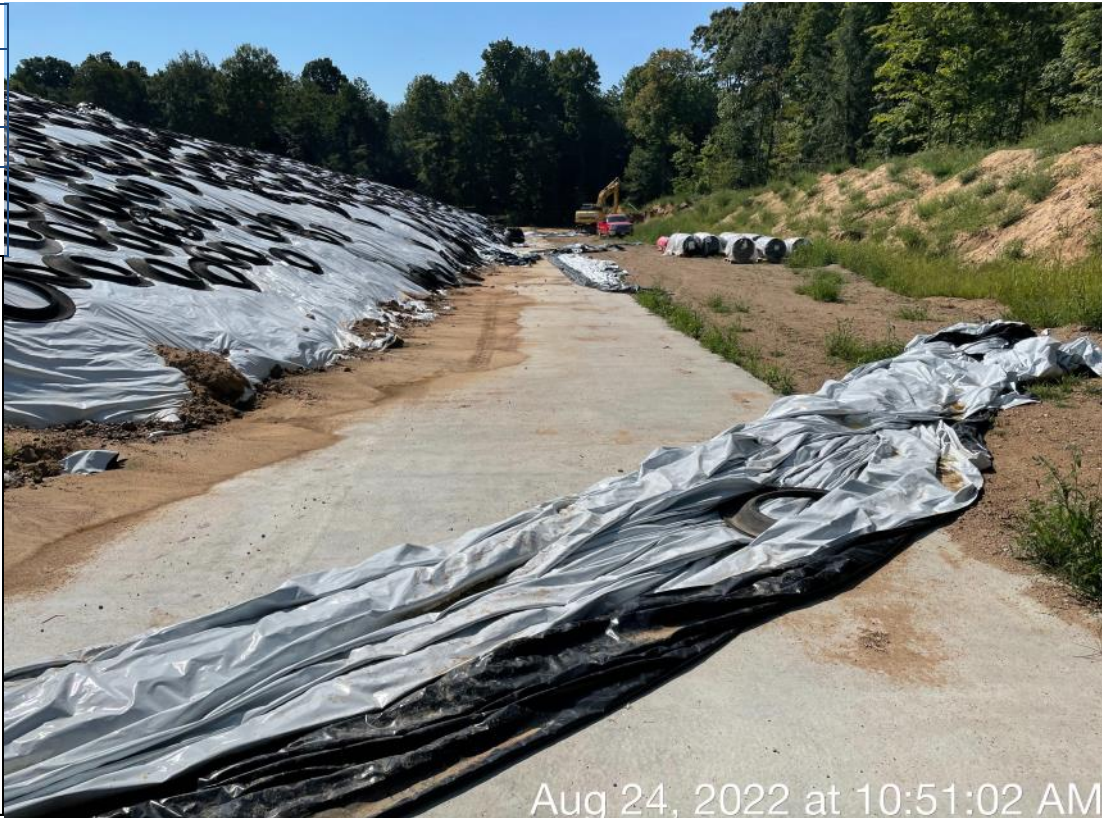
Photo #:	3259
Date/Time of Photo:	8/24/2022 10:51
Photo By:	Brian Hanson
Photo Location:	Feed Storage- 2022 Addition
Photo Description:	
<p>Standing at the northwest corner of feedpad looking south: View of western edge of FSA.</p>

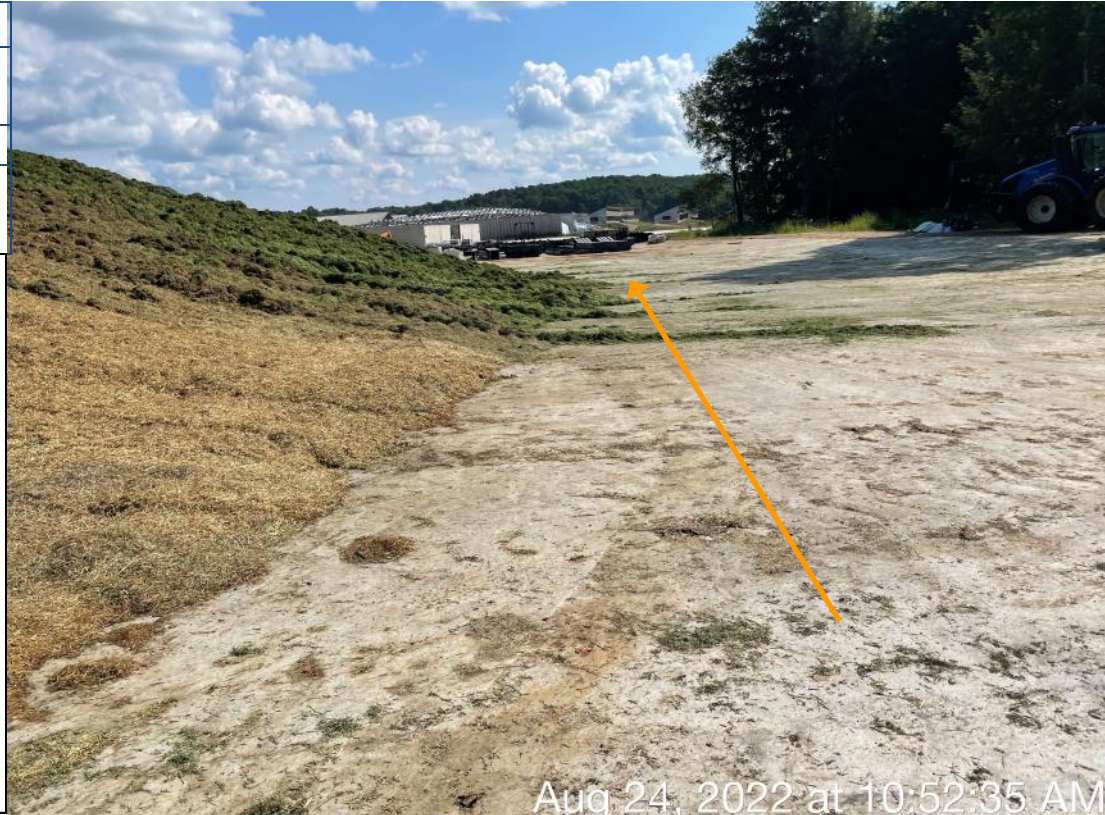
Standing at the southwest corner of feedpad looking east: View of south edge of FSA. Arrows indicate direction of runoff flow.

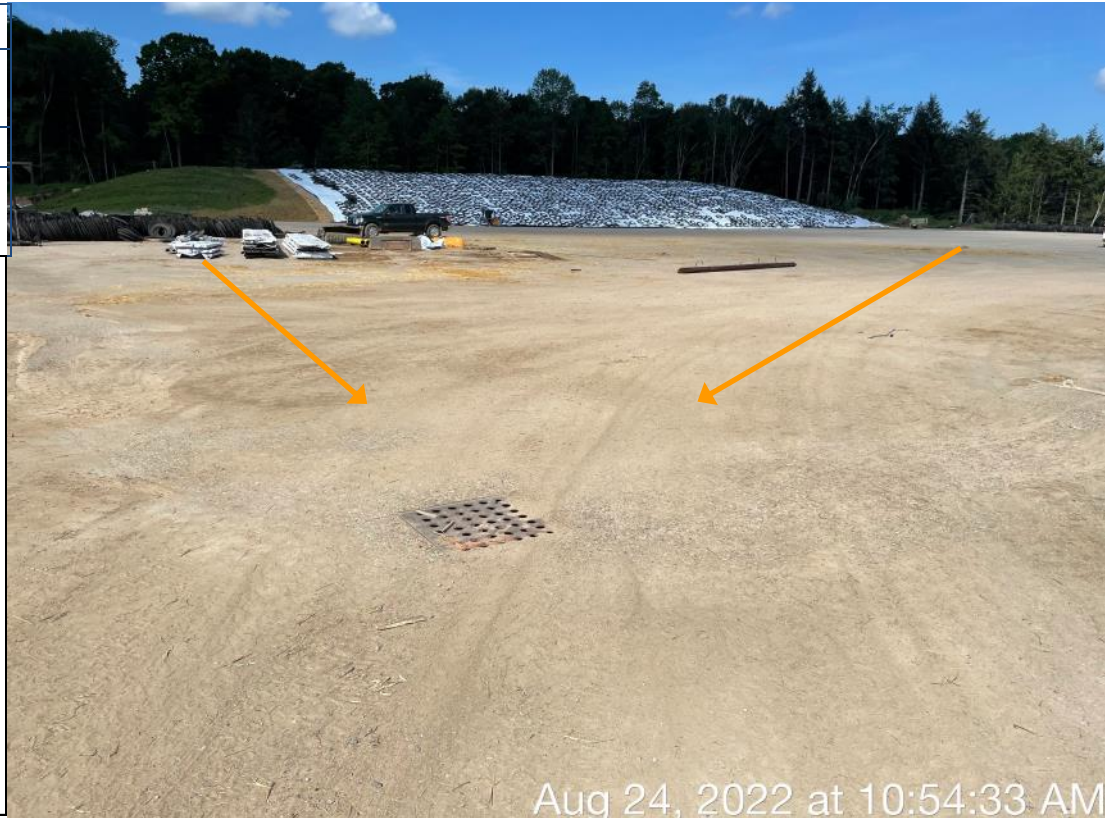
Photo #:	3271
Date/Time of Photo:	8/24/2022 10:54
Photo By:	Brian Hanson
Photo Location:	Feed Storage- 2021 Addition

Standing at southeast corner of feedpad looking northwest: View of runoff collection inlet in southeast corner of feedpad used to collect all runoff from 2021 & 2022 additions. Arrows indicate direction of runoff flow.

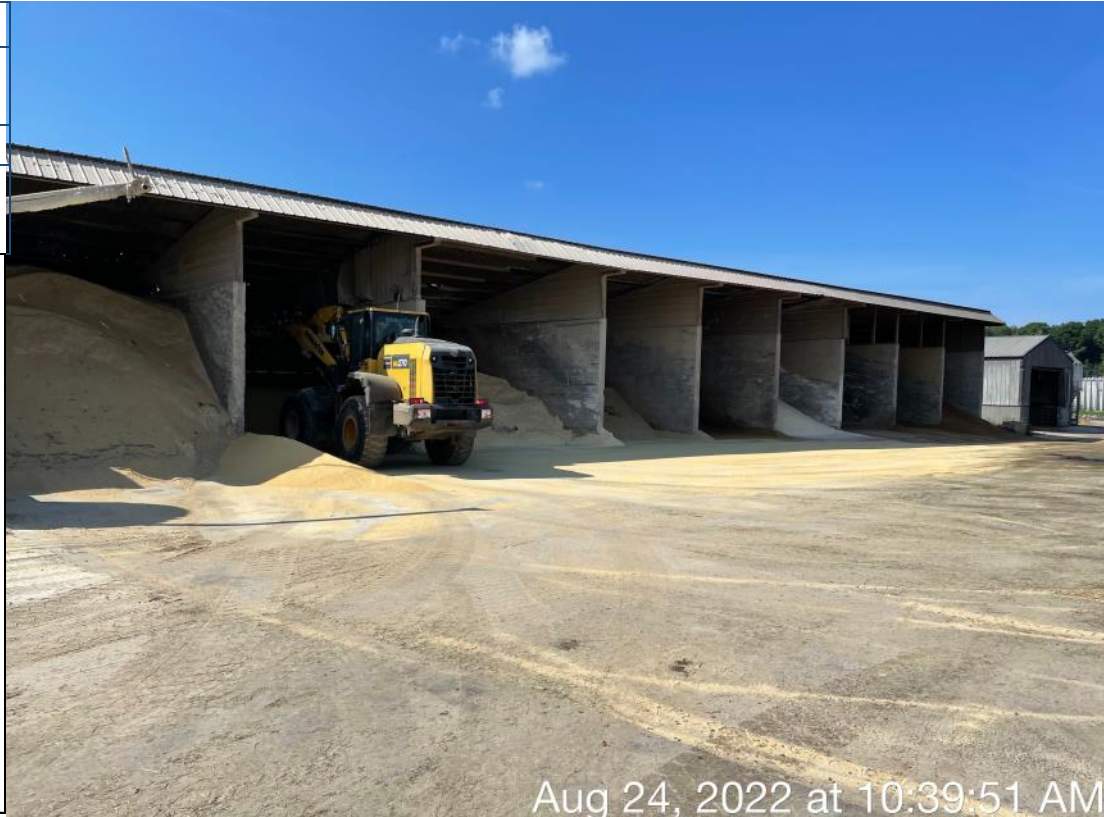
Photo #:	3220
Date/Time of Photo:	8/24/2022 10:39
Photo By:	Brian Hanson
Photo Location:	Feed Storage- Old Commodity

Standing on the south side of bunkers looking south: View of original commodity shed located directly south of bunkers.

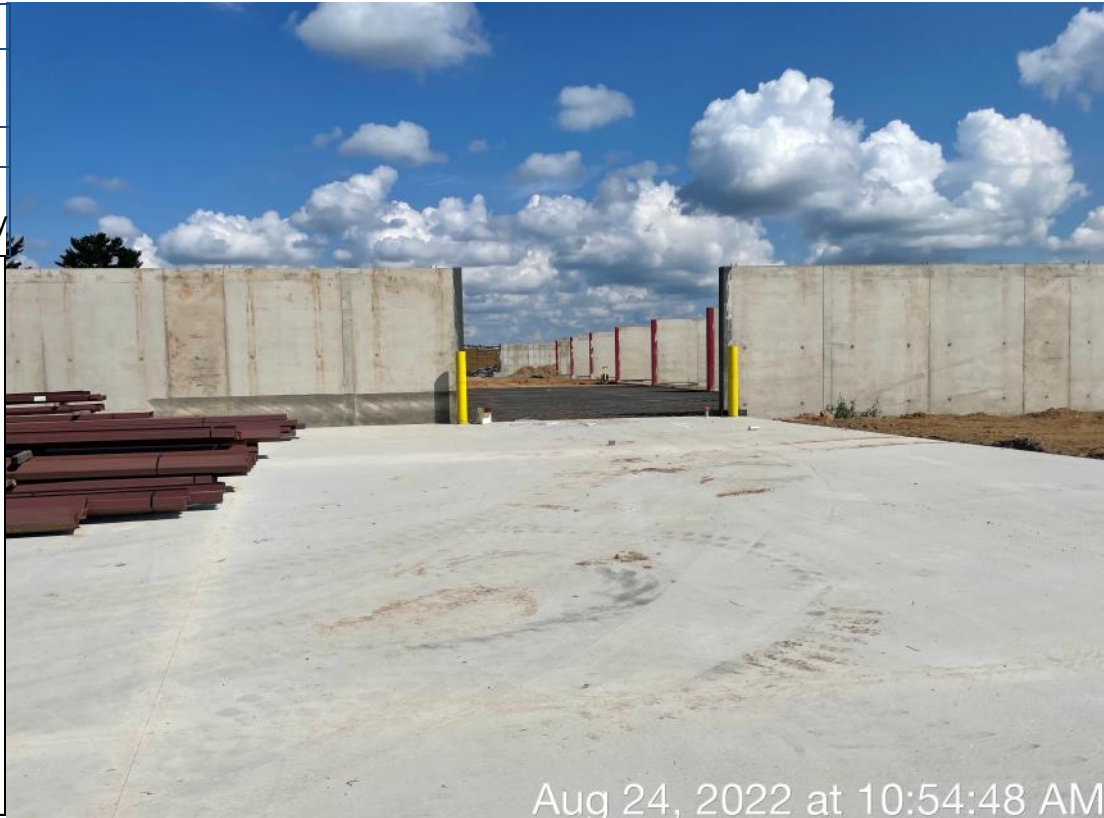
Photo #:	3274
Date/Time of Photo:	8/24/2022 10:54
Photo By:	Brian Hanson
Photo Location:	Feed Storage- New Commodity

Standing at the southeast corner of 2021 addition looking north: View of new commodity shed currently under construction.

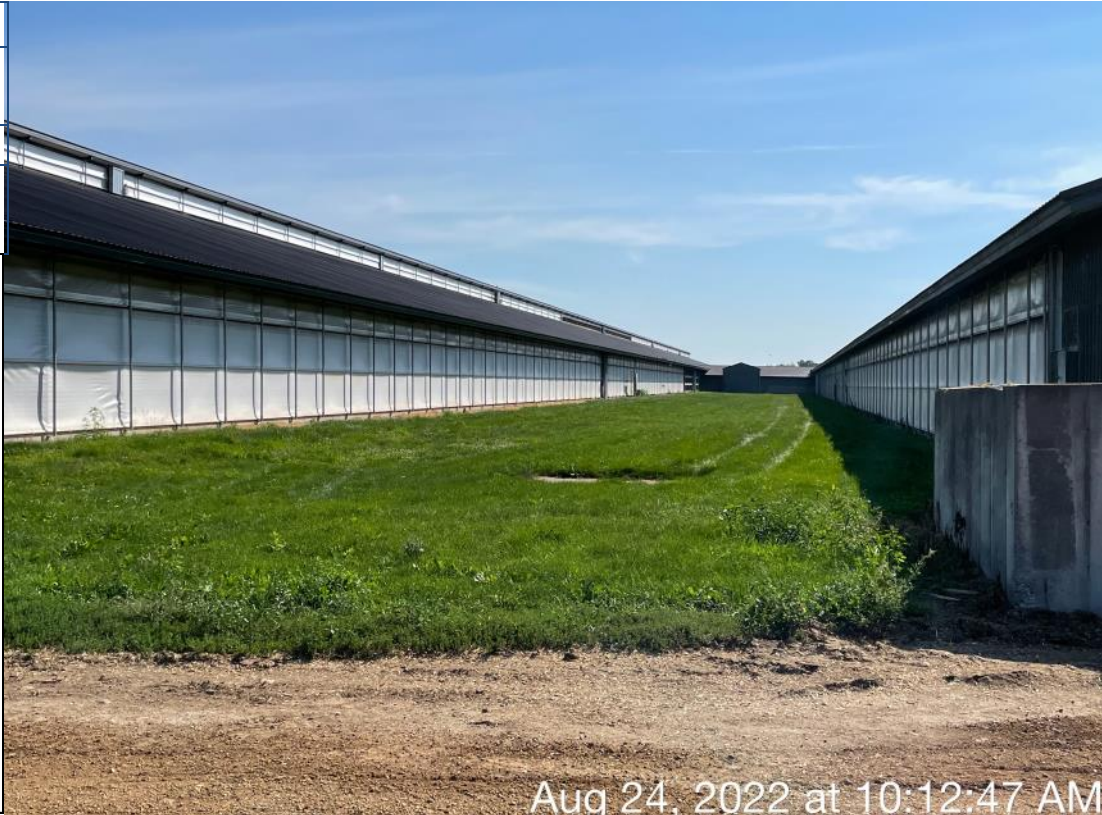
Photo #:	3180
Date/Time of Photo:	8/24/2022 10:12
Photo By:	Brian Hanson
Photo Location:	Main Dairy— North
Photo Description:	
<p>Standing on the west side of freestall barns looking east: View of stormwater runoff area between barns.</p>

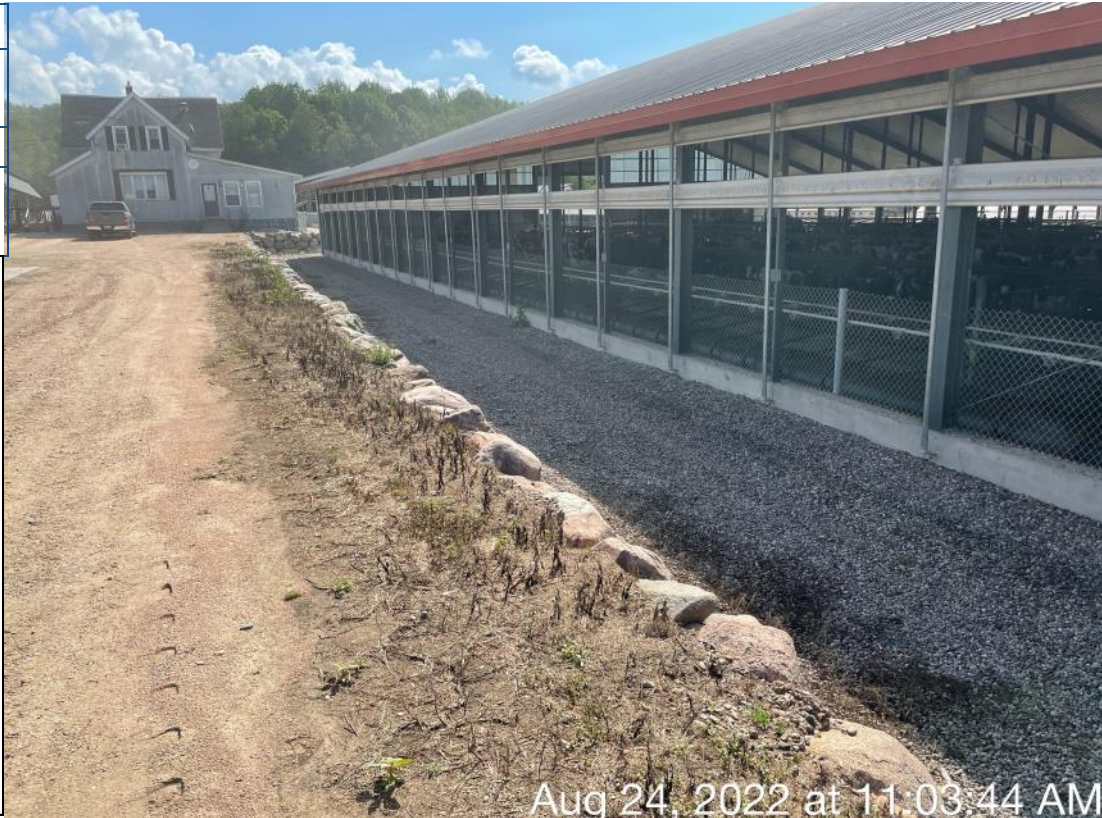
Photo #:	3297
Date/Time of Photo:	8/24/2022 11:03
Photo By:	Brian Hanson
Photo Location:	Main Dairy— South
Photo Description:	
<p>Standing on north side of heifer barn looking east: View of stormwater runoff area on north side of heifer barn.</p>

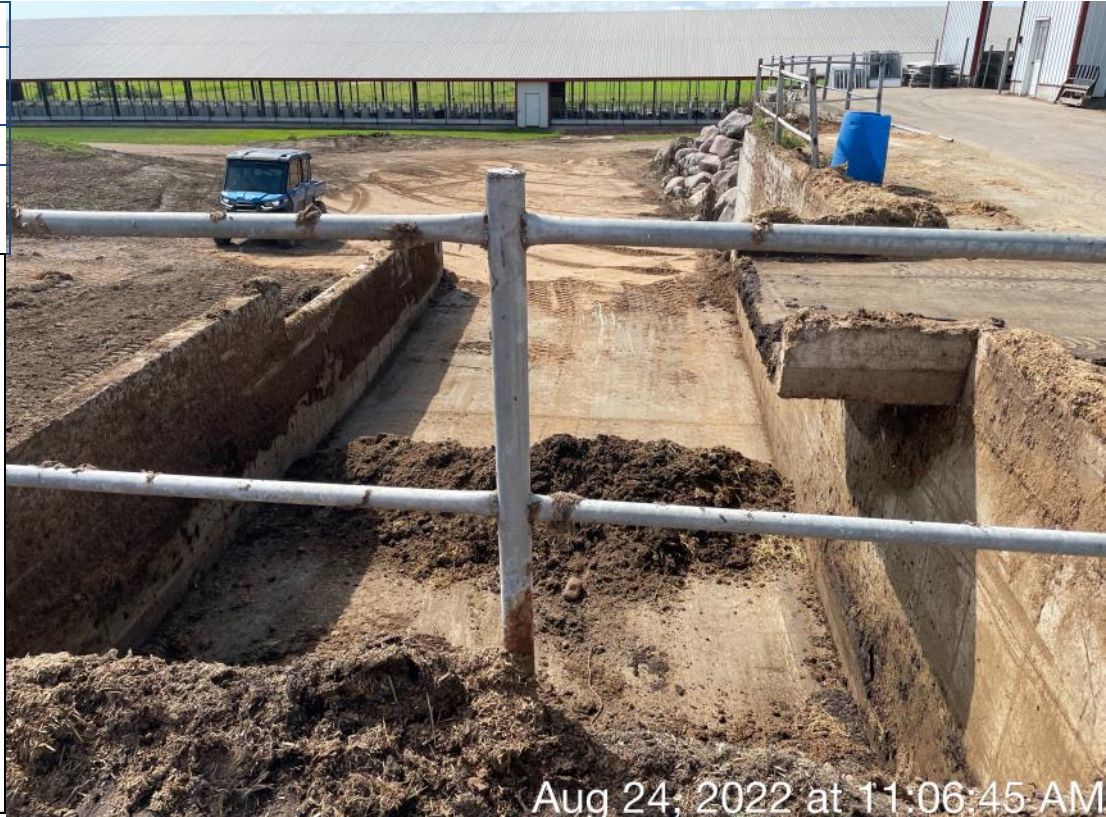
Standing on the east end of heifer barn looking south: View of manure load out area on east end of heifer barn. This area needs to be kept clean to prevent discharges.
