Permit Fact Sheet

Permit Number:	WI-0063932-03-0
Permittee Name:	Tag Lane Dairy Farm
Address:	N8812 River Valley Rd
City/State/Zip:	Ixonia WI 53036
Discharge Location:	W801 Gopher Hill Road, Ixonia WI, 53036; Jefferson County WI, Town of Ixonia, SW ¼ of SW ¼ Sec. 11 T8N R16N
Receiving Water:	Unnamed tributaries within the Ashippun River-Rock River Watershed, and ground waters of the state.
Discharge Type:	Existing

Tag Lane Dairy Farm is an existing Concentrated Animal Feeding Operation (CAFO). **Tag Lane Dairy Farm** is owned and operated by **the Griswold Family**. The farm currently has **3,129** animal units. **1,900 milking & dry cows, 560 heifers, and 390 calves**. **Tag Lane Dairy Farm** has a total of **3,080.3** acres available for land application of manure and process wastewater. Of this acreage, **308.4** acres are owned, and **2,813** acres are rented or controlled through manure agreements. **Tag Lane Dairy Farm** has no planned expansion during the proposed permit term. Approximately **27,305,640 gallons** of manure and process wastewater and **1,900 tons** of solid manure in the first year of the permit term. The farm has a proposed **243 days** of liquid manure st

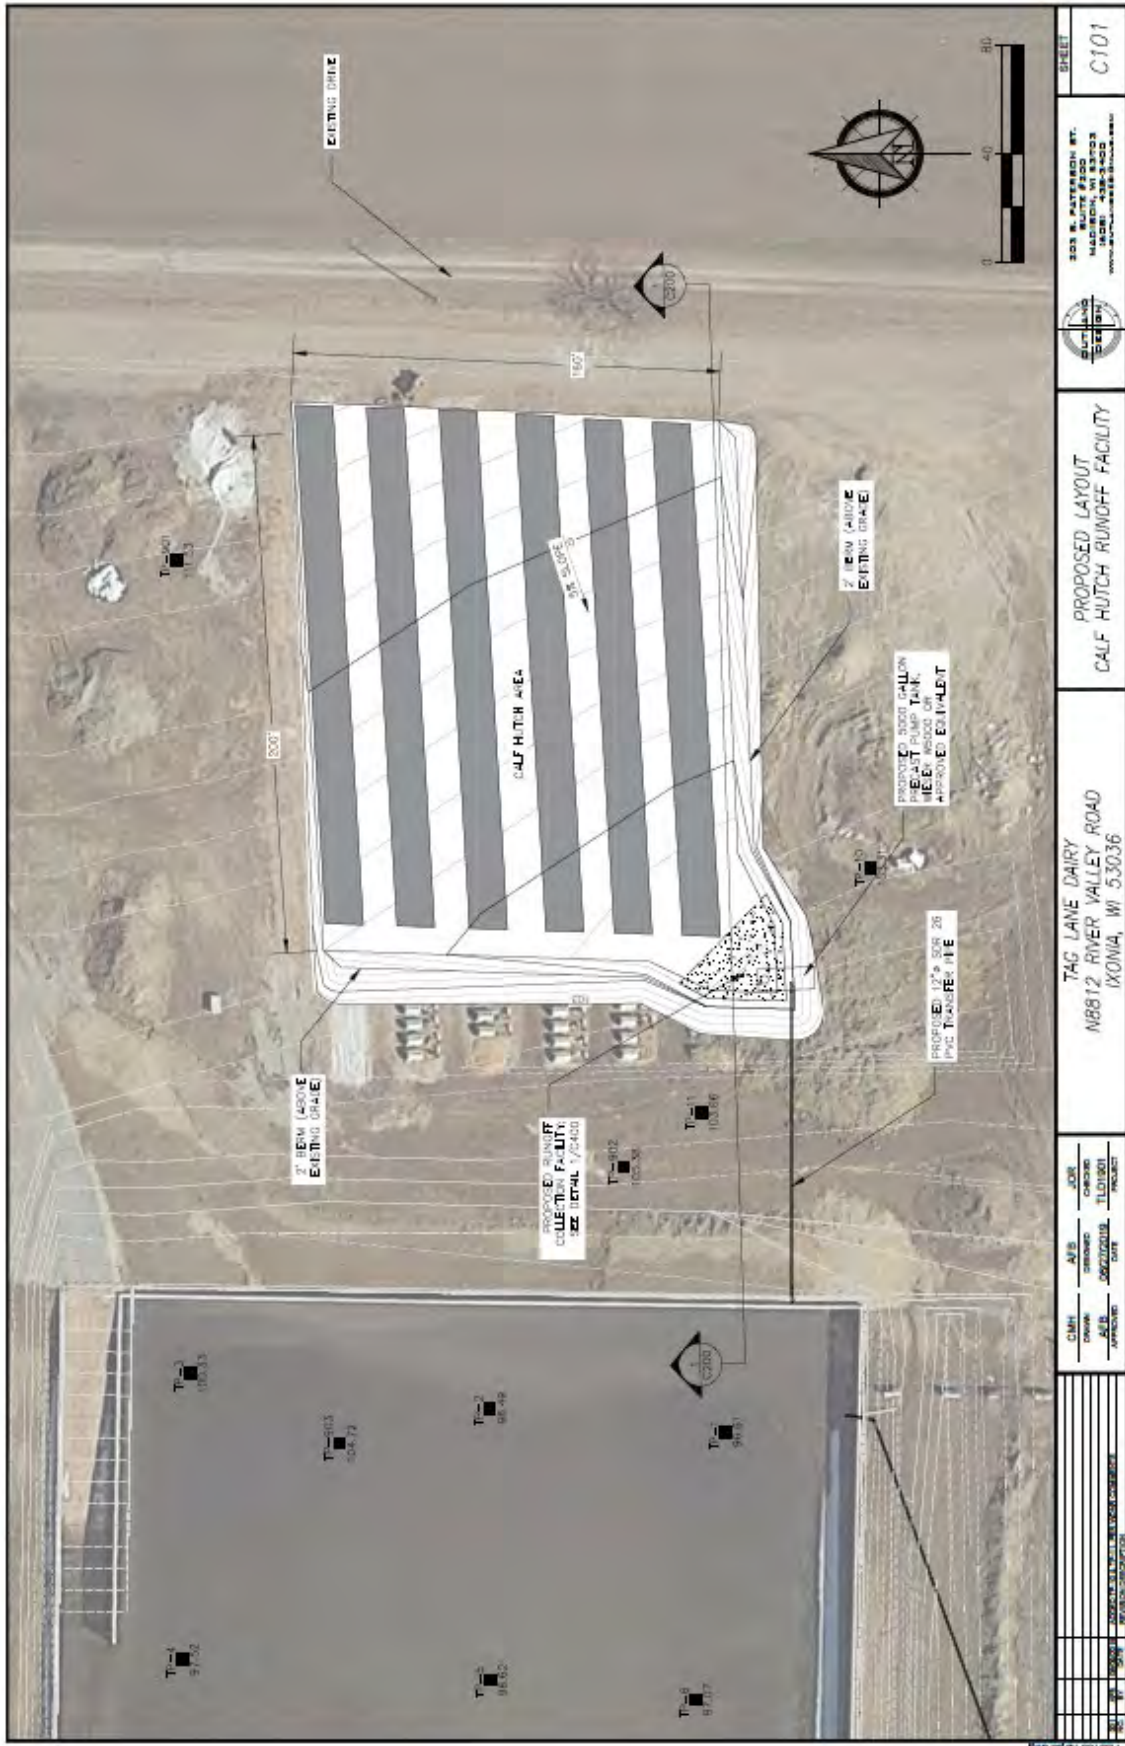
Map 3 Design of the new calf hutch area installed at Tag Lane Dairy LLC.

303 S. PATTERSON ST. MADISON, WI 53703 PHONE: 608-263-8400 WWW.S&SENGINEERING.COM	
SHEET C101		PROPOSED LAYOUT CALF HUTCH RUNOFF FACILITY	
TAG LANE DAIRY N8812 RIVER VALLEY ROAD IXONIA, WI 53036		A/E/S DESIGNER DATE	JOB CHECKED PROJECT
C/M/R DRAWN APPROVED	DATE DATE	DATE DATE	DATE DATE

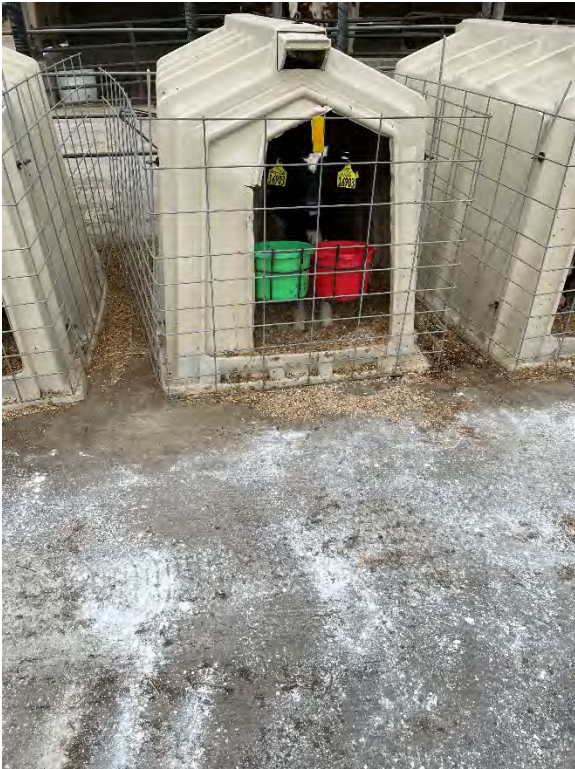
Photo #:	2
Date/Time:	10/11/2022
Photo Location:	Tag Land Dairy LLC
Photo taken by:	Struck, Eric J

Description: Calf hutches on old feed lot, calves housed inside of the hutches, bedded with straw on concrete.

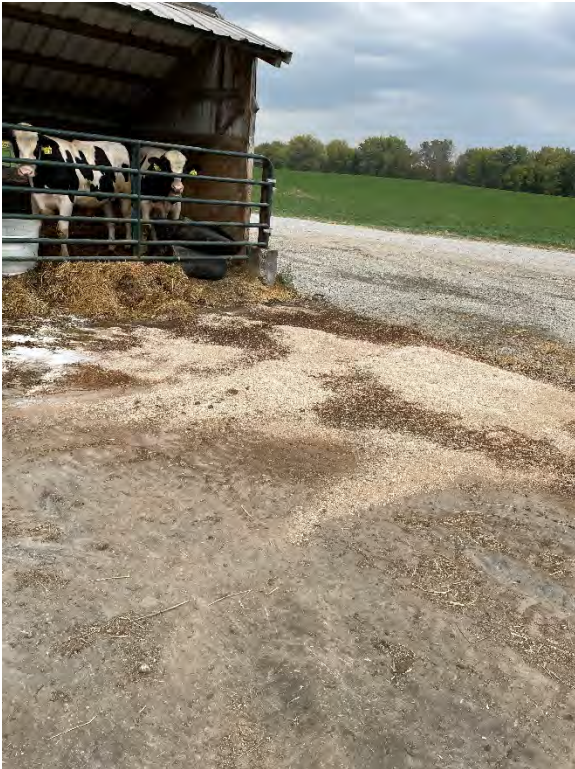
Photo #:	3
Date/Time:	10/11/2022
Photo Location:	Tag Land Dairy LLC
Photo taken by:	Struck, Eric J

Description: Facing northeast at the corner of the old concrete feed lot, calf hutches behind the photo. No runoff observed leaving the feed lot. New driveway runs north to south beyond barn.

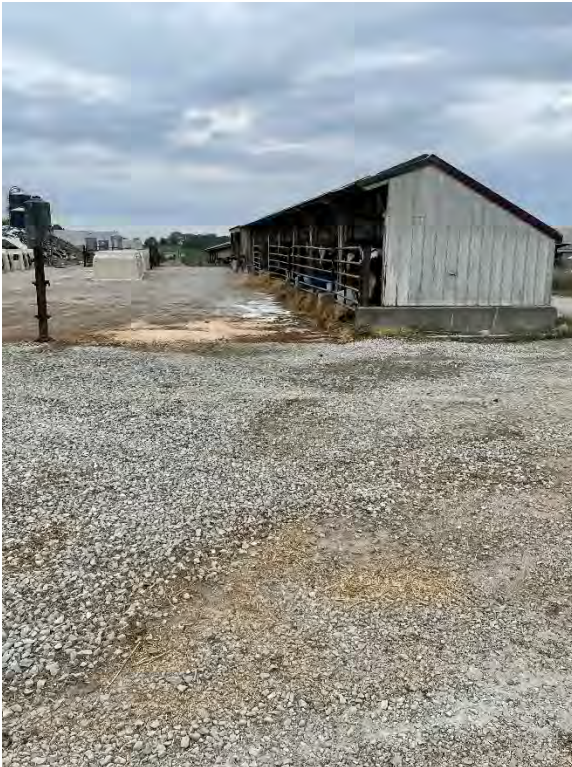
Photo #:	4
Date/Time:	10/11/2022
Photo Location:	Tag Land Dairy LLC
Photo taken by:	Struck, Eric J

Description: Facing west at barn and calf hutches on old feed lot from new driveway.

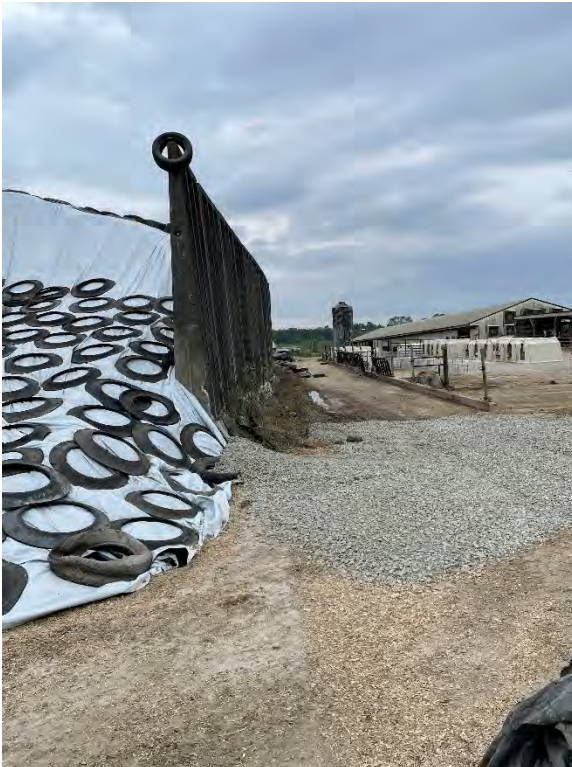
Photo #:	5
Date/Time:	10/11/2022
Photo Location:	Tag Land Dairy LLC
Photo taken by:	Struck, Eric J

Description: facing west at bunker wall and calf hutches on old feed lot. Existing curb on the north and side of the lot. Noticeable bow in the northern feed bunker wall.

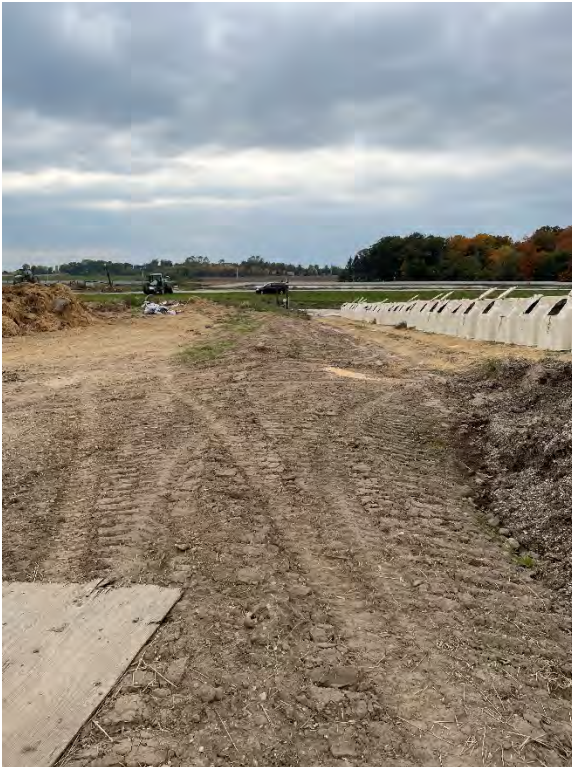
Photo #:	7
Date/Time:	10/11/2022
Photo Location:	Tag Land Dairy LLC
Photo taken by:	Struck, Eric J

Description: Facing west along south side of the calf hutch area and WSF 3. Dry bedding stored south of the calf hutches. Area south is also graded for a proposed new calf barn.

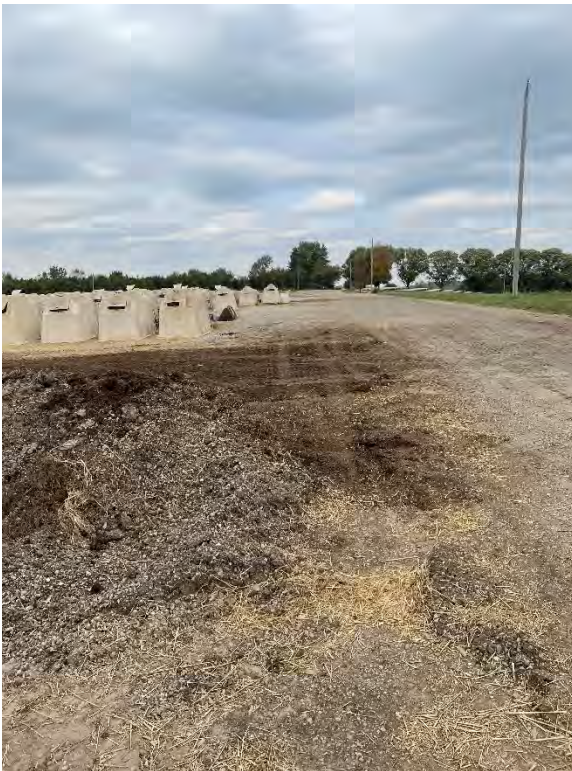
Photo #:	8
Date/Time:	10/11/2022
Photo Location:	Tag Land Dairy LLC
Photo taken by:	Struck, Eric J

Description: Facing north along east side of calf hutch area and driveway to Gopher Hill Road. Used gravel and bedding stored on calf hutch area before land application. Used bedding material is within the runoff collection of the calf hutch area.

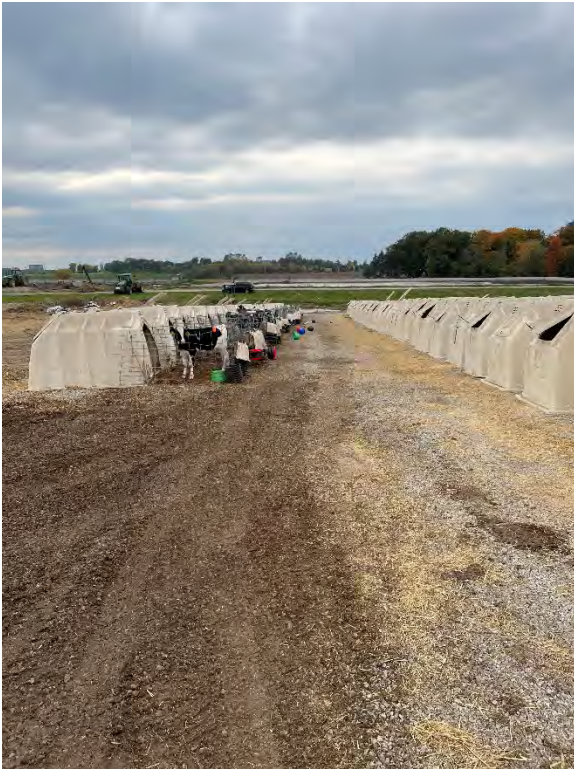
Photo #:	9
Date/Time:	10/11/2022
Photo Location:	Tag Land Dairy LLC
Photo taken by:	Struck, Eric J

Description: Facing south down calf hutch area. Gravel is removed from the calf hutches once calves are moved out.

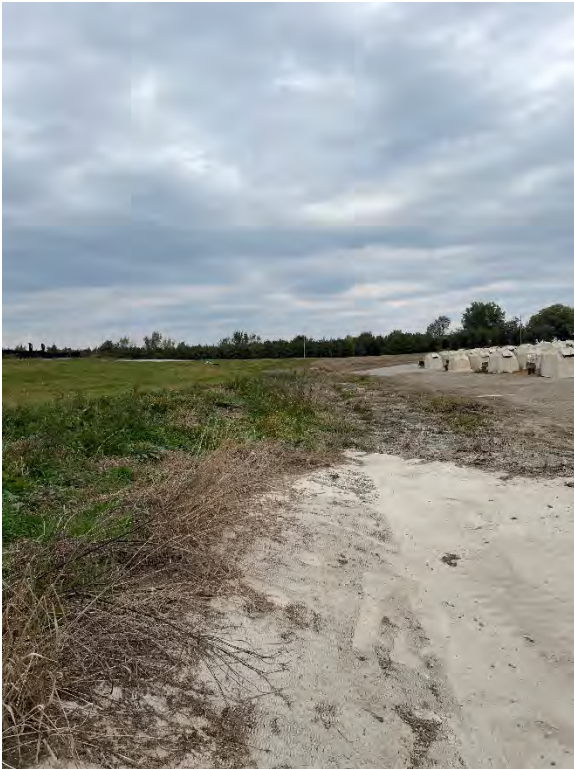
Photo #:	10
Date/Time:	10/11/2022
Photo Location:	Tag Land Dairy LLC
Photo taken by:	Struck, Eric J

Description: Facing north from collection apron. Maintenance should be performed around apron from settled gravel from construction.

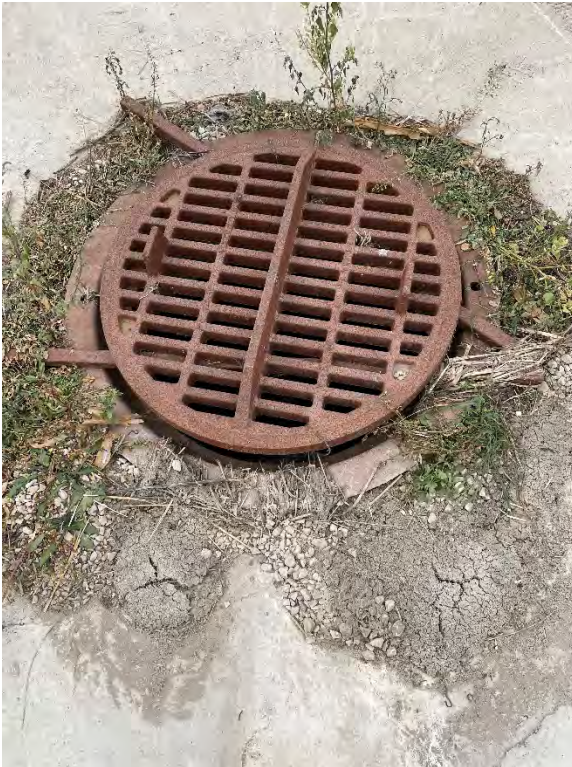
Photo #:	11
Date/Time:	10/11/2022
Photo Location:	Tag Land Dairy LLC
Photo taken by:	Struck, Eric J

Description: Manhole drain for collection tank for calf hutch area runoff controls. Some debris but flow was not obstructed. Some grading maybe needed around the concrete apron so flow and reach the concrete.

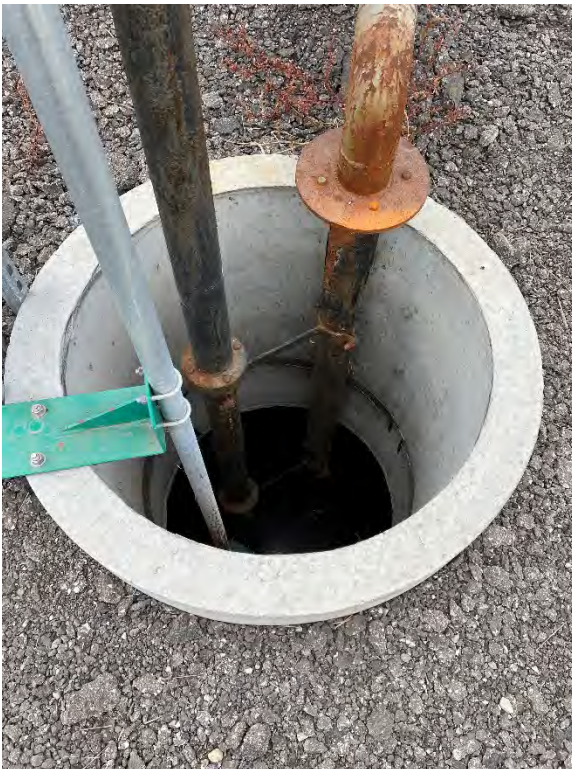
Photo #:	12
Date/Time:	10/11/2022
Photo Location:	Tag Land Dairy LLC
Photo taken by:	Struck, Eric J

Description: Reception tank and pump of calf hutch area runoff controls. Collection tank is pumped automatically to WSF 3.

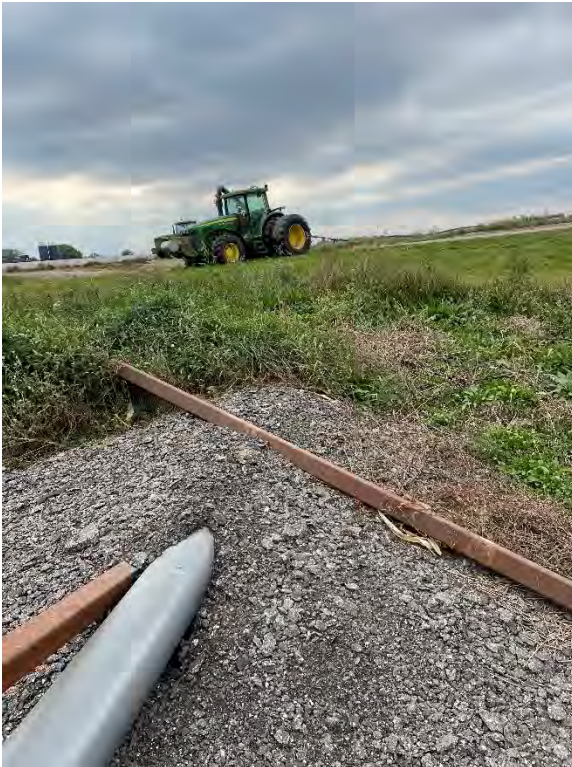
Photo #:	13
Date/Time:	10/11/2022
Photo Location:	Tag Land Dairy LLC
Photo taken by:	Struck, Eric J
Description: Pipeline running from calf hutch area runoff collection tank to WSF 3.

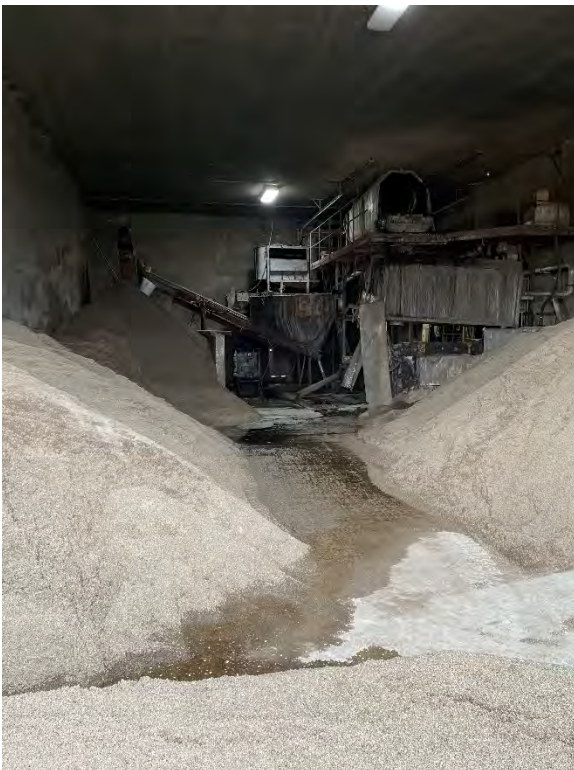
Photo #:	14
Date/Time:	10/11/2022
Photo Location:	Tag Land Dairy LLC
Photo taken by:	Struck, Eric J
Description: Looking inside the sand separation building. Recaptured sand is dried and stored underroof prior to being used in the freestall barns for bedding.

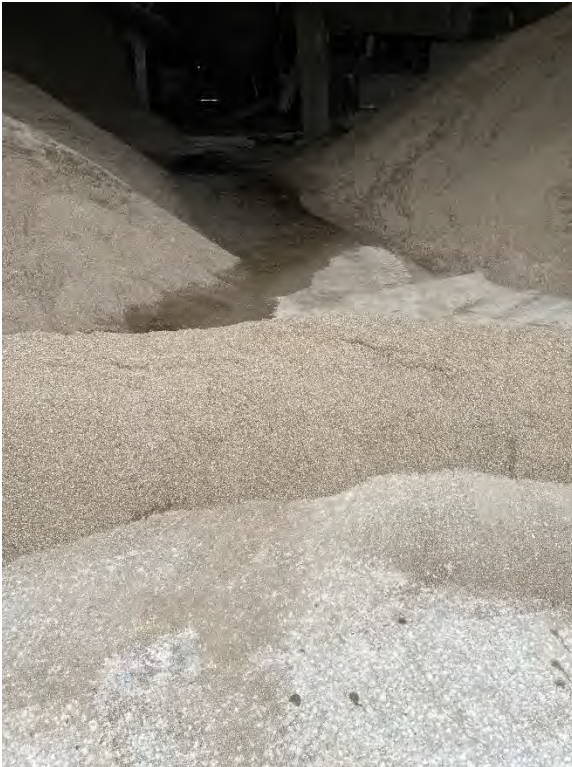
Photo #:	15
Date/Time:	10/11/2022
Photo Location:	Tag Land Dairy LLC
Photo taken by:	Struck, Eric J

Description: A sand berm just off the main piles to help hold runoff from the separates sand in the building.

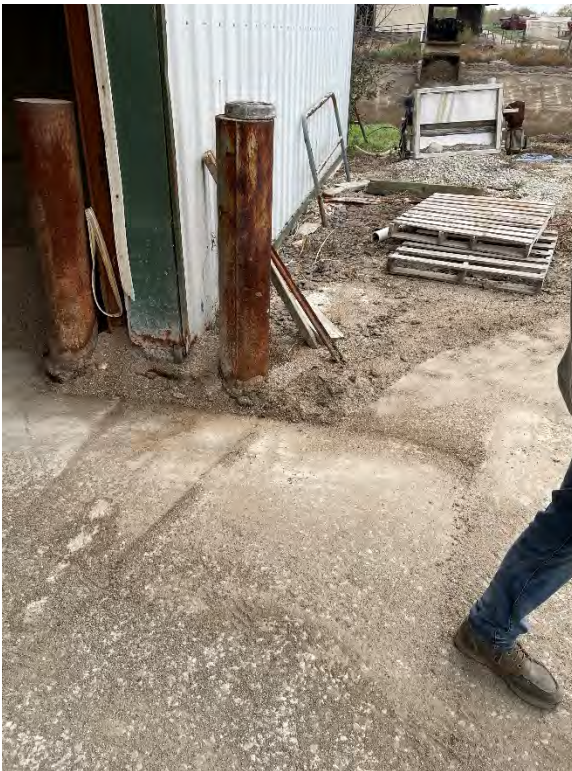
Photo #:	16
Date/Time:	10/11/2022
Photo Location:	Tag Land Dairy LLC
Photo taken by:	Struck, Eric J

Description: Just outside the entrance to the sand separation building. All sand and runoff contained to the building.

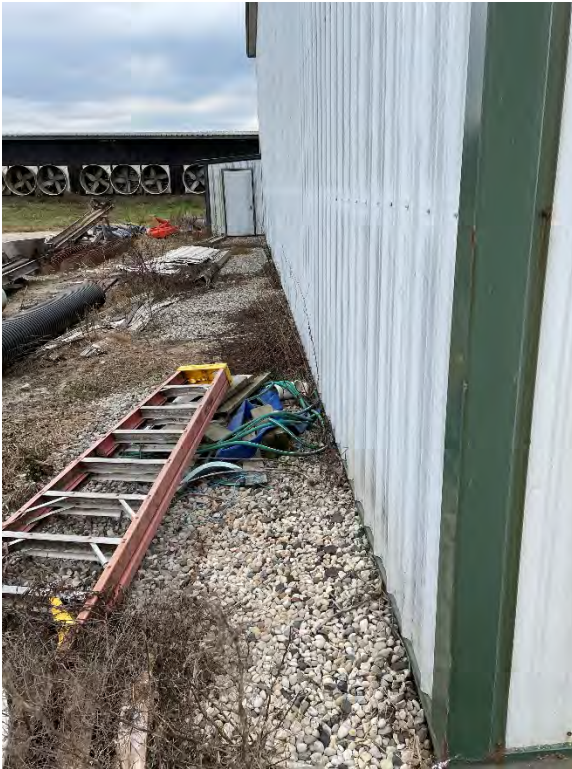
Photo #:	17
Date/Time:	10/11/2022
Photo Location:	Tag Land Dairy LLC
Photo taken by:	Struck, Eric J
Description: West exterior wall of the sand separation building facing north.

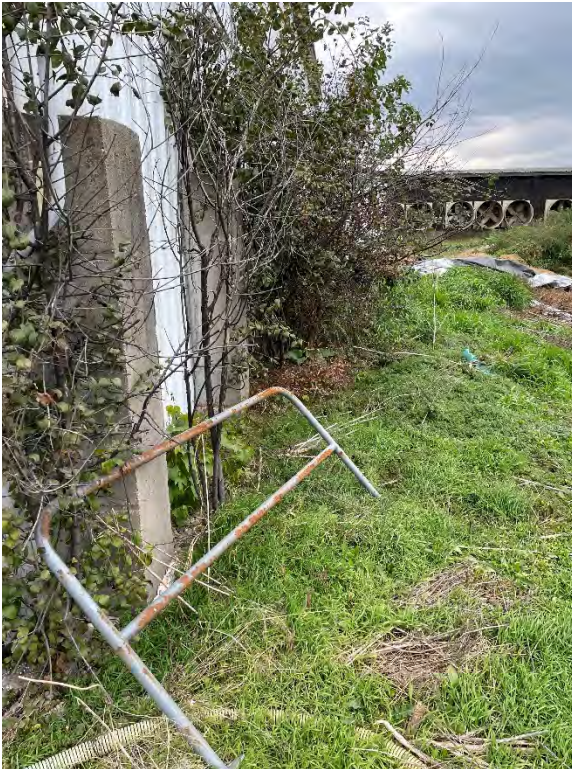
Photo #:	18
Date/Time:	10/11/2022
Photo Location:	Tag Land Dairy LLC
Photo taken by:	Struck, Eric J
Description: East exterior wall of the sand separation building facing north.

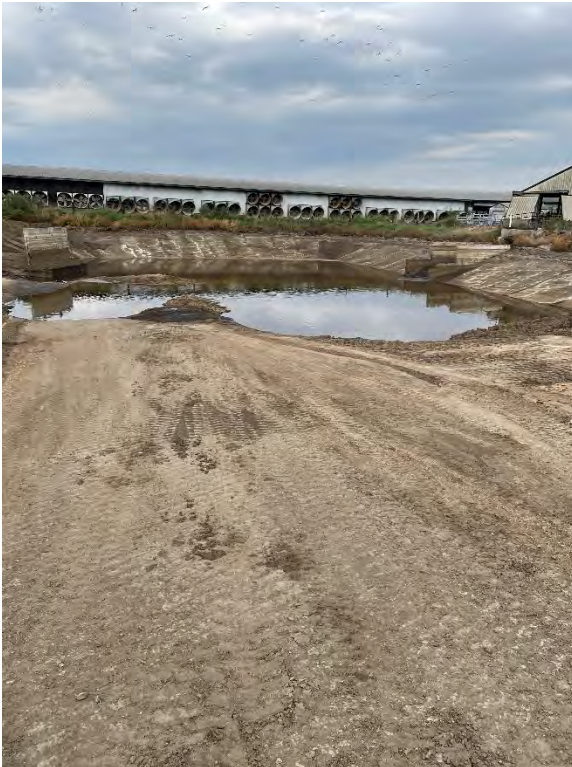
Photo #:	19
Date/Time:	10/11/2022
Photo Location:	Tag Land Dairy LLC
Photo taken by:	Struck, Eric J

Description: WSF 1 from the access ramp facing north.

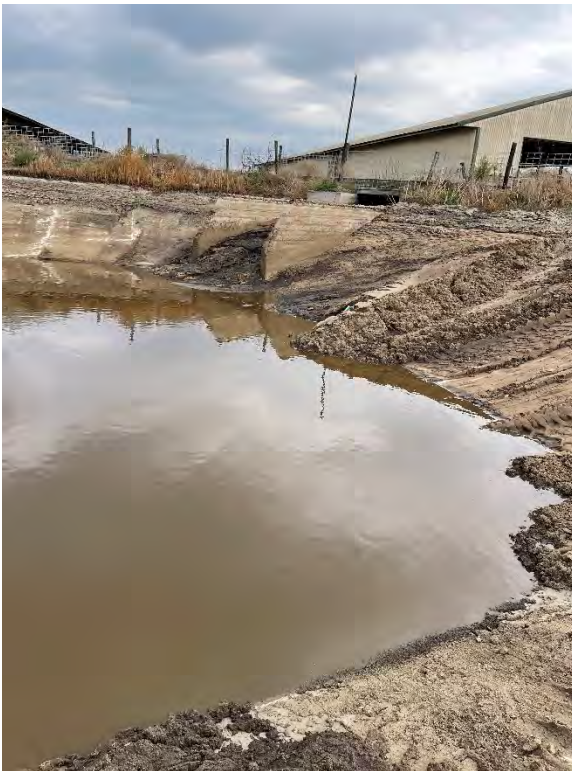
Photo #:	20
Date/Time:	10/11/2022
Photo Location:	Tag Land Dairy LLC
Photo taken by:	Struck, Eric J

Description: WSF 1 facing east from ramp. Storage is at a low level at the time of the inspection.

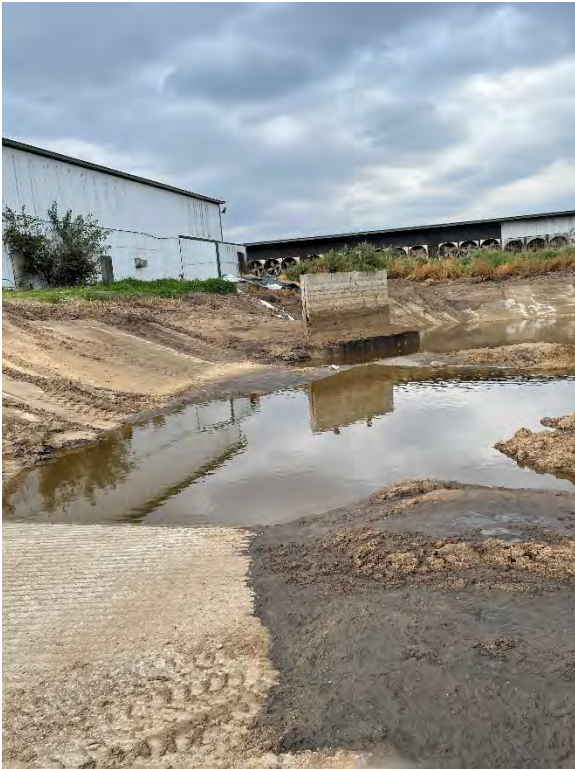
Photo #:	22
Date/Time:	10/11/2022
Photo Location:	Tag Land Dairy LLC
Photo taken by:	Struck, Eric J
<p>Description: Facing north at WSF 1, wall in the left center has markers on the south side of the wall.</p>

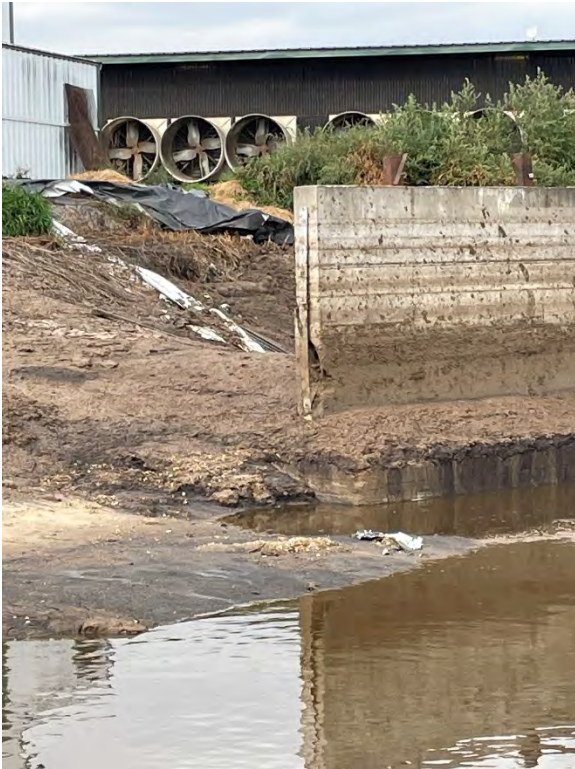
Photo #:	23
Date/Time:	10/11/2022
Photo Location:	Tag Land Dairy LLC
Photo taken by:	Struck, Eric J

Description: Close up of the markers on wall in WSF 1, graded marker for measuring depths.

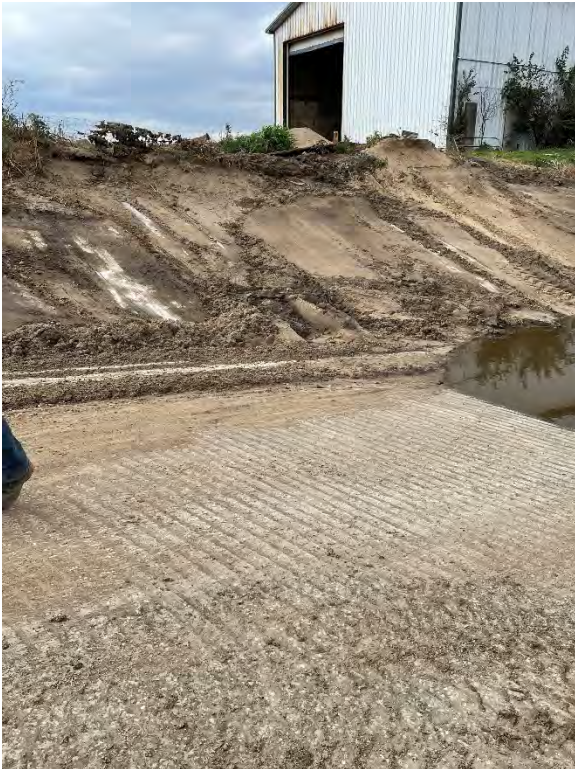
Photo #:	24
Date/Time:	10/11/2022
Photo Location:	Tag Land Dairy LLC
Photo taken by:	Struck, Eric J

Description: facing west from access ramp at concrete side walls. Some solids remain from recent cleaning. Appears storage is in good condition.

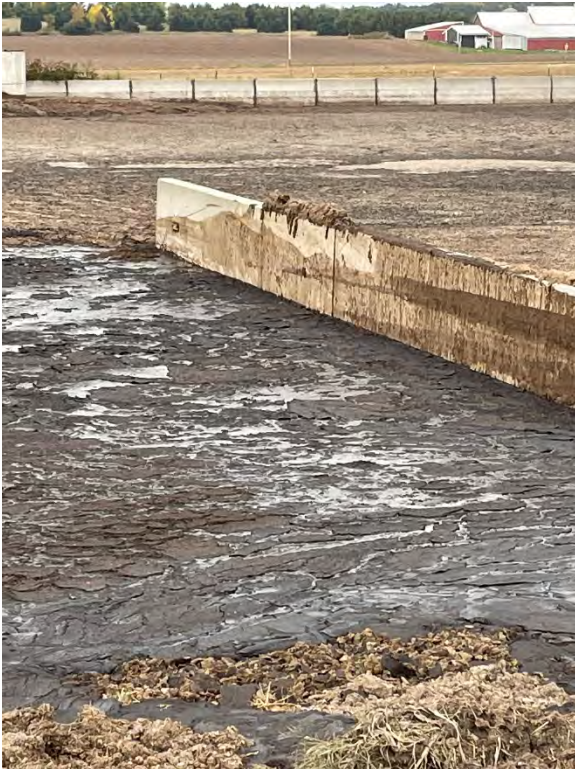
Photo #:	26
Date/Time:	10/11/2022
Photo Location:	Tag Land Dairy LLC
Photo taken by:	Struck, Eric J
Description: Wall along access ramp, has a marker at end of the wall. Southeast corner of WSF 2.

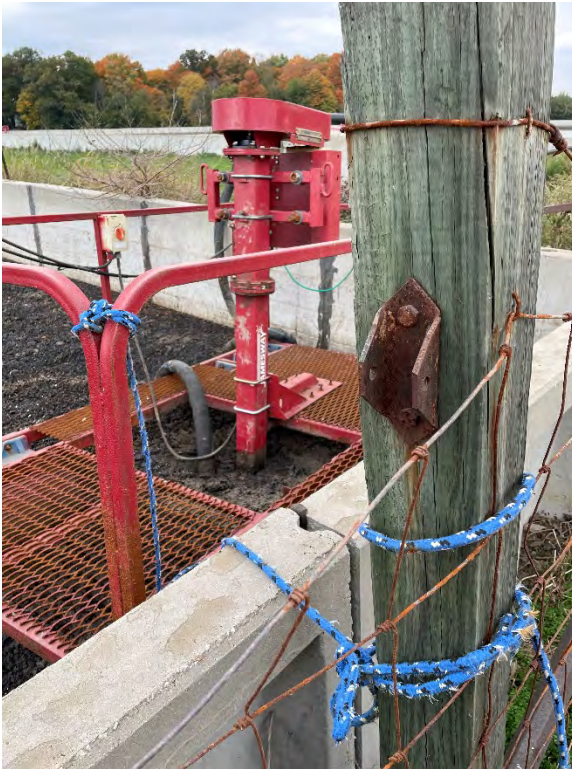
Photo #:	27
Date/Time:	10/11/2022
Photo Location:	Tag Land Dairy LLC
Photo taken by:	Struck, Eric J

Description: Pump in the northeast corner of WSF 2 for the transfer of waste to WSF 3. Levels must be maintained to ensure the function of the flush flume system.

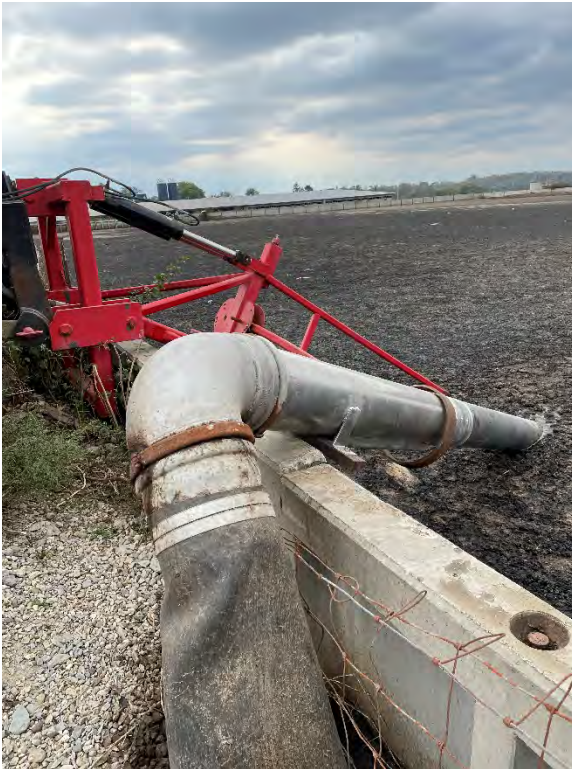
Photo #:	28
Date/Time:	10/11/2022
Photo Location:	Tag Land Dairy LLC
Photo taken by:	Struck, Eric J

Description: Pump in WSF 2 for land application.

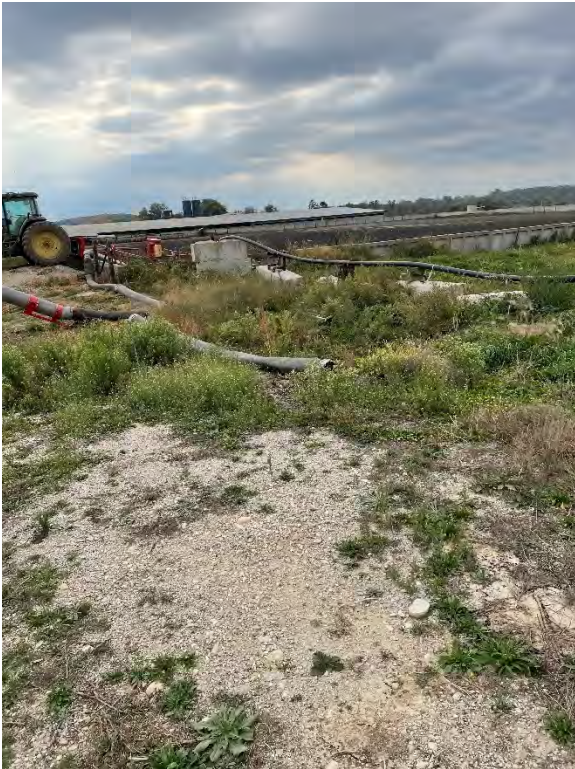
Photo #:	29
Date/Time:	10/11/2022
Photo Location:	Tag Land Dairy LLC
Photo taken by:	Struck, Eric J

Description: Facing southwest at the pump and load out area of WSF 2. Hose to WSF 3 and for land application transfer laying out.

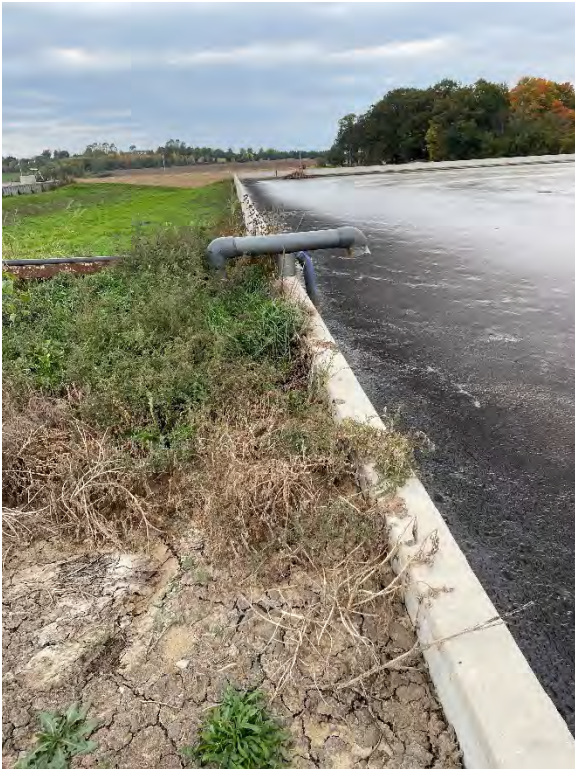
Photo #:	30
Date/Time:	10/11/2022
Photo Location:	Tag Land Dairy LLC
Photo taken by:	Struck, Eric J

Description: Pipe stand from WSF 2 to WSF 3 for the manual transfer of manure to WSF 3. Located on the south side of WSF 3.

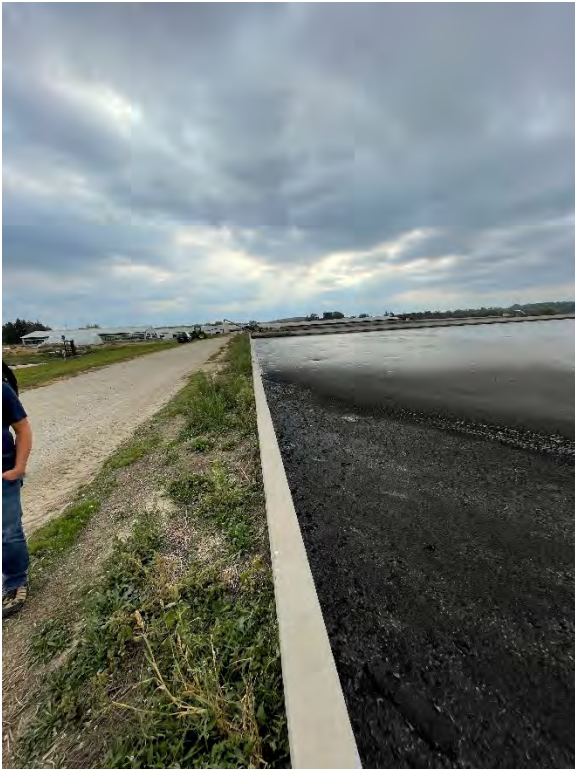
Photo #:	31
Date/Time:	10/11/2022
Photo Location:	Tag Land Dairy LLC
Photo taken by:	Struck, Eric J

Description: East side of WSF 3 facing south.

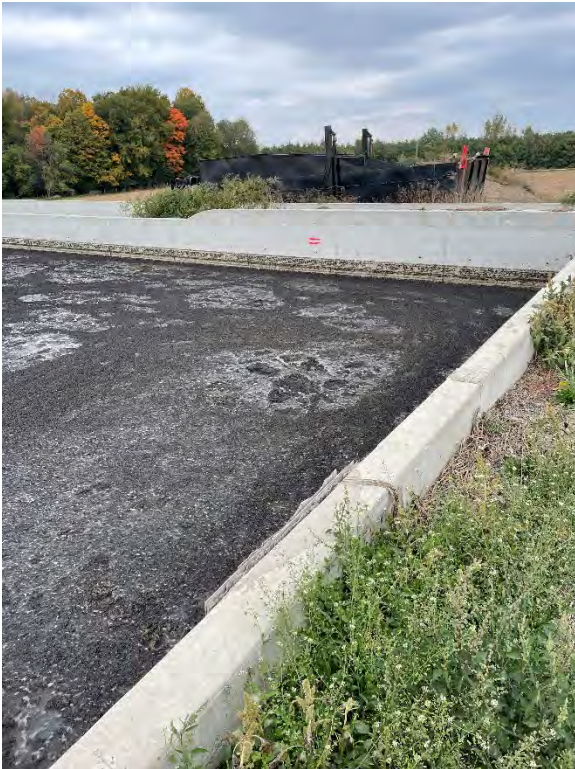
Photo #:	32
Date/Time:	10/11/2022
Photo Location:	Tag Land Dairy LLC
Photo taken by:	Struck, Eric J

Description: facing north at the northeast corner of WSF 3. Spray painted markers located on the access ramp in the northeast corner.

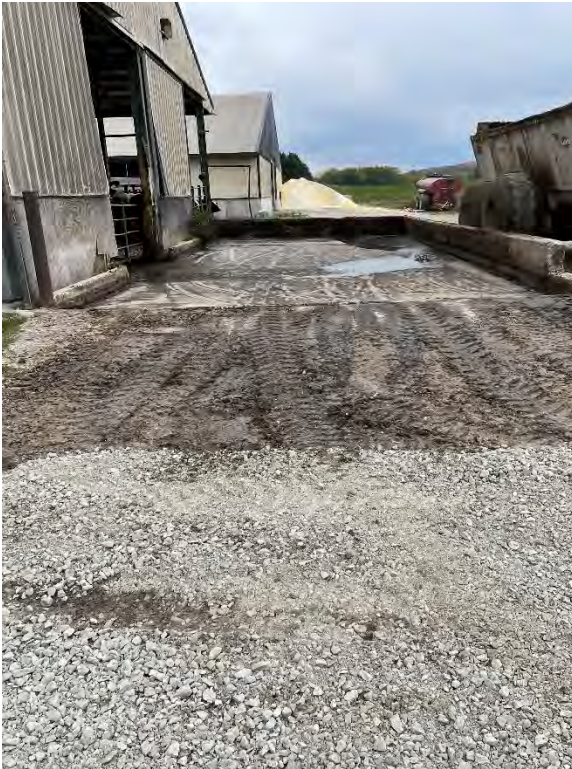
Photo #:	33
Date/Time:	10/11/2022
Photo Location:	Tag Land Dairy LLC
Photo taken by:	Struck, Eric J

Description: Load out area on the west end of the southern heifer barns. The in the load out area of the southernmost heifer barn dry corn was being stored while the harvest was still underway. Dry corn does not pose a resources concern and the farm planned to use the corn up in the coming weeks.

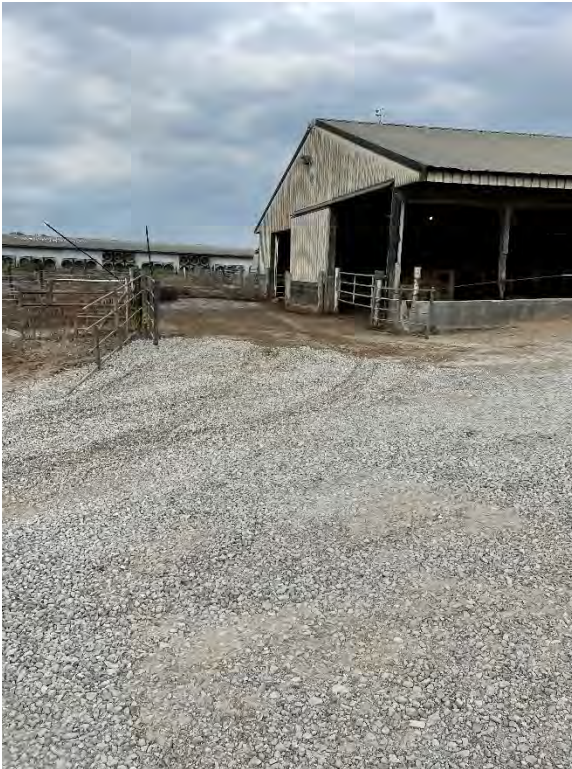
Photo #:	34
Date/Time:	10/11/2022
Photo Location:	Tag Land Dairy LLC
Photo taken by:	Struck, Eric J

Description: Push out area on the west end of the central free stall barn, north of the feed storage area, and southeast of WSF 1. Area was well maintained.

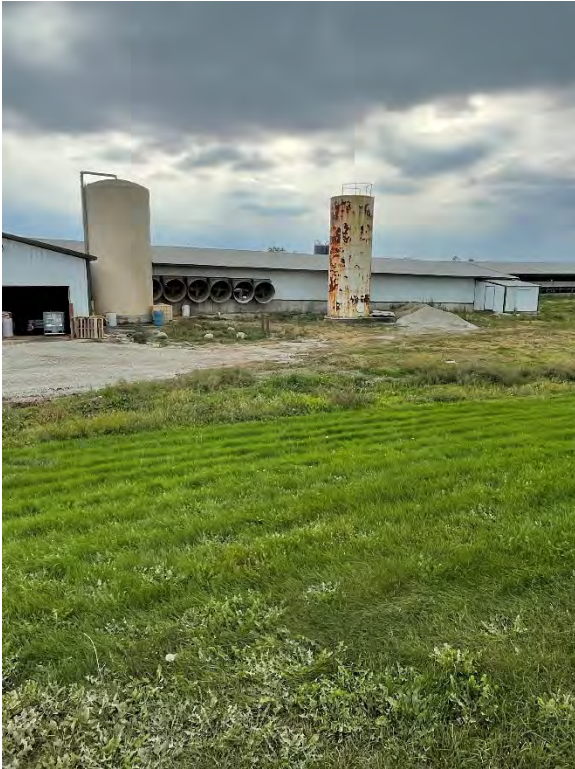
Photo #:	35
Date/Time:	10/11/2022
Photo Location:	Tag Land Dairy LLC
Photo taken by:	Struck, Eric J
Description: Holding tanks outside milking parlor.

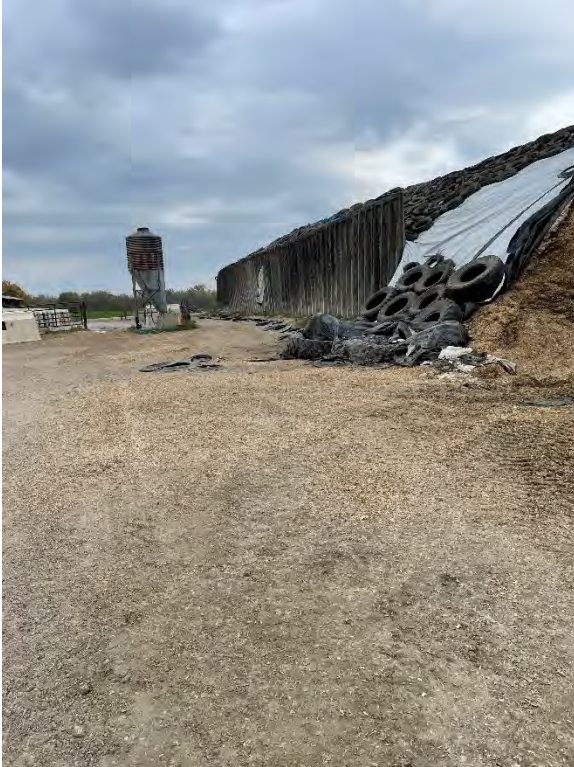
Photo #:	36
Date/Time:	10/11/2022
Photo Location:	Tag Land Dairy LLC
Photo taken by:	Struck, Eric J
Description: North side of feed storage area, wall on the eastern half had bow in the wall. Wall should be monitored for safety concerns.

Some bunker walls also appeared to be bowing and some cracks in the concrete was observed. Maintenance should be performed as needed. Changes to the walls and floors may need department plan approval. The

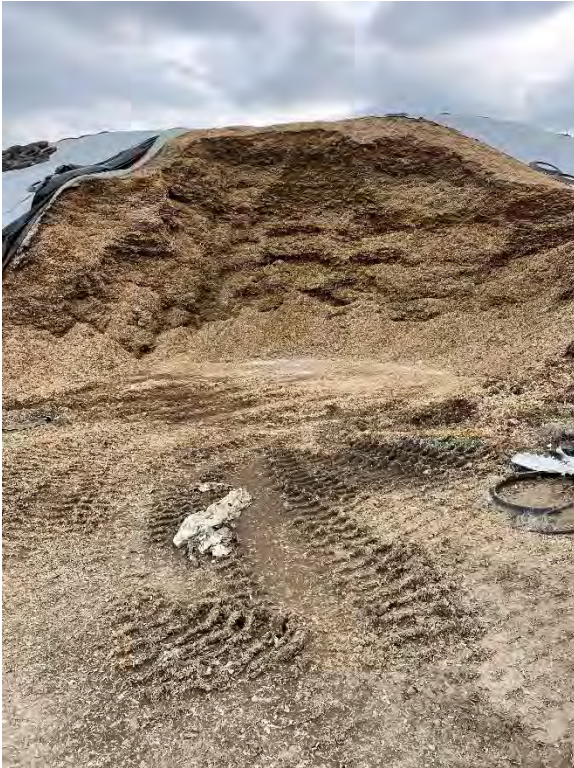
Photo #:	37
Date/Time:	10/11/2022
Photo Location:	Tag Land Dairy LLC
Photo taken by:	Struck, Eric J
Description: Middle of the north side of the feed storage area. Area is being feed from.

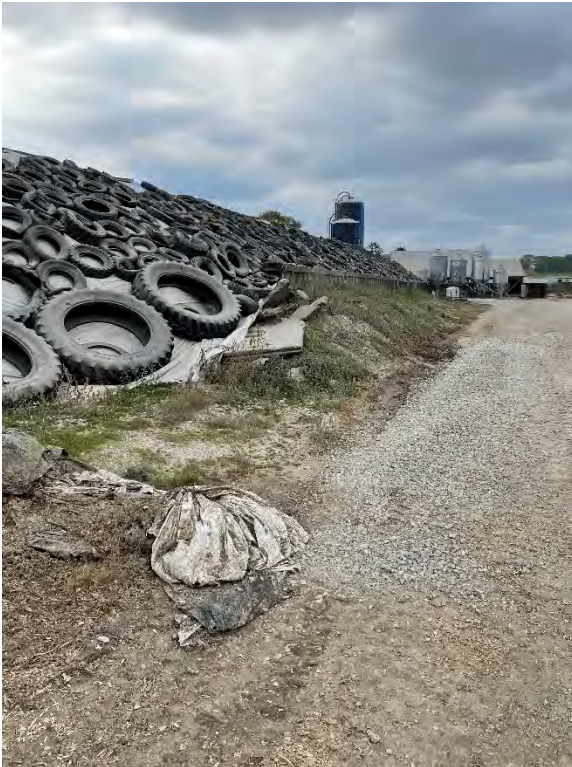
Photo #:	38
Date/Time:	10/11/2022
Photo Location:	Tag Land Dairy LLC
Photo taken by:	Struck, Eric J

Description: Facing west from the center of the northern wall of the feed storage area. Wall appears to be in better condition, no leachate observed outside the storage area.

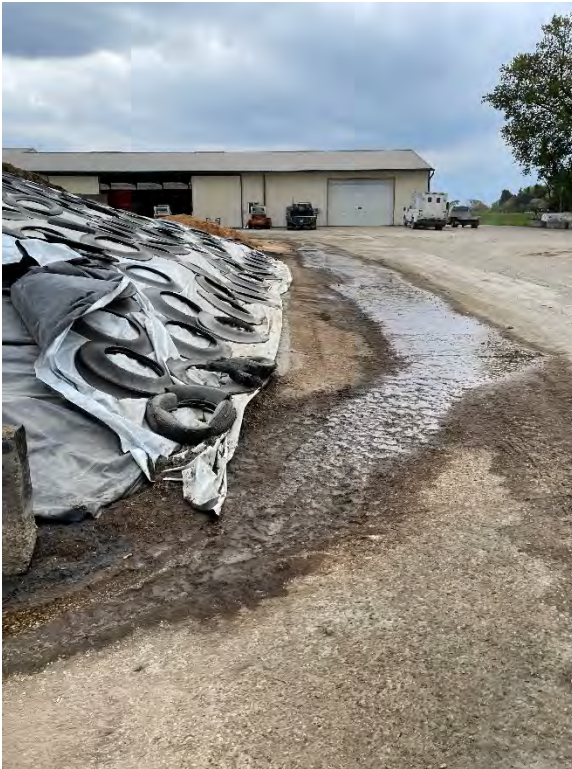
Photo #:	39
Date/Time:	10/11/2022
Photo Location:	Tag Land Dairy LLC
Photo taken by:	Struck, Eric J

Description: Facing south along the western end of the feed storage area. Leachate observed flowing to feed storage runoff collection.

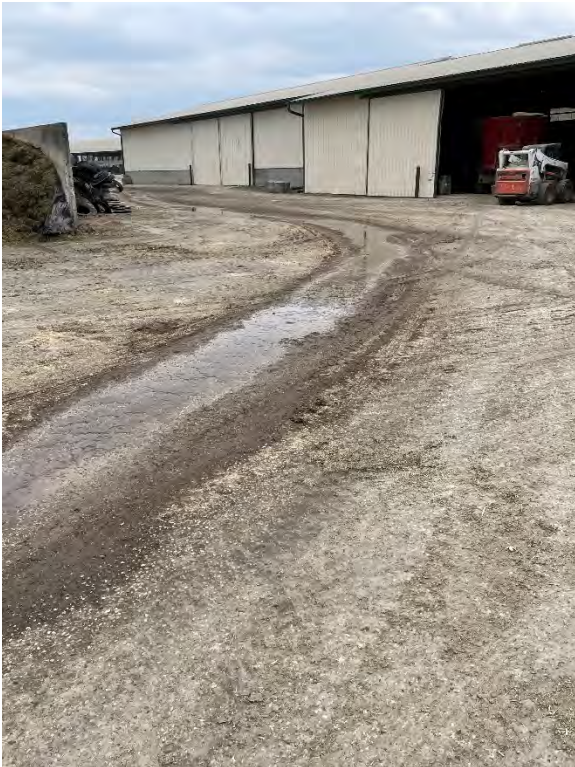
Photo #:	40
Date/Time:	10/11/2022
Photo Location:	Tag Land Dairy LLC
Photo taken by:	Struck, Eric J

Description: Facing southeast along the southwest end of the feed storage area, leachate flow path observed flowing to reception tank.

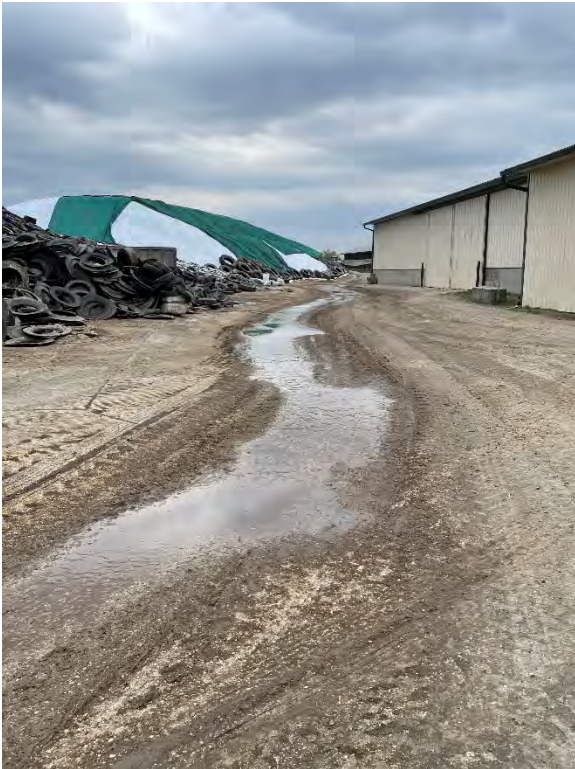
Photo #:	41
Date/Time:	10/11/2022
Photo Location:	Tag Land Dairy LLC
Photo taken by:	Struck, Eric J

Description: Facing east along the southern side of the feed storage area, leachate flowing west.

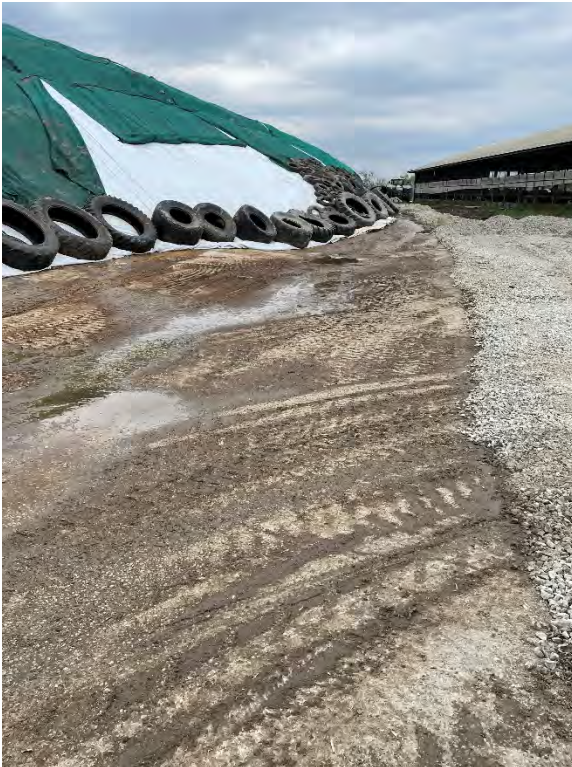
Photo #:	42
Date/Time:	10/11/2022
Photo Location:	Tag Land Dairy LLC
Photo taken by:	Struck, Eric J

Description: Facing east along the middle of southern side of the feed storage area, leachate flowing west.

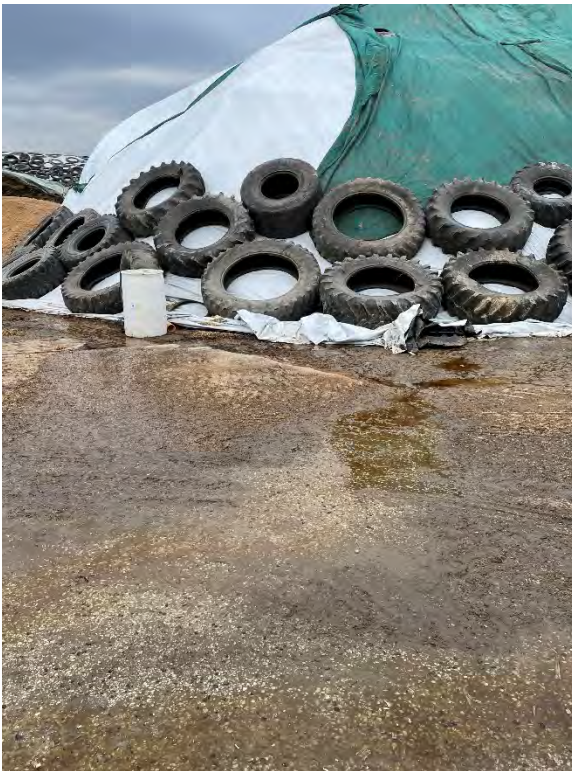
Photo #:	43
Date/Time:	10/11/2022
Photo Location:	Tag Land Dairy LLC
Photo taken by:	Struck, Eric J

Description: Leachate and runoff coming from recently harvested corn silage.

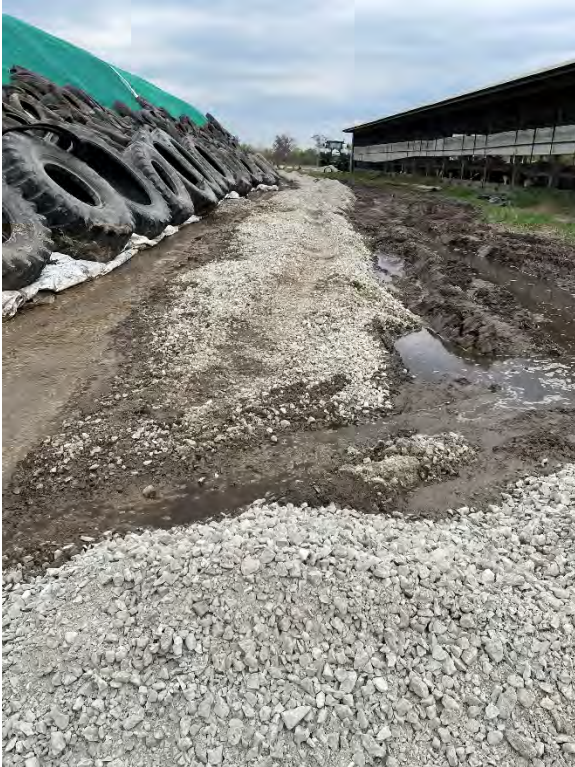
Photo #:	44
Date/Time:	10/11/2022
Photo Location:	Tag Land Dairy LLC
Photo taken by:	Struck, Eric J

At the time of the inspection corn silage had just been finished. After a second round of harvest with a different moisture of silage the pile settled and pushed off the feed pad. Tag Lane made attempts to move the feed pile, but it was too large and damage to the ground around the area was occurring. Tag Lane built a berm to direct any surface runoff from the edge of the pile to the feed storage area reception tank. The perimeter drain tile appeared to be collecting any leachate under the pile and was flowing to the collection tank. Once the silage is fermented, and pile becomes accessible the farm will work to remove the feed and repair any damage to the surrounding area. Tag Lane Dairy should notify Eric Struck of the clean up progress and note any changes in their monitoring and inspection program and CAFO calendar. The farm has considered long term plans to make some changes to this side of the feed storage area. Plans and specification requirements were discussed as well as possible rain gutters on the heifer barn and further grading to help with clean water diversions from the area.

Description: South side of the southeast corner of the feed storage area. Pile had settled off the feed storage pad. Evidence of trying to clean and stop the pile from moving visible. Gravel berm was added to direct any surface flow to the reception tank. Feed storage area has perimeter drain tile to collect any other runoff from the area.
