Permit Fact Sheet

Permit Number:	WI-0063932-03-0
Permittee Name:	Tag Lane Dairy Farm
Address:	N8812 River Valley Rd
City/State/Zip:	Ixonia WI 53036
Discharge Location:	W801 Gopher Hill Road, Ixonia WI, 53036; Jefferson County WI, Town of Ixonia, SW ¼ of SW ¼ Sec. 11 T8N R16N
Receiving Water:	Unnamed tributaries within the Ashippun River-Rock River Watershed, and ground waters of the state.
Discharge Type:	Existing

Tag Lane Dairy Farm is an existing Concentrated Animal Feeding Operation (CAFO). **Tag Lane Dairy Farm** is owned and operated by **the Griswold Family**. The farm currently has **3,129** animal units. **1,900 milking & dry cows, 560 heifers, and 390 calves**. **Tag Lane Dairy Farm** has a total of **3,080.3** acres available for land application of manure and process wastewater. Of this acreage, **308.4** acres are owned, and **2,813** acres are rented or controlled through manure agreements. **Tag Lane Dairy Farm** has no planned expansion during the proposed permit term. Approximately **27,305,640 gallons** of manure and process wastewater and **1,900 tons** of solid manure in the first year of the permit term. The farm has a proposed **243 days** of liquid manure st

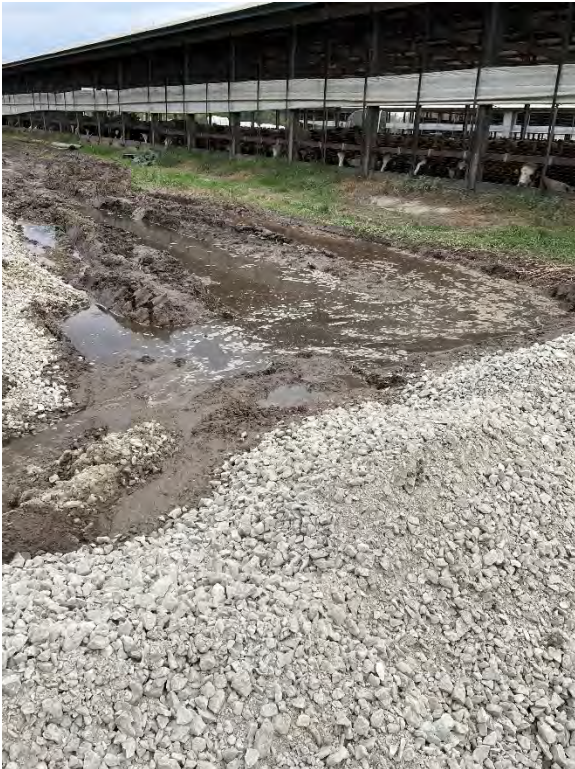
Photo #:	45
Date/Time:	10/11/2022
Photo Location:	Tag Land Dairy LLC
Photo taken by:	Struck, Eric J

Description: Gravel berm and tire tracks from efforts to stop the pile from moving any further. Surface flow directed back to the feed pad for collection.

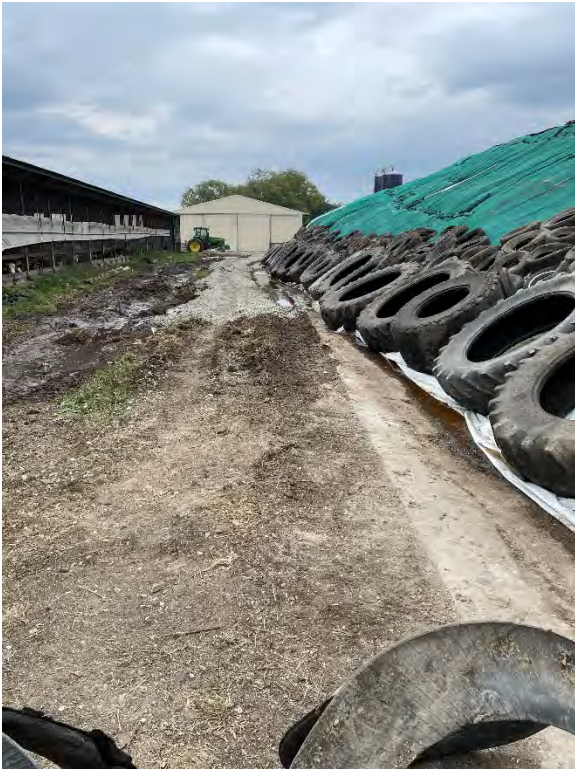
Photo #:	46
Date/Time:	10/11/2022
Photo Location:	Tag Land Dairy LLC
Photo taken by:	Struck, Eric J

At the time of the inspection corn silage had just been finished. After a second round of harvest with a different moisture of silage the pile settled and pushed off the feed pad. Tag Lane made attempts to move the feed pile, but it was too large and damage to the ground around the area was occurring. Tag Lane built a berm to direct any surface runoff from the edge of the pile to the feed storage area reception tank. The perimeter drain tile appeared to be collecting any leachate under the pile and was flowing to the collection tank. Once the silage is fermented, and pile becomes accessible the farm will work to remove the feed and repair any damage to the surrounding area. Tag Lane Dairy should notify Eric Struck of the clean up progress and note any changes in their monitoring and inspection program and CAFO calendar. The farm has considered long term plans to make some changes to this side of the feed storage area. Plans and specification requirements were discussed as well as possible rain gutters on the heifer barn and further grading to help with clean water diversions from the area.

Description: Facing west from the east end of the southern side of the feed storage area. Feed pile settled over the curb of the feed storage area. Attempts were made to stop the pile from moving.

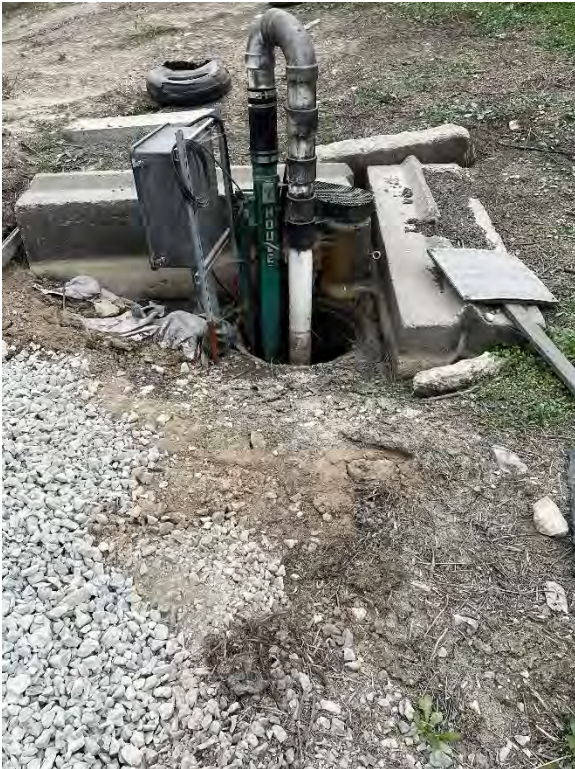
Photo #:	47
Date/Time:	10/11/2022
Photo Location:	Tag Land Dairy LLC
Photo taken by:	Struck, Eric J

Description: pump located in the reception tank of the feed storage area runoff collection tank.

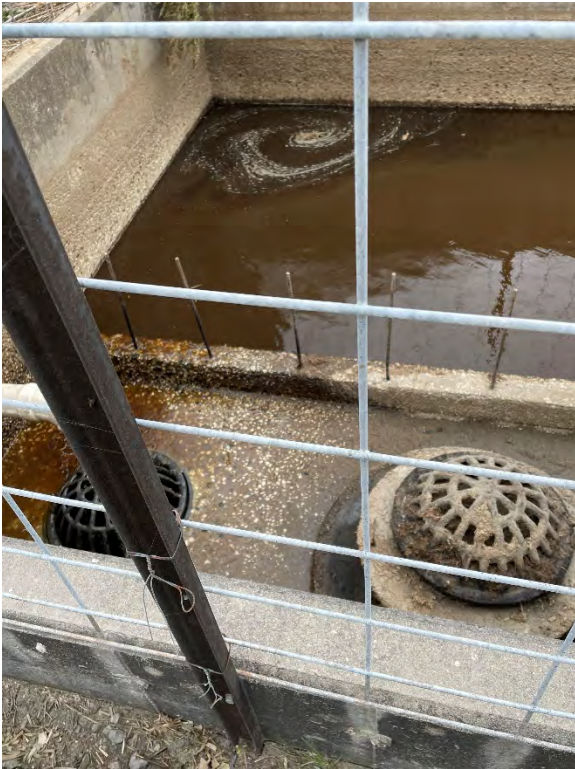
Photo #:	48
Date/Time:	10/11/2022
Photo Location:	Tag Land Dairy LLC
Photo taken by:	Struck, Eric J

Description: Feed storage runoff collection tank. Leachate and runoff is collected in 3000 gallon tank and gravity flows to WSF 1.

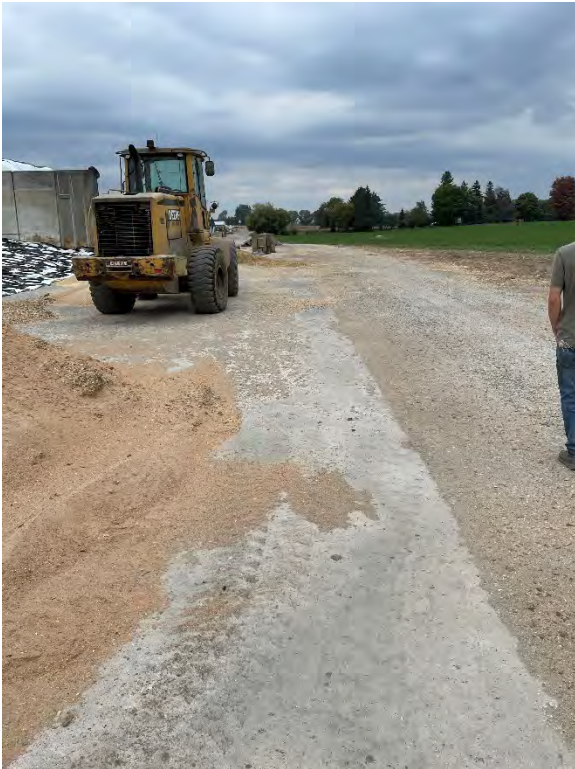
Photo #:	49
Date/Time:	10/11/2022
Photo Location:	Tag Land Dairy LLC
Photo taken by:	Struck, Eric J

Description: Eastern end of the feed storage area facing north. Feed contained to feed pad.

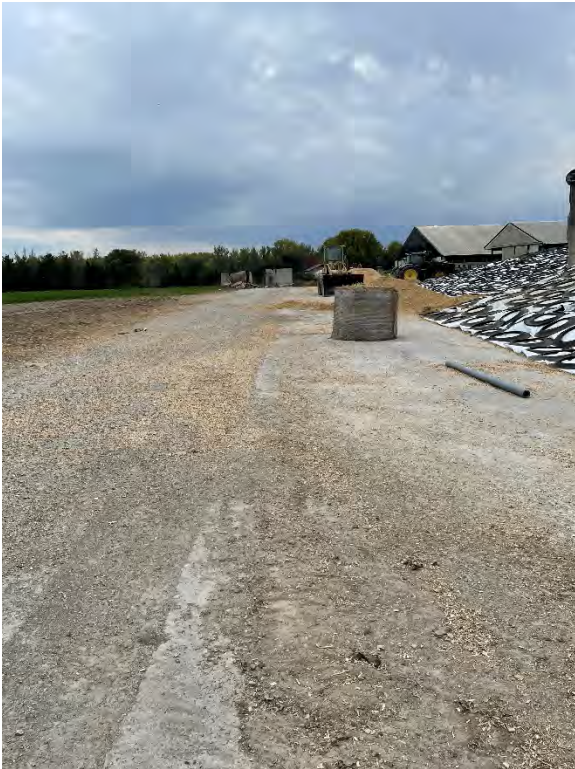
Photo #:	50
Date/Time:	10/11/2022
Photo Location:	Tag Land Dairy LLC
Photo taken by:	Struck, Eric J

Description: Eastern end of the feed storage area facing south. Feed contained to feed pad.

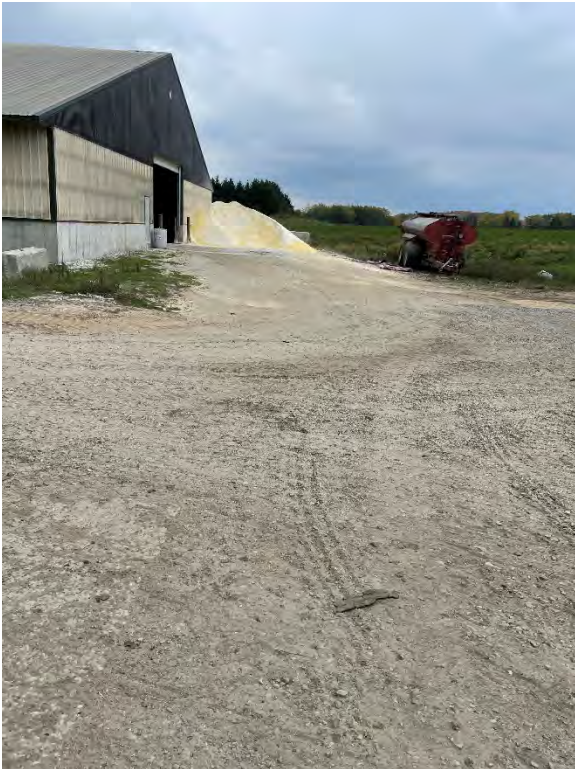
Photo #:	51
Date/Time:	10/11/2022
Photo Location:	Tag Land Dairy LLC
Photo taken by:	Struck, Eric J

Description: Dry corn being stored outside for immediate use while harvest is taking place. Short term storage and did not pose a resource concern at the time of the visit.

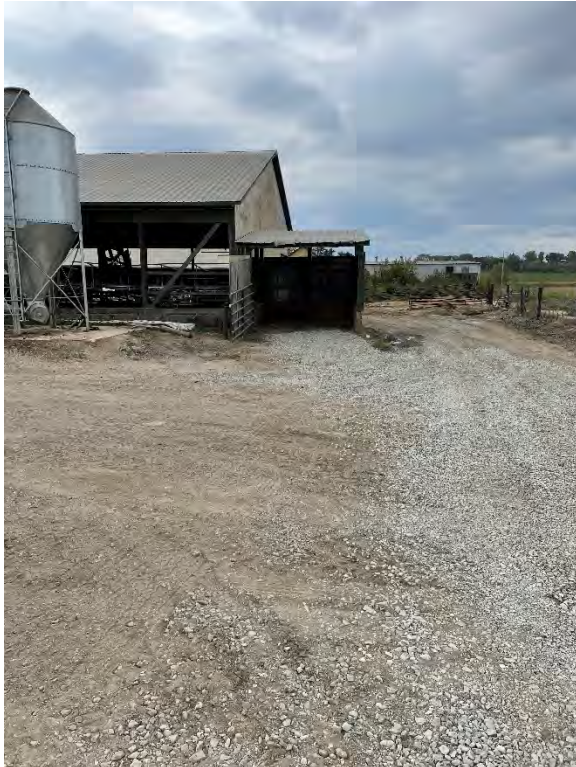
Photo #:	52
Date/Time:	10/11/2022
Photo Location:	Tag Land Dairy LLC
Photo taken by:	Struck, Eric J
Description: Mortality shed located south of WSF 1 and west of the feed storage area.

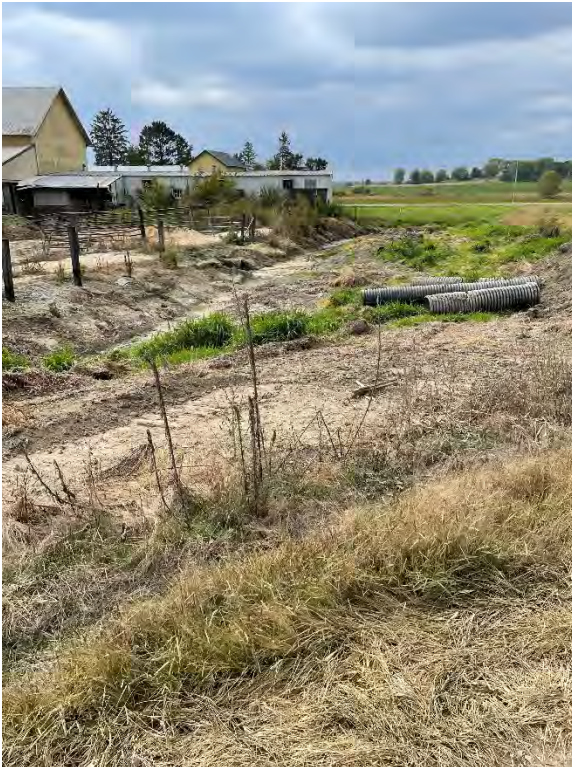
Photo #:	53
Date/Time:	10/11/2022
Photo Location:	Tag Land Dairy LLC
Photo taken by:	Struck, Eric J

Description: Abandoned VTA west of WSF 1. Now used for storm water only. Further grading needed from removal of culverts. Facing west near sand separation building.

Driveways and storm drains were free of debris and manure. Unused straw should be cleaned up before it becomes saturated, and poses a resource concern. Push out areas and sand storage were clean and well maintained. The unabandoned VTA is in the process of being cleaned up and grated to improve stormwater conveyances. This area should be reseeded as soon as possible to help prevent erosion and the farm is in the process of completing this project. Drive through feed lanes appeared clear of waste feed and were under roof.

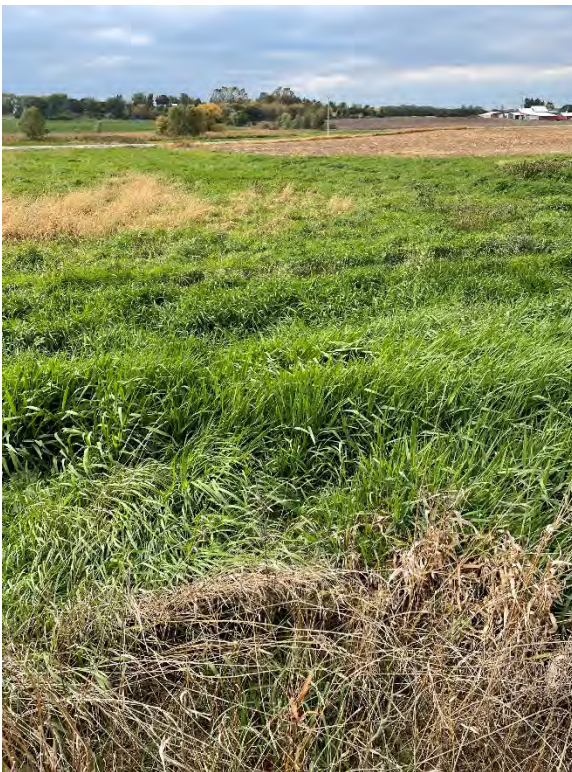
Photo #:	54
Date/Time:	10/11/2022
Photo Location:	Tag Land Dairy LLC
Photo taken by:	Struck, Eric J

Description: Facing west at abandoned VTA. Well vegetated and free of debris.

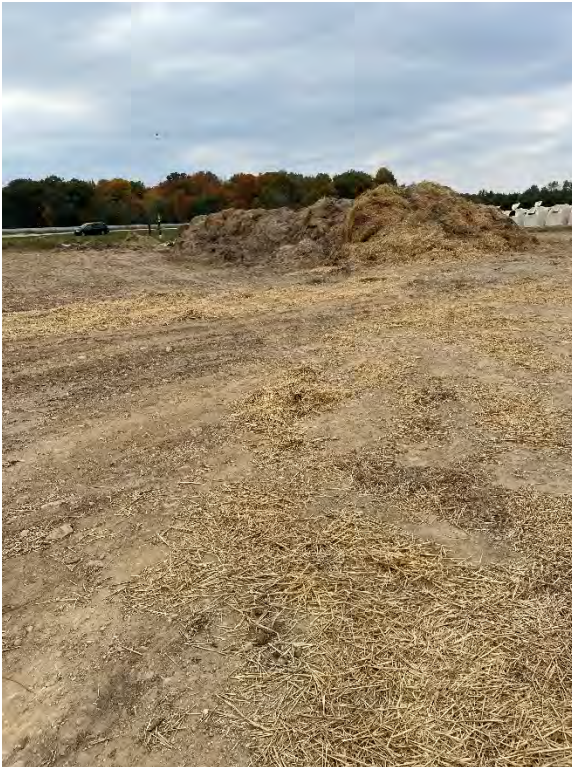
Photo #:	55
Date/Time:	10/11/2022
Photo Location:	Tag Land Dairy LLC
Photo taken by:	Struck, Eric J

Description: Unused straw stored south of the calf hutch area. Straw should be used or removed before saturation or moved to proper storage area. Farm plans to use or land apply this fall.

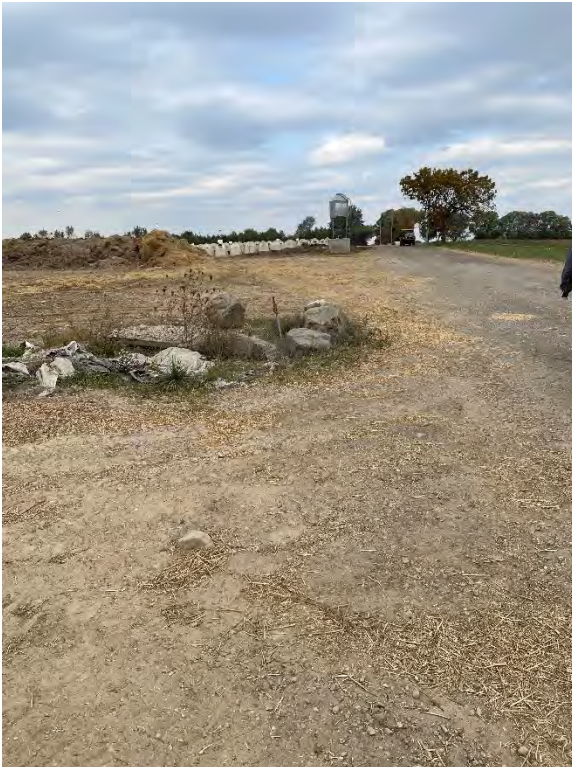
Photo #:	56
Date/Time:	10/11/2022
Photo Location:	Tag Land Dairy LLC
Photo taken by:	Struck, Eric J

Description: Facing north along main driveway to Gopher Hill Road. Looking towards calf hutch area. Left side of photo is possible location of future calf barn.

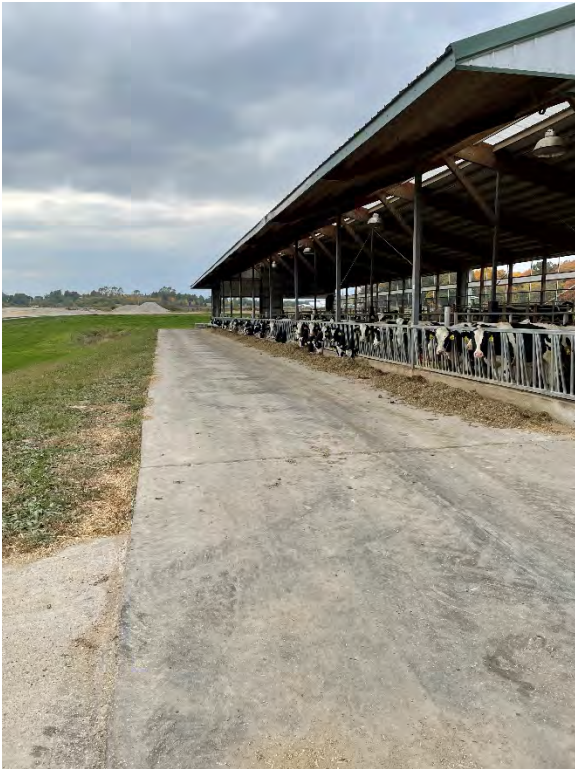
Photo #:	57
Date/Time:	10/11/2022
Photo Location:	Tag Land Dairy LLC
Photo taken by:	Struck, Eric J

Description: Facing west at covered drive by feeding lane of calf barn south of the calf hutch area.

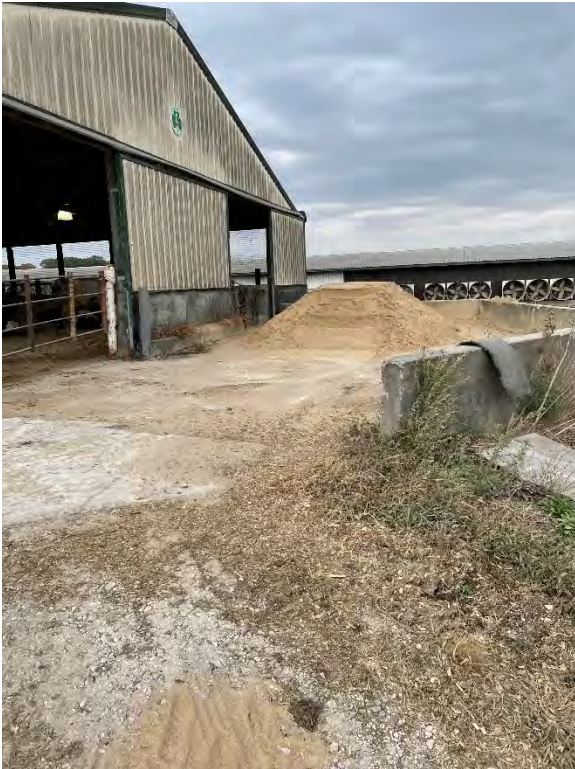
Photo #:	58
Date/Time:	10/11/2022
Photo Location:	Tag Land Dairy LLC
Photo taken by:	Struck, Eric J

Description: Clean sand storage outside of middle freestall barn.

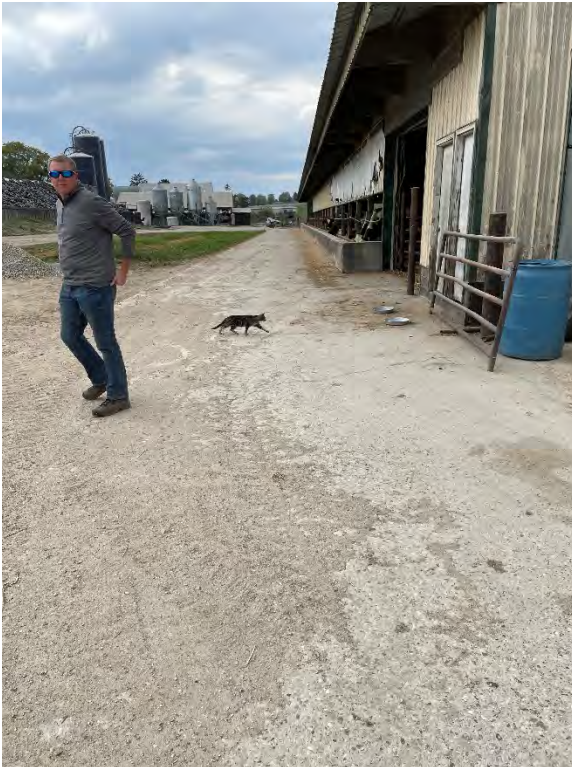
Photo #:	59
Date/Time:	10/11/2022
Photo Location:	Tag Land Dairy LLC
Photo taken by:	Struck, Eric J
Description: Facing west at drive by feeding lane along mild free stall barn. Under roof and free of waste feed.
