CHAPTER 13. LEARNING FROM PAST EXPERIENCES: Case Studies from Wisconsin

Case Study #1: Ozaukee County

Case Study #2: Walker Site, Columbia County . . .

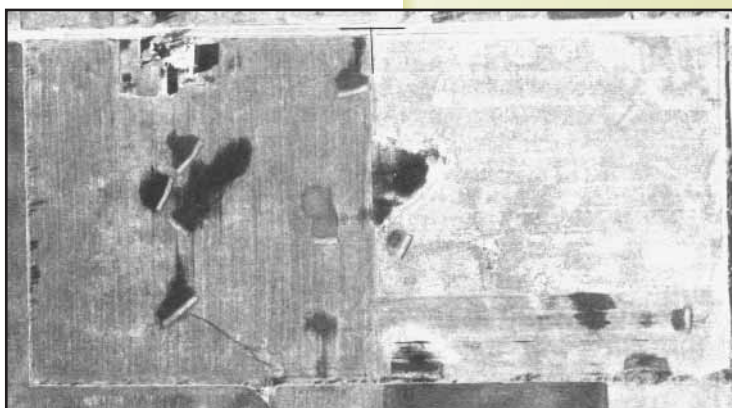
Middle, aerial photo of "1989" restoration site one year following restoration work. Note clusters of berm and scrape wetlands within farm field.

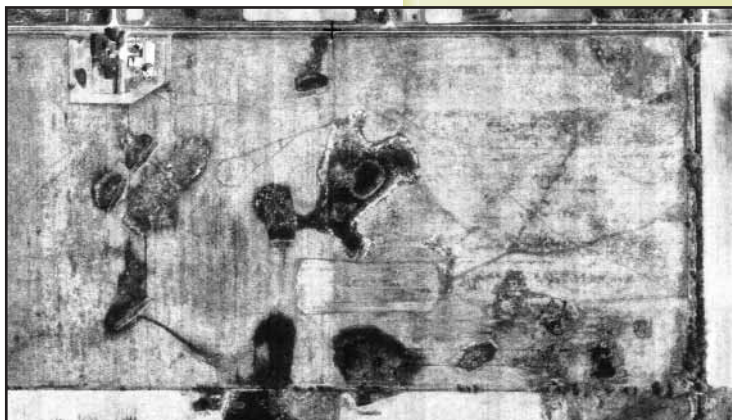
Bottom, aerial photo of "1989" restoration site five years after restoration.

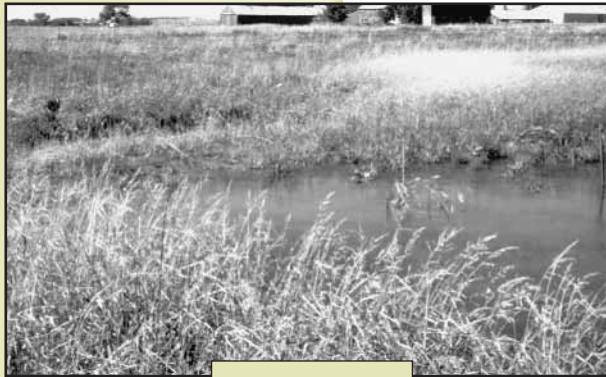
1989 SITE

Top left, "1989" restoration one year after restoration.

A closer comparison of the sites reveals some important distinctions between these two wetlands. The wetland constructed in 1989 appears to rely solely on surface water to supply the hydrology. This surface water drains agricultural land, with nearby cattle and sheep. As a result, the nutrient-rich animal waste drains directly to the wetland. In contrast, the wetland constructed in 1990 shows signs of groundwater input for its hydrology. Groundwater provides a stable, year-round water source that is lower in nutrients that favor invasive plants. Additionally, in the wetland constructed in 1990, the year-round supply of water made conditions favorable for a resident population of muskrats. The muskrats continually clip and chew wetland plants, including cattails. All of these differences illustrate the complexity in evaluating the results of wetland restoration.

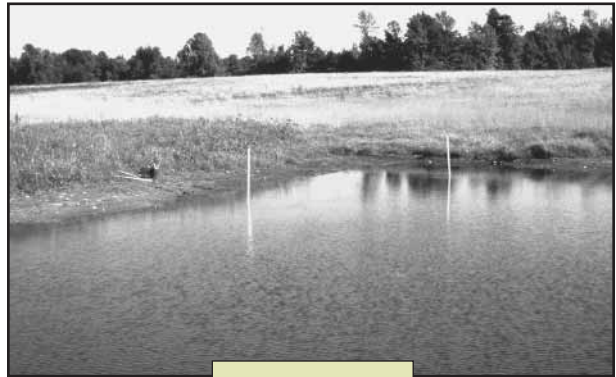
1990 SITE

Top right, "1990" site during first growing season.

Native wetland seed was not used in the wetland constructed in 1989. As part of a University of Wisconsin-Milwaukee project led by Dr. Reinartz, the site constructed in 1990 became one of five wetlands seeded with a mixture of 22 native wetland species. The seeds were collected locally on private land and stored outdoors in a metal can for winter stratification (to break dormancy). They were then hand scattered around the edge of the wetland in the spring of 1991, with half the seed cast in the shallow water at the wetland edge and half just above the water line. The development of vegetation and wildlife usage was monitored on these sites and 28 other

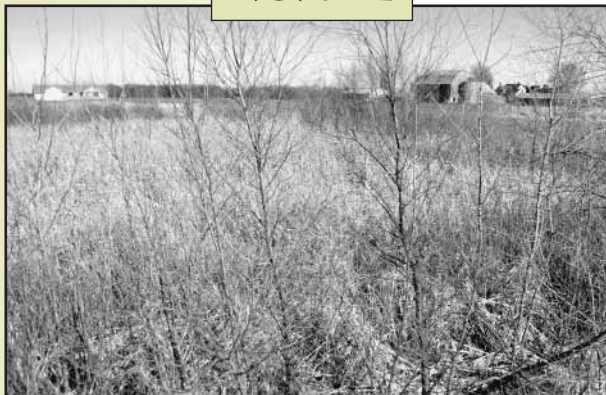
Bottom left, "1989" site ten years after restoration. Open water has been replaced by cattails in the basin and willows on the berm.

Viewing both wetlands 10 years after construction, the difference between these similarly constructed wetlands is remarkable. About half of the 1990 restoration area is open water with a diverse native and non-native plant community surrounding the open water. The shallow water edges are colonized by spike rushes (*Eleocharis* spp.) and coontail, a submerged aquatic. Very few cattails are present. In contrast, the 1989 site has a dense thicket of cattails with no open water, and by early summer no standing water. On the drier perimeter, the cattails give way to an equally dense willow fringe. After 10 years, all five of the seeded wetlands had higher diversity than the unseeded wetlands. These studies suggest that early seeding with native plants can “jump-start” the colonization of the site by natives and give the natives the establishment advantage. Cattail seed is light and wind blown and can quickly seed in from nearby wetlands. If cattail is the only plant in the wetland, it can rapidly spread. Once it is dominant it will exclude any other plants from gaining a foothold.

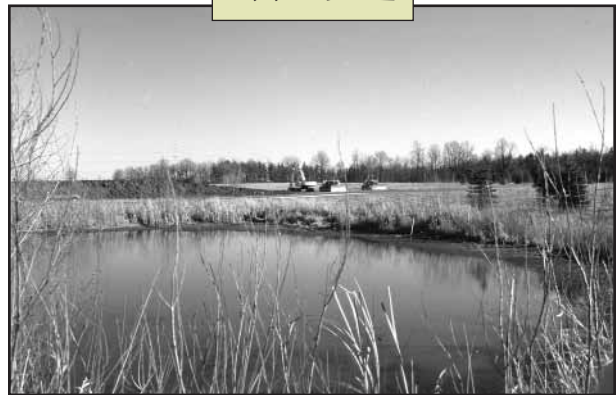
Bottom right, "1990" site nine years later. Open water and a diversity of native plants support wildlife use, including waterfowl and muskrats.

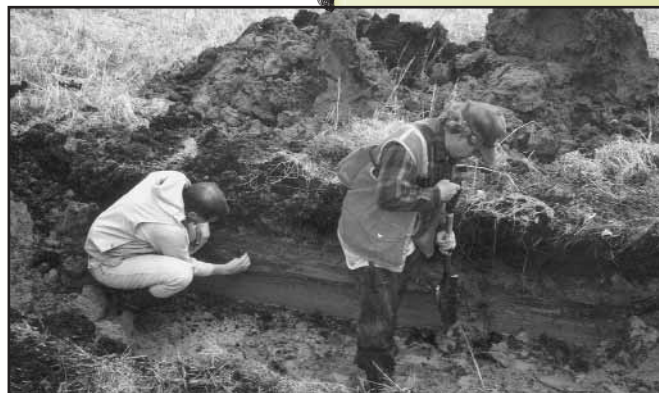
Determining the depth at which wetland (hydric) soils still occur is important in planning a wetland restoration.

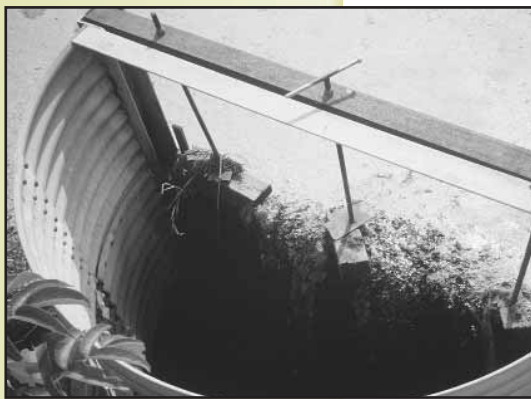
A water control structure is used to control water levels during restoration, creating a regime of high water and drawdown to stress reed canary grass.

In the summer of 1996, a temporary water control structure was installed at the drainage outlet to manage water levels during construction. A series of water level manipulations were planned, alternating with prescribed burns, to eradicate the reed canary grass. During the first summer, water levels were set

2 feet higher than the estimated historic levels in order to flood the reed canary grass. The water levels were then drawn down in winter. A prescribed burn in the spring preceded another water level elevation for the next summer. Four cycles of flooding/drawdown/burn resulted in eliminating about 80 percent of the reed canary grass in the basin. The reed canary that persisted occurred on the upper reaches of the site where it could not be flooded.

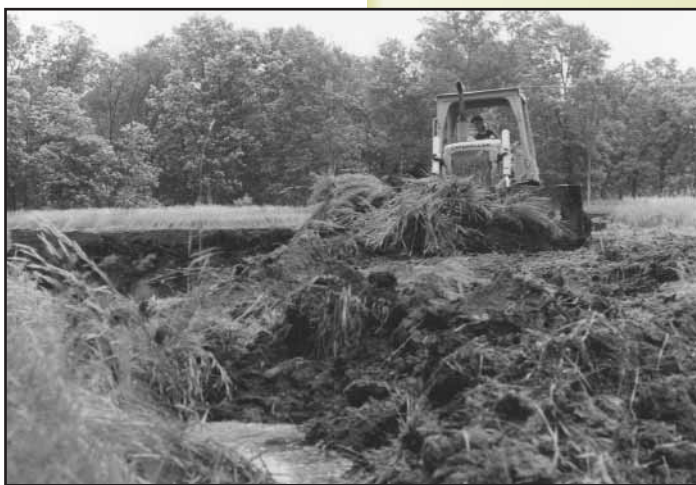
Reed canary grass is scraped from a restoration site and used to fill an existing ditch.

Beginning in 1996, the most critical portions of the ditches were filled over a four-year period. By the end of the first season, about a quarter of the ditches were filled. Water levels rose with the combination of ditch filling and the use of a water control structure. To fill the main ditch, a low pressure bulldozer skimmed 4 to 8 inches of remaining reed canary grass sod that was on a spoil pile and rolled it into the ditch. The remainder of the ditch was filled with spoils still intact from the original ditching. Ditched areas and slopes were graded to approximate the original elevations. Areas that had received erosional deposition from uplands were bulldozed to the original soil layer. In three successive years most of the ditches were filled, and the rising water levels affected more areas each year. The 60-acre upland area was planted with native prairie seed collected on nearby private land. The prairie was seeded over a three-year period, as seed became available.

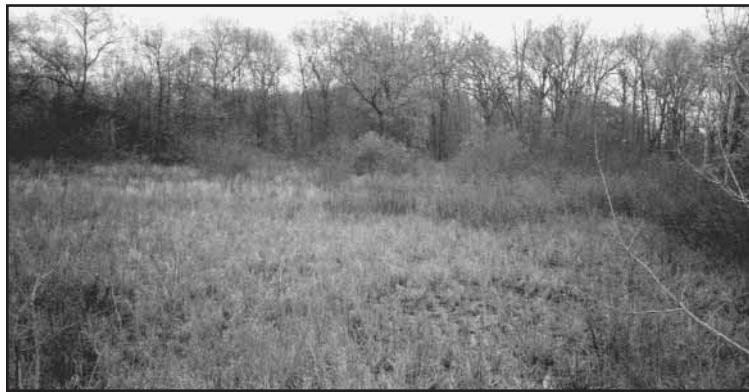
Wetland vegetation returns to the restored Walker site from the dormant seed bank.

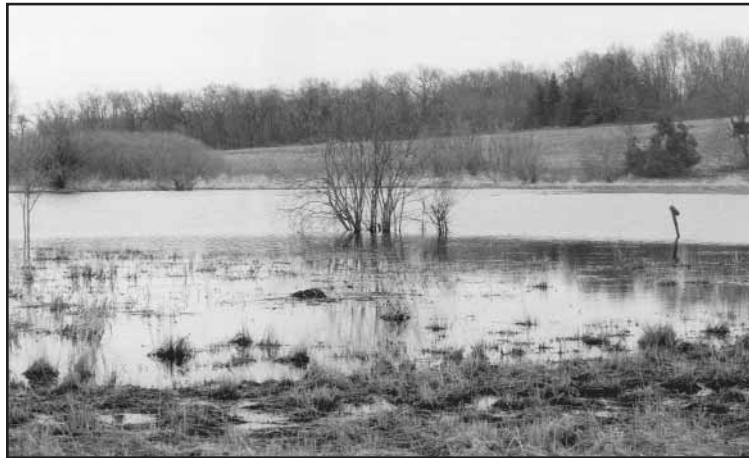
Wetland hydrology returns to the historic level at the Walker site following the filling of ditches that have a high water storage capacity.

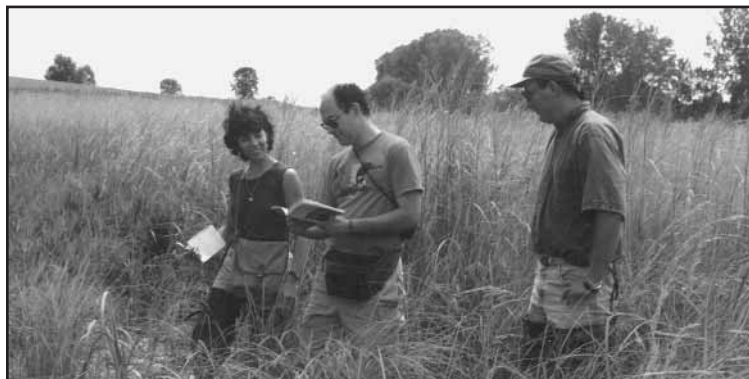
It is important to continue monitoring your wetland restoration for many years to determine what species become established and to detect any invasive plant problems.
